Cranbrook Japanese Garden Historic Landscape Study

January 2018

Cranbrook Center for Collections and Research
Cranbrook Educational Community
Bloomfield Hills, Michigan

QUINN EVANS
ARCHITECTS

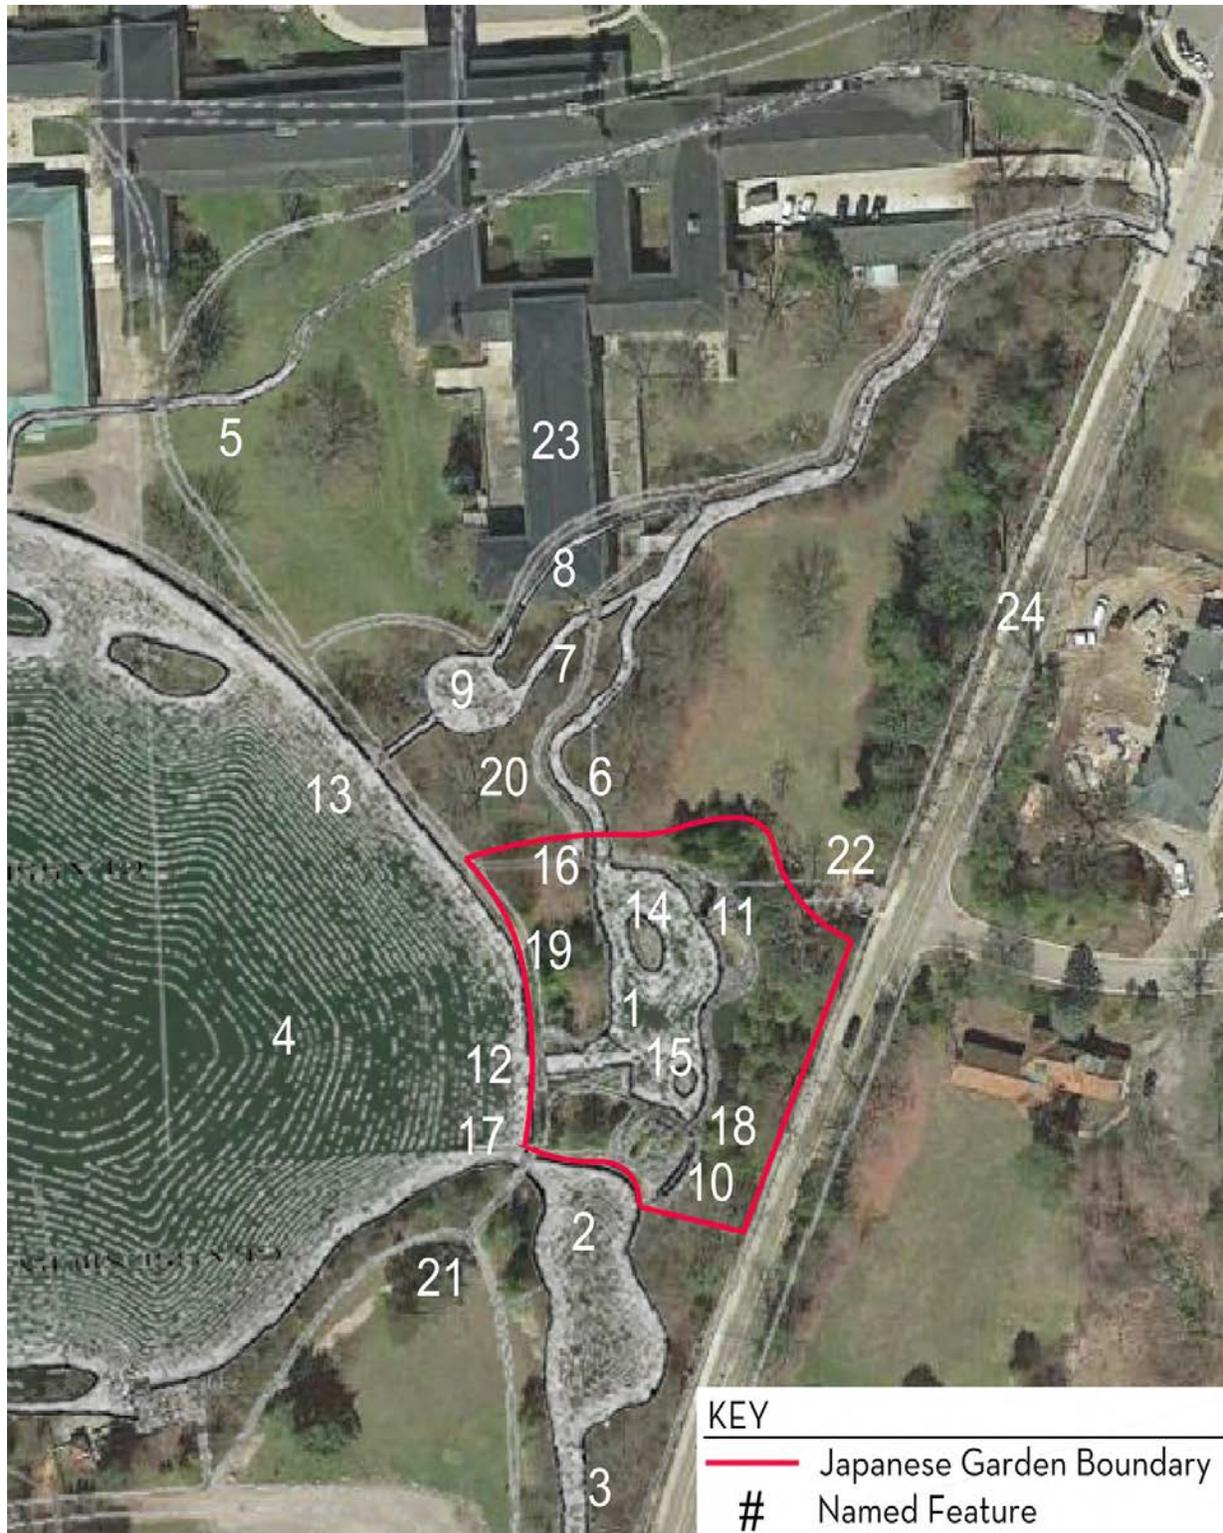
Figure 1.1 Study Area of the Japanese Garden and surrounds. Numbers correspond to historical terminology for places and landscape features used in this HLS, as listed on the previous page. The diagram is an overlay of the 1914 appraisal map by Coats & Burchard Co. on a 2017 aerial photograph to facilitate the location of historic features. QEA.

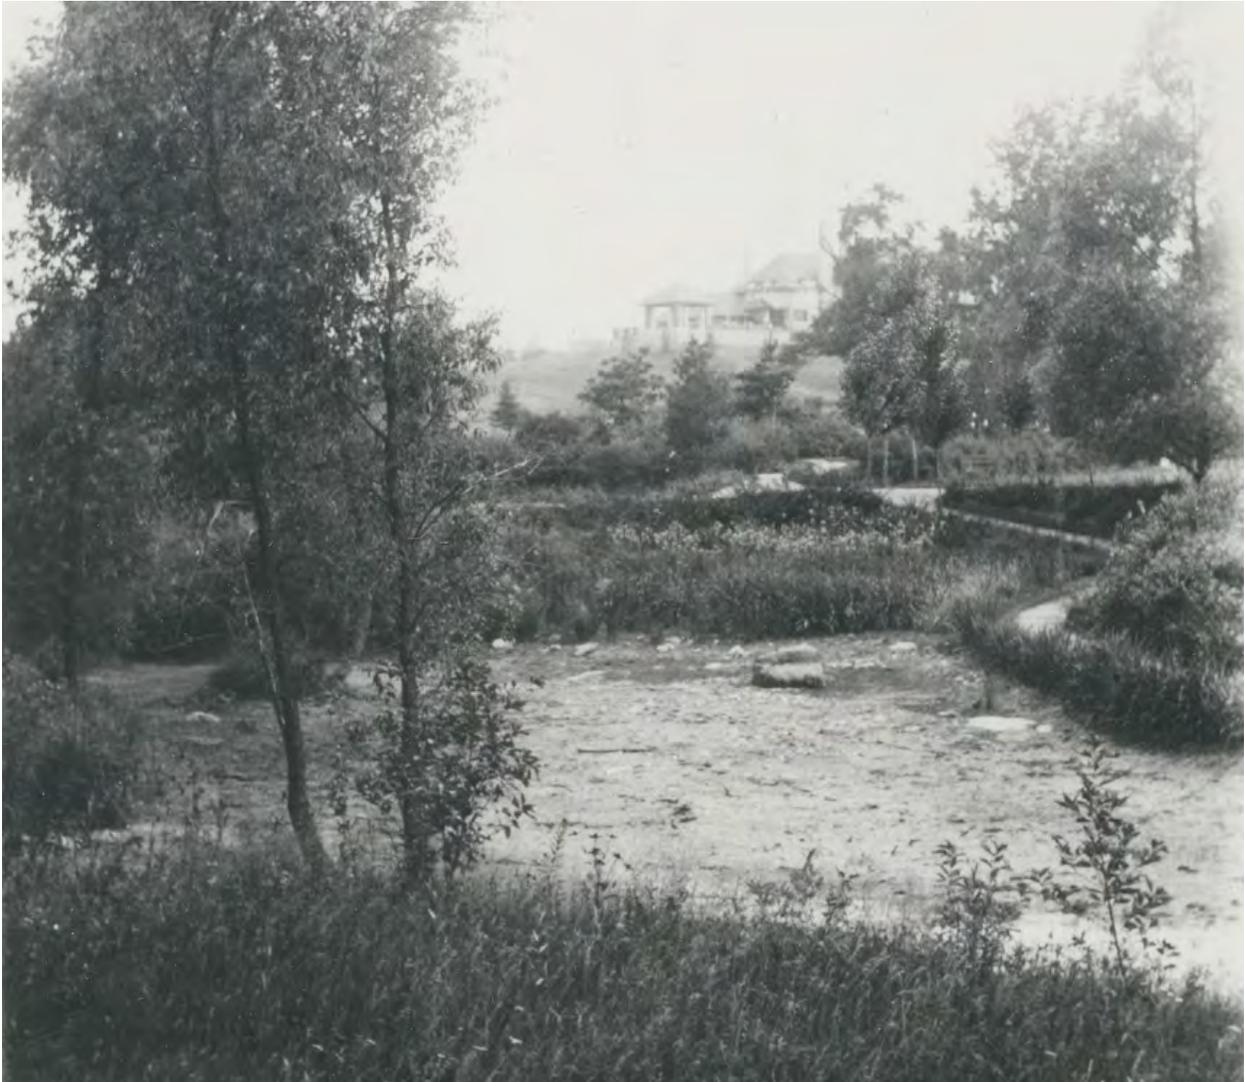
Figure 2.3 View southwest showing a dry water body, paths, and recent plantings in the Japanese Garden area, ca. 1909.

ca. 1909 A photograph shows curving paths in the Japanese Garden area that offer a view of the recently constructed Cranbrook House (Figure 2.3).⁹ The shallow depth of a pond or stream and recently planted deciduous and evergreen trees planted in meadow areas are visible. The partially screened views to the southwest will be blocked by tree growth in the following years.

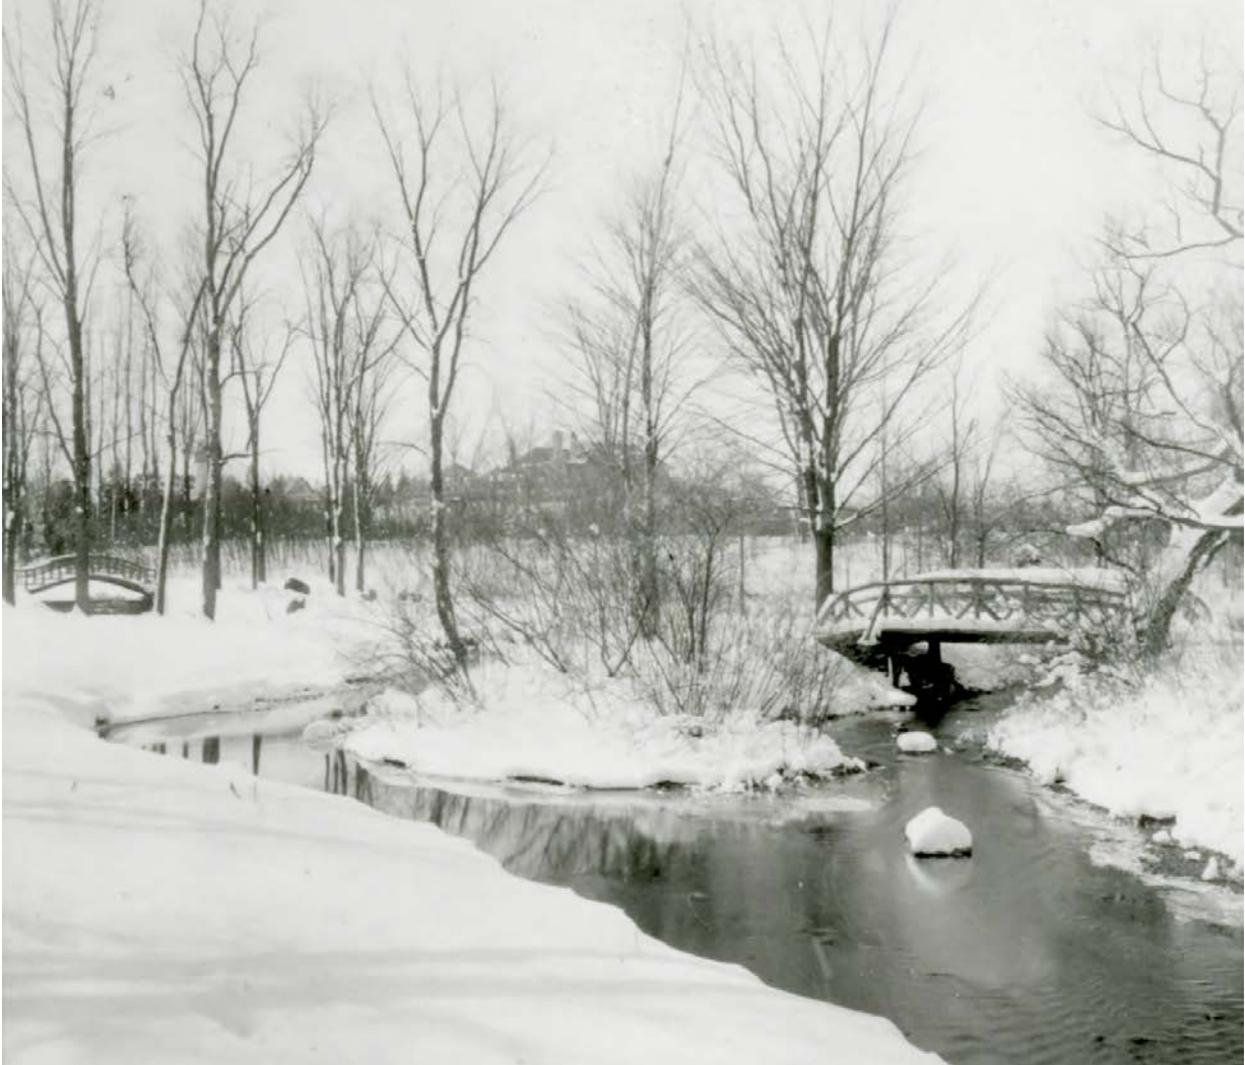
Figure 2.4 Winter view of the rustic Sunny Brook Bridge looking southwest through scattered canopy trees toward the Japanese Bridge at the north side of the Rock Garden, ca.1915, CEC808, Collection of Cranbrook Archives.

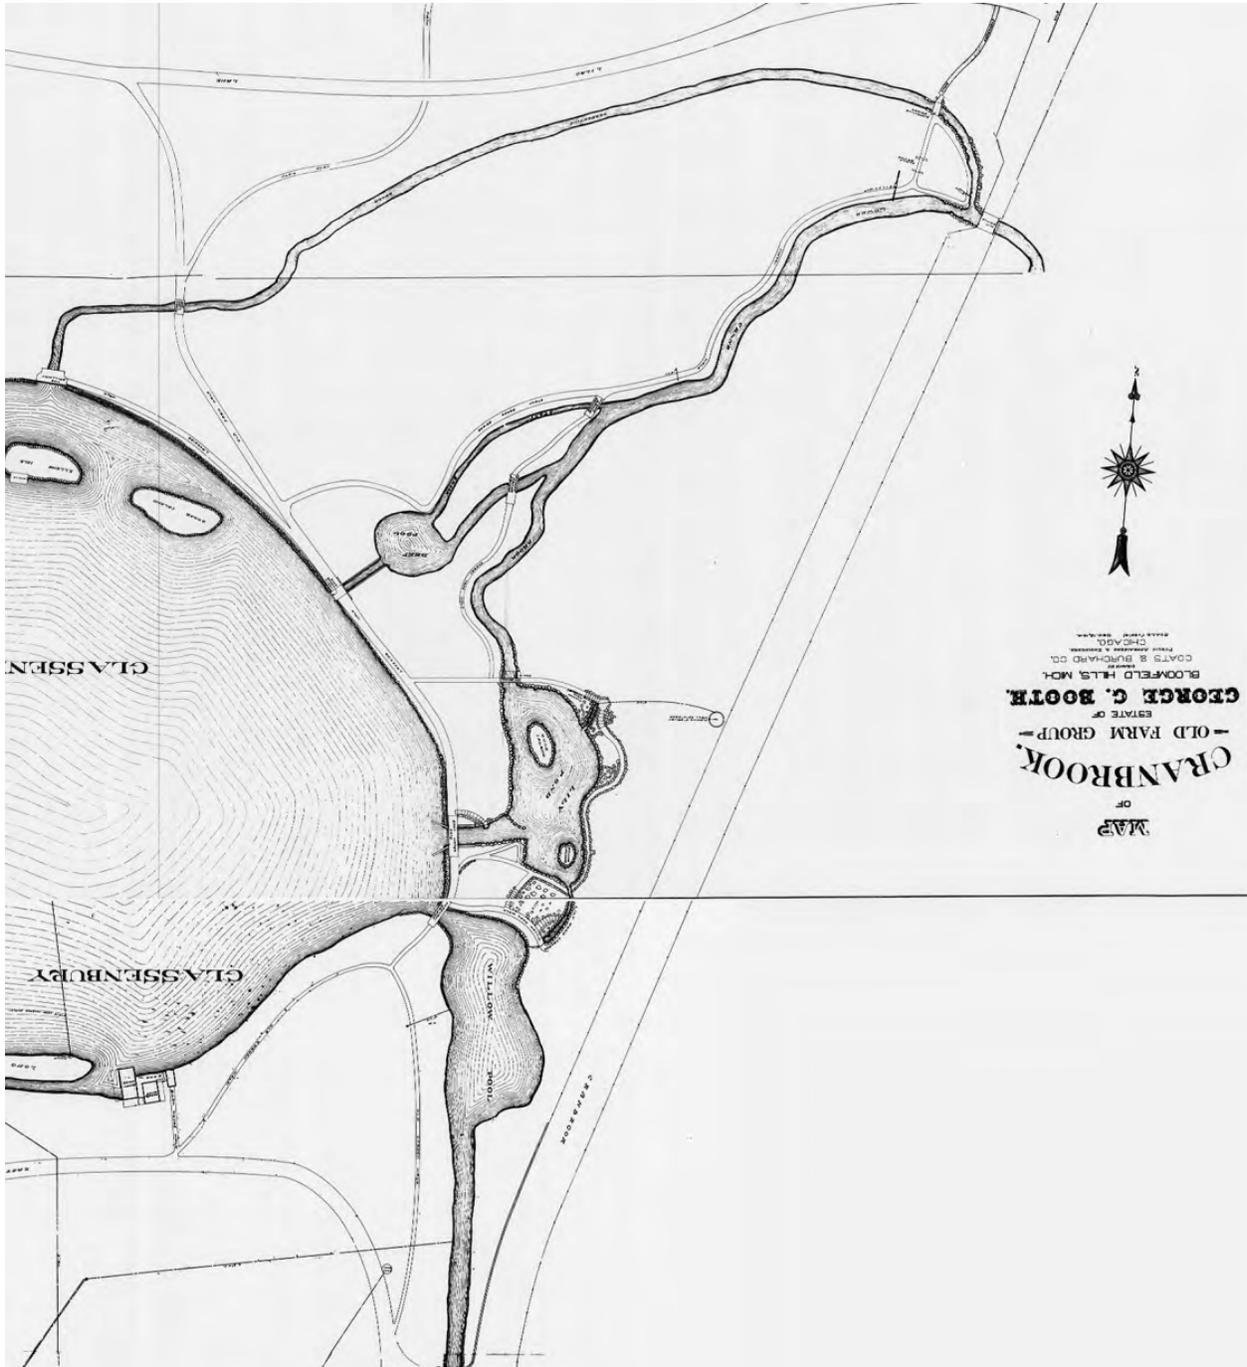
Figure 2.6 Features of the Japanese Garden appear on the 1914 appraisal map by Coats & Burchard Co. See Figure 1.1 in Chapter 1 and the 1928 Period Plan for the location of places and features referenced on this map. (The map is intentionally rotated to the north.)

-1 -6'2"x24'0" Rustic Bridge with 4 Oak Girders, 18" thick split field stone Walls 3'6" Below Grade and 3'6" Above Grade, with 1"x18" cement Wall Coping, as follows:-

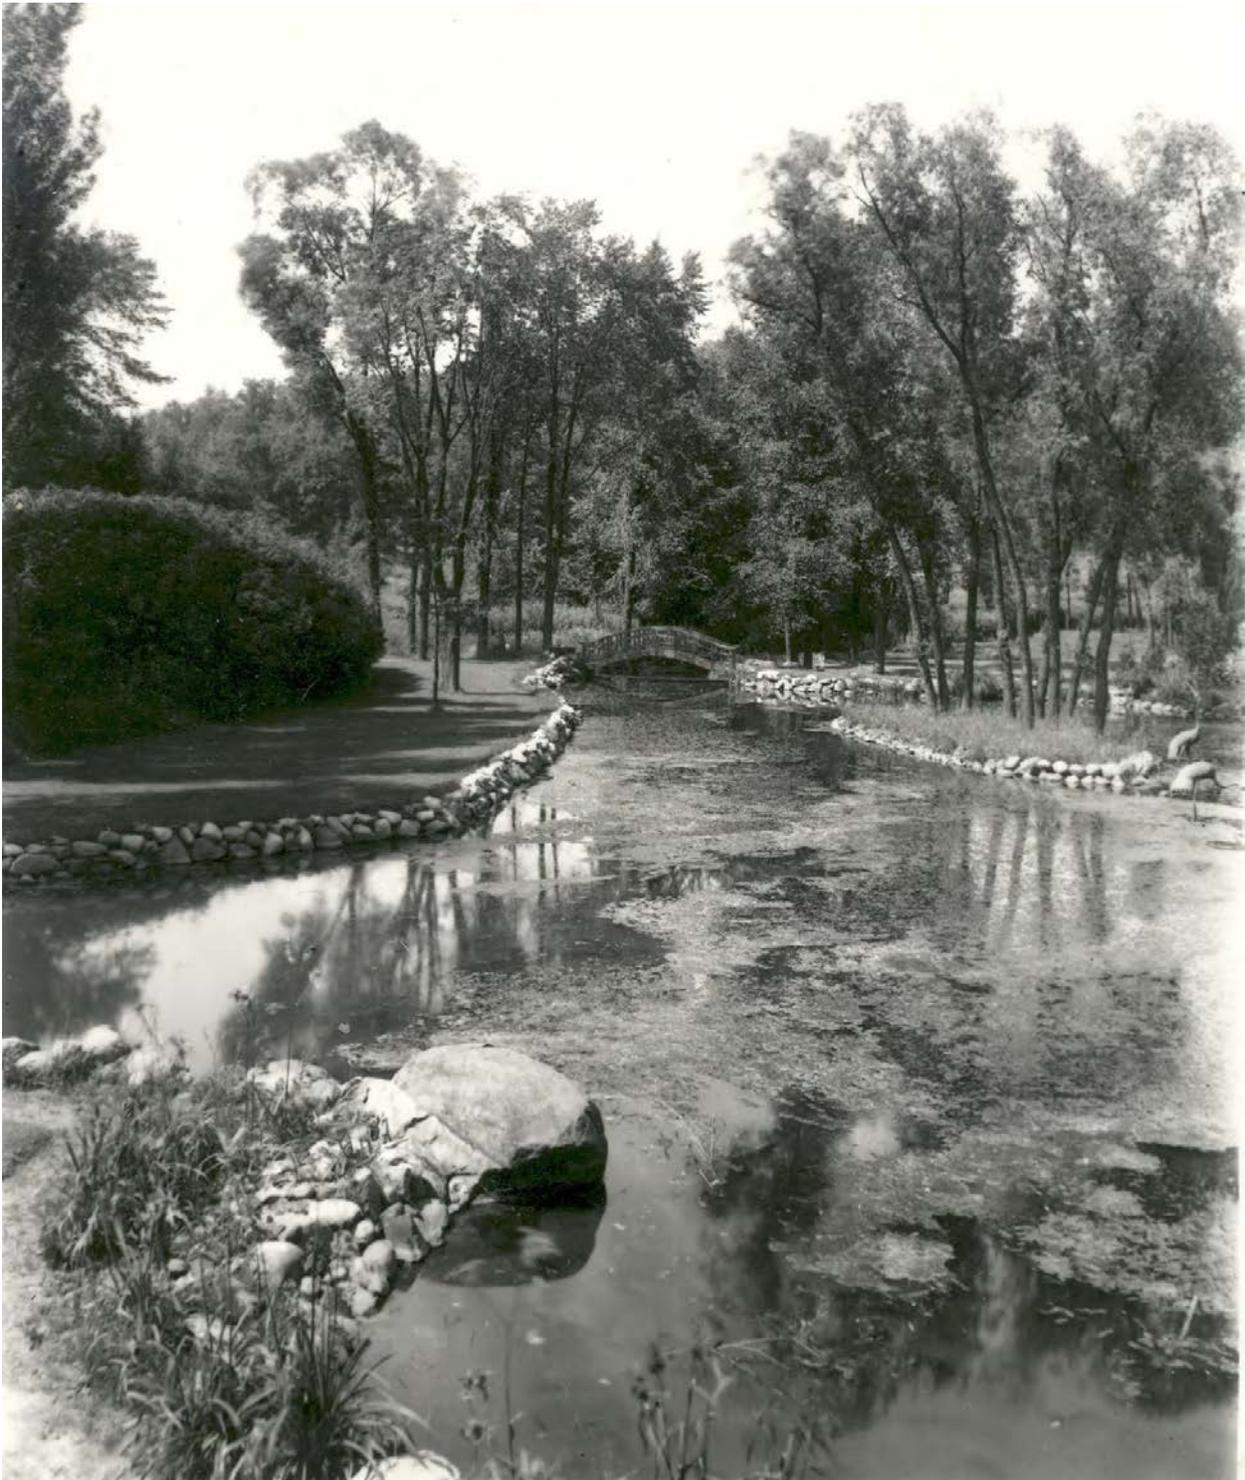
Figure 2.8 View north across the Lily Pond toward a large boulder, crane sculptures near Duck Island, and the Japanese Bridge. The western bank of the pond is turf in 1915. E133, Collection of Cranbrook Archives.

Photographs reveal the early character and development of the Japanese Garden (Figures 2.8 and 2.9). Small boulders line the Lily Pond and a few larger stones punctuate points of land that extend into the water. Nine trees, possibly ash (*Fraxinus* sp.), and meadow-like grasses on Duck Island, are protected from flowing water by a double row of larger stones along the shore. Two crane sculptures are located at the south end of the island. Pathways appear to be gravel in 1915. At this time, there is no path along the west side of the Lily Pond south of the Japanese Garden; instead, a wide, closely mown area separates the stone-lined pond from dense evergreen plantings on the embankment of the lake. A bench or table on a knoll at the top of the Lily Pond Cascade provides views south over the pond. This perspective reveals plants on the bank in the future location of the Yokohama lantern, the island with crane sculptures, the Japanese Bridge, and an open ground plane through the trunks of canopy trees in the distance. In contrast, views to the north across the pond are enclosed by horizontal layers of stones, groups of herbaceous plants, shrubs along an incline, and trees in the background.

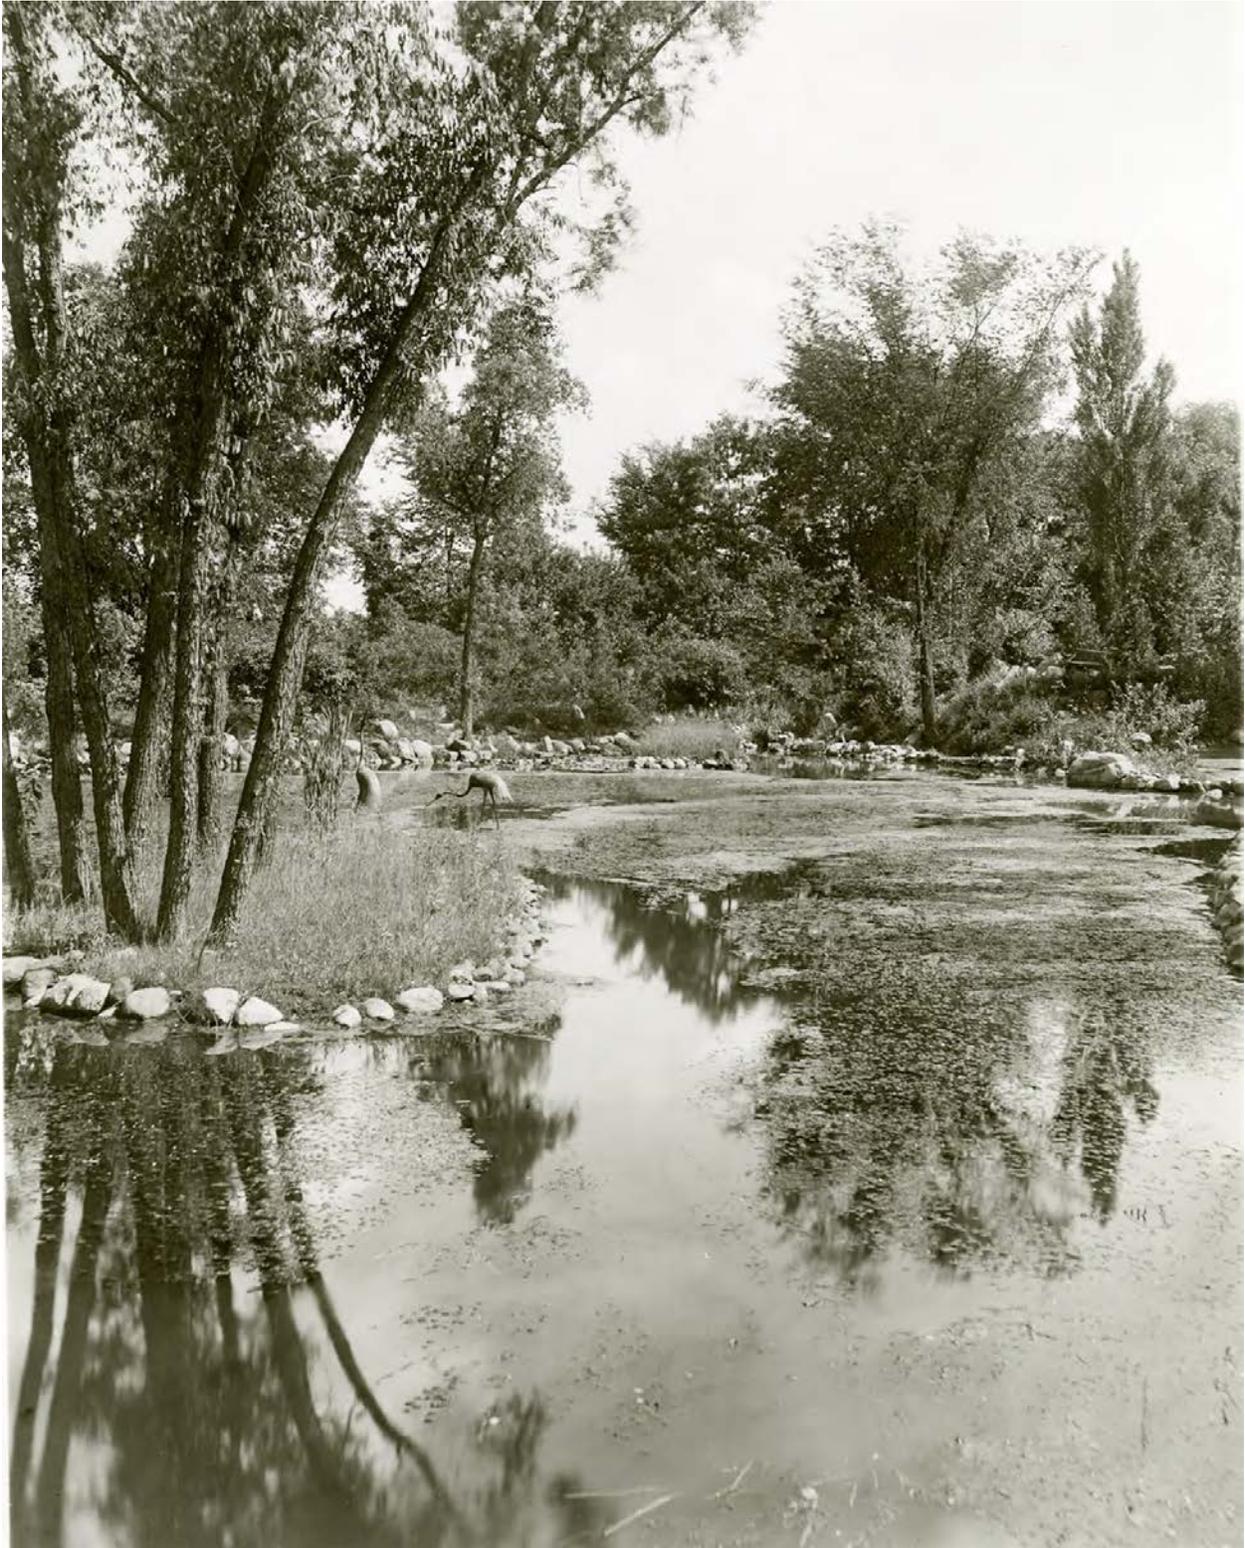
Figure 2.9 View south from the Japanese Bridge shows a bench or table on a promontory above the future location of the Yokohama lantern in 1915.

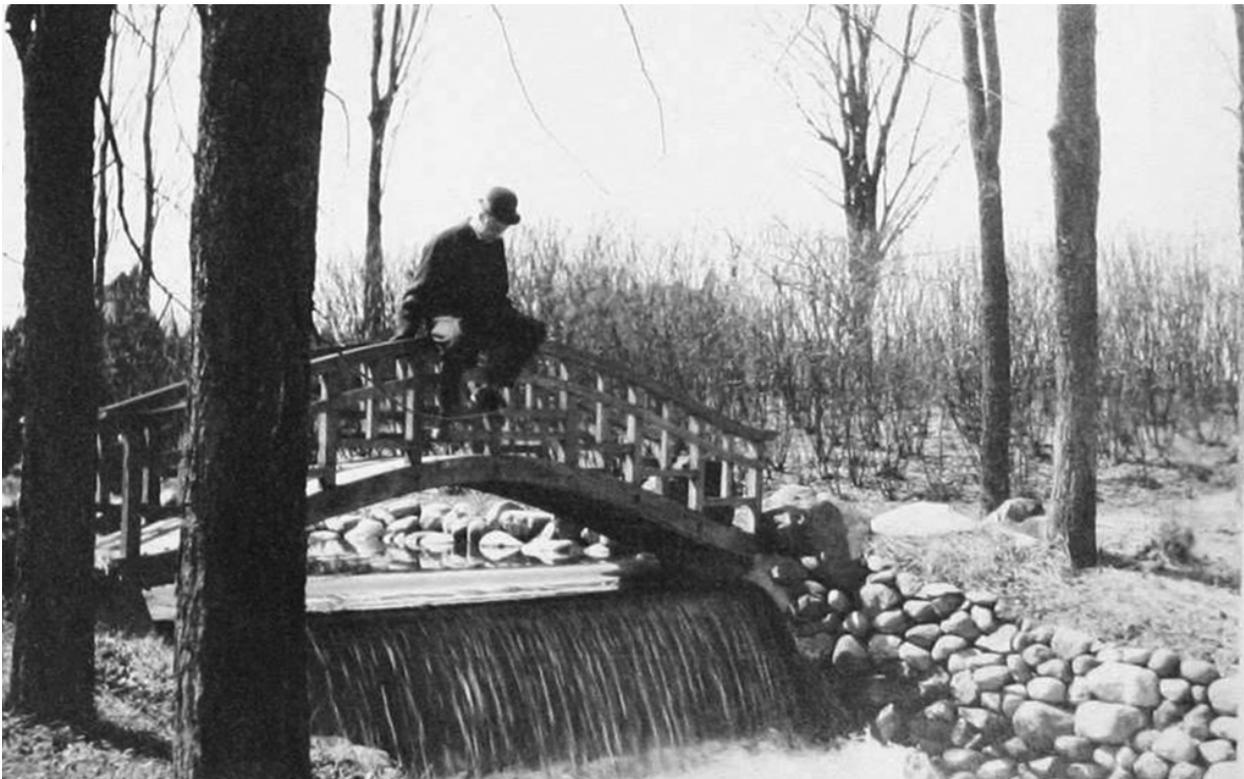
Figure 2.10 A photograph of the Japanese Garden bridge and dam with stone lined banks and deciduous trees and a shrub mass in the background, ca.1916.

Photographs taken around 1916 reveal the original character of the Japanese Garden. Henry Scripps Booth captions a photograph of his friend sitting on the unpainted Japanese Bridge, “Jean Steketee in the Japanese Garden, 1916” (Figure 2.10).³⁰ The photograph shows a hillside massing of upright shrubs suggestive of forsythia (*Forsythia* sp.) or red-osier dogwood (*Cornus sericea*) between the stone-lined stream and the Lakeside Walk. Evergreen trees are visible in the background on the slope adjacent to the deciduous shrub massing.

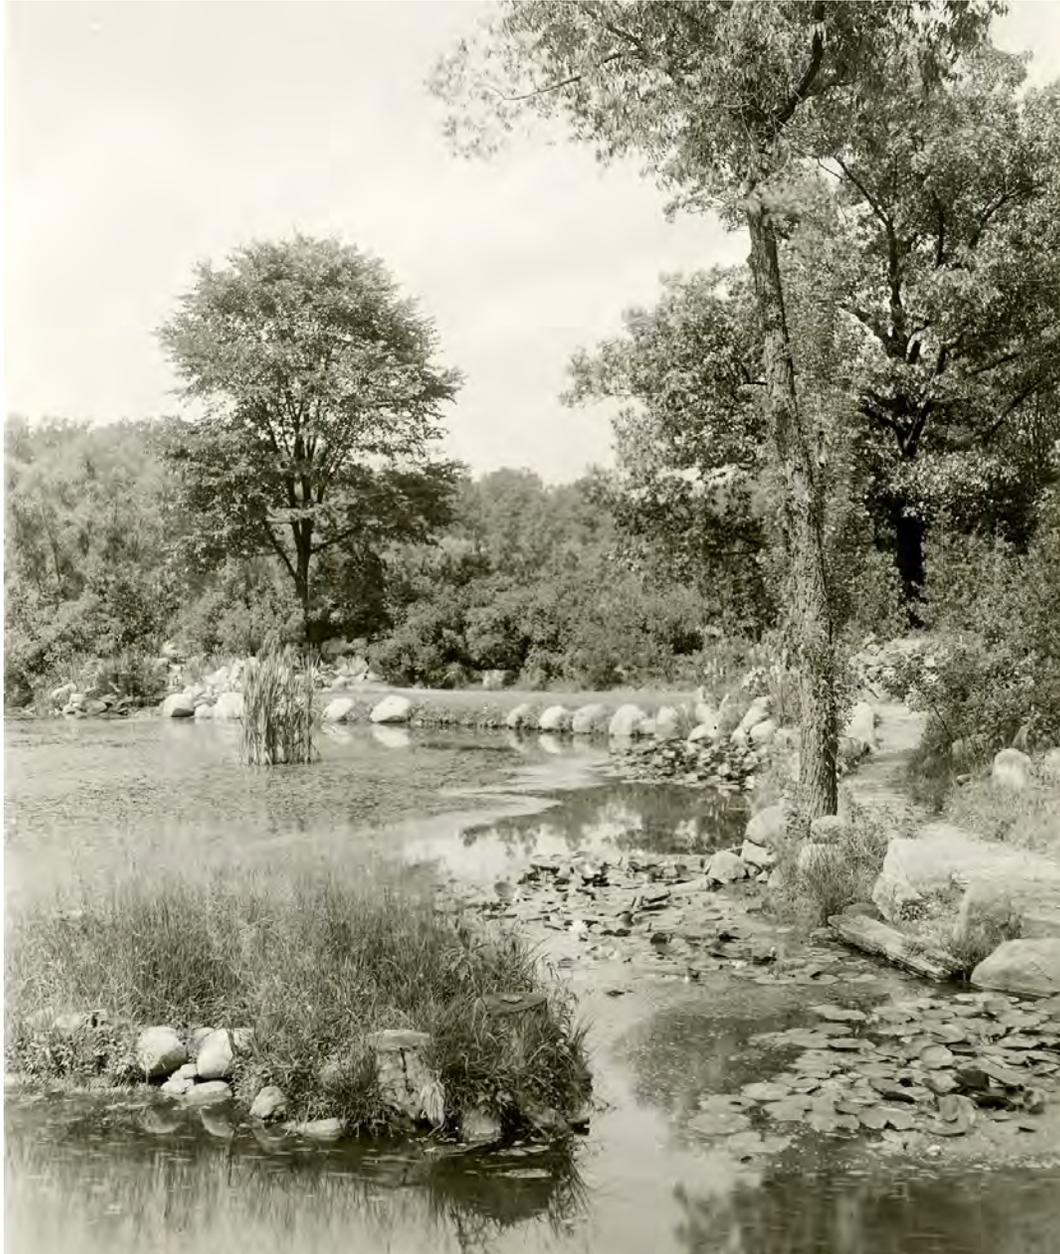
Figure 2.11 A narrow path along the eastern edge of the Lily Pond connects the southern end of the garden with the open shore near the Flowing Well Cascade, ca.1916. It is possible that a small bridge connected the lower east walk to the small island around this time. The stone-lined bank between the shoreline tree and the northeast landing in the distance may have been modified to expand the pond around this time.

By 1916, aquatic and terrestrial plantings gradually expand. These include cattails and water lilies in the Lily Pond and grasses and wildflowers along the narrow gravel paths that surround the pond (Figure 2.11). On the wide level bank of the northeast shore of the Lily Pond, a mown edge provides water access. Masses of shrubs provide a back edge to the level area near the bank. Canopy trees beyond this area fill the space between the Japanese Garden and Cranbrook Road to the east.

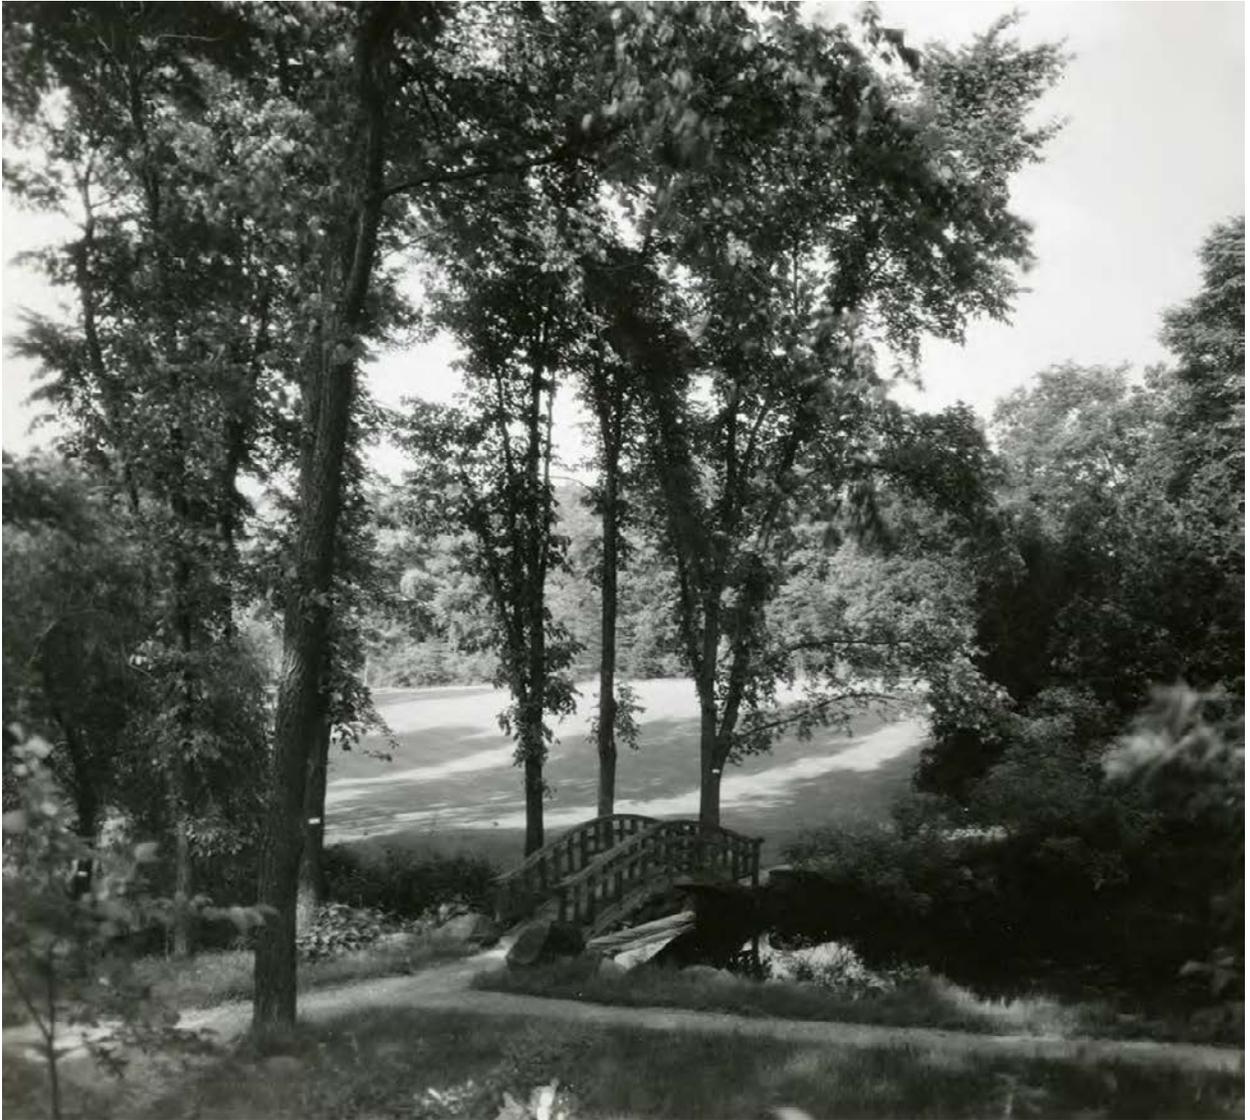
Figure 2.12 The setting of the Japanese Bridge forms a threshold and offers views at the north side of the Japanese Garden, ca.1917. An open lawn is visible from the vantage of the Lakeside Walk.

By the summer, views are opened between the Japanese Bridge from the Lakeside Walk through the removal of shrubs and planting of grass (Figure 2.12). This increases views below the canopy of American elm (*Ulmus americana*) trees to the grassy field northeast of the garden area.

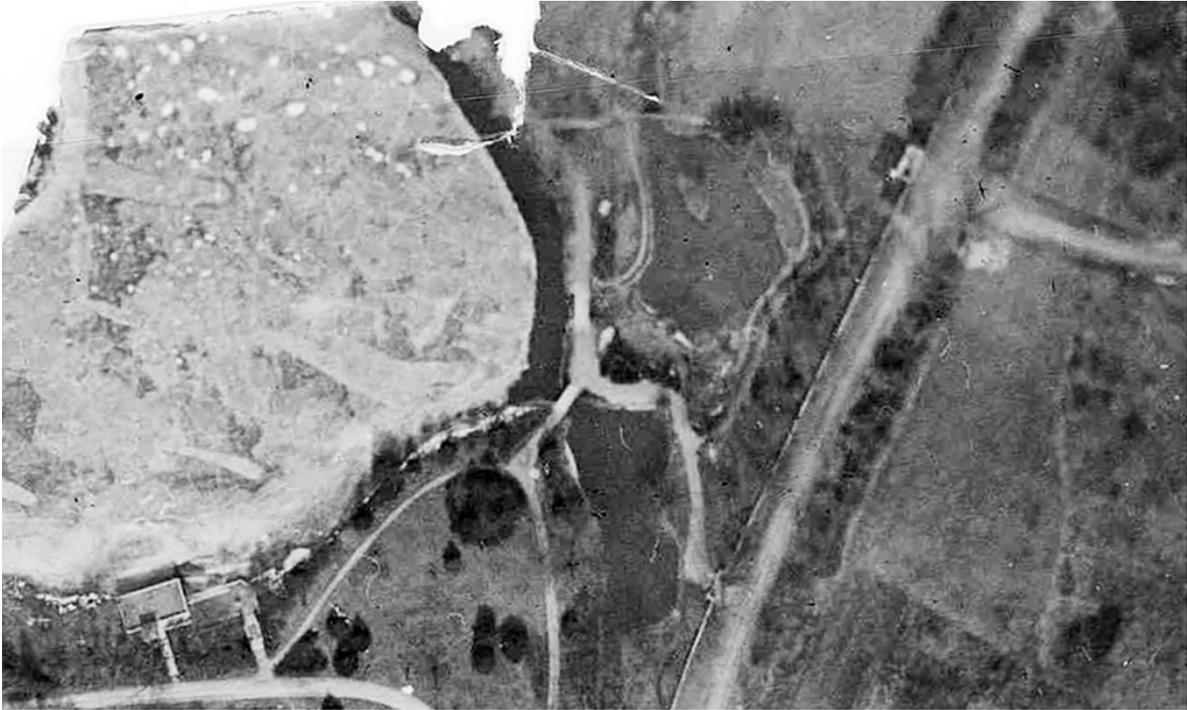
Figure 2.13 A winter aerial photograph from 1918 reveals patterns of circulation and evergreen vegetation.

1918 Aerial photographs record the pathways, stone-lined banks, and landscape context of the Japanese Garden (Figures 2.13 and 2.14). Photographs reveal the absence of a protruding bank shown on the 1914 appraisal map. This suggests that the east side of the Lily Pond (near the lower east walk in the vicinity of Figure 2.11) had been modified prior to 1918. Patterns of vegetation including areas of massed evergreens are apparent in the winter views around the Flowing Well Cascade, between the pond and Cranbrook Road to the east, on both sides of the East Water Gate bridge, and both sides of the Corduroy Bridge at the Willow Pool.³⁴ The historic density of evergreen vegetation persists in these areas. Older evergreen trees that predate Cranbrook appear as larger, dark masses along the

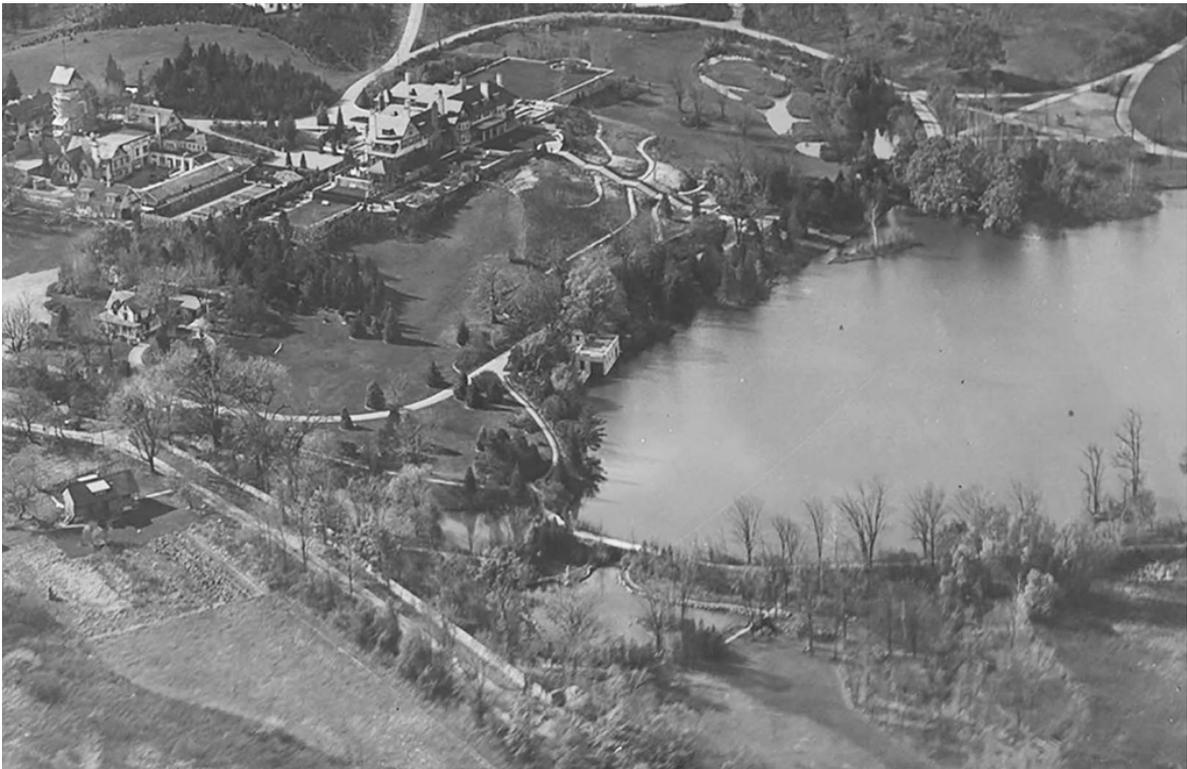
Figure 2.14 An oblique aerial photograph shows the Yokohama lantern and rocky edges of the water bodies in the Japanese Garden in the context of the Cranbrook House, 1918.

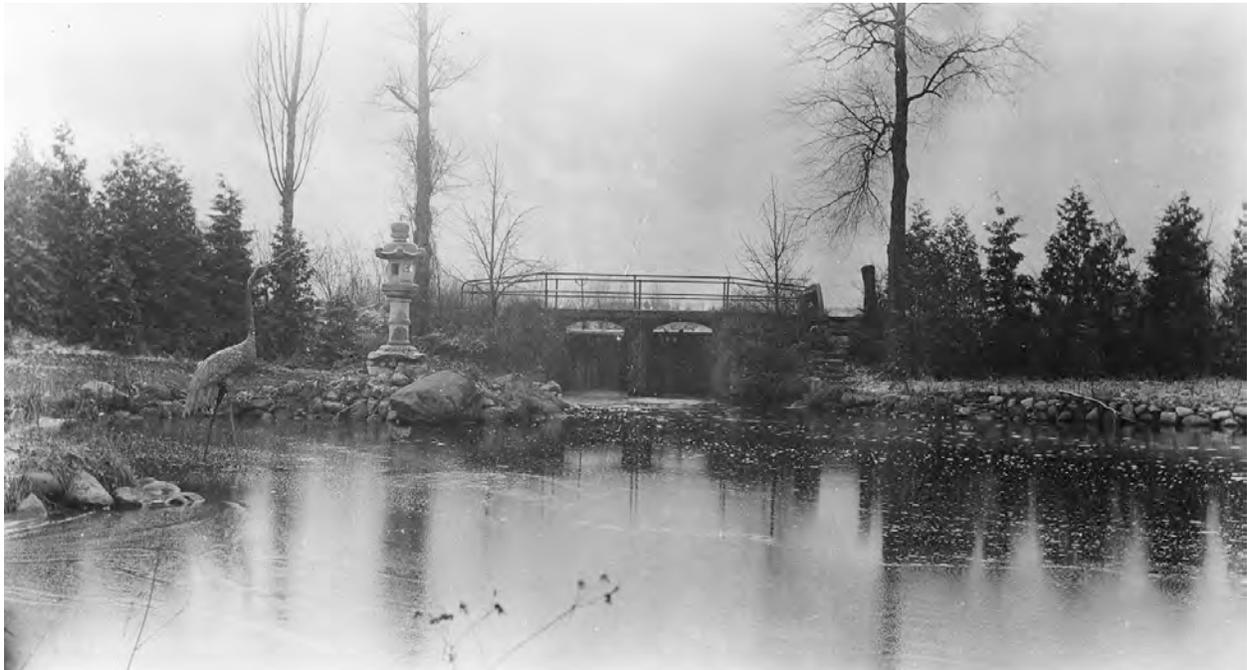
Figure 2.15 Winter view from Round Island west toward the Yokohama lantern and upright and crouching crane sculptures in the foreground and a symmetrical landscape design around the East Water Gate in the background, 1919.

1919 A winter photograph shows the placement of the lantern on an open promontory at the south end of the pond in 1919 (Figure 2.15). Two crane sculptures are also visible in the water near the lantern. The photograph reveals the structure of symmetry in the planting design for the East Water Gate at the Lily Pond. Paired vines drape from the walls containing the inlet from the lake. Above these, two American lindens (*Tilia americana*) project from the north and south ends of the concrete bridge. Stone steps descend from the Lakeside Walk on both sides of the bridge which indicates the placement of a new path along the west side of the Lily Pond. Selective removal of trees in the area retains a pair of large canopy trees, including one Siberian elm (*Ulmus pumila*), near the Lakeside Walk. Extending north and south along the upper bank are masses of evergreens, possibly Chinese juniper (*Juniperis chinensis*). Flooding in the spring of 1919 raises the lake level and undermines parts of the Millrace but the Japanese Garden is largely unaffected.³⁵ After this time, the stone shoreline of the pond and streams becomes seasonally less distinct and blended with encroaching vegetation.

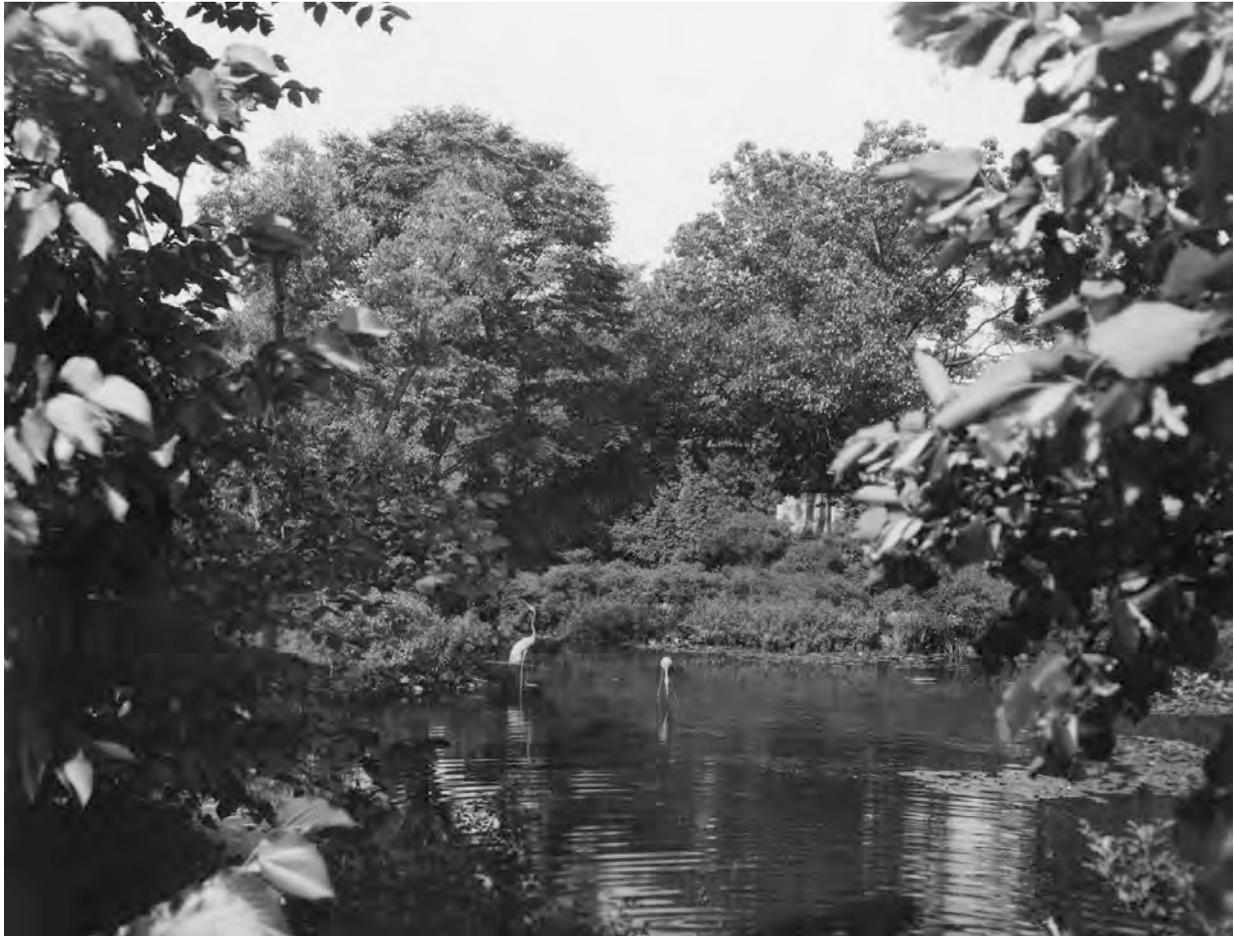
Figure 2.16 A view northeast through linden leaves from the East Water Gate bridge shows the two crane sculptures and provides a glimpse of the Rainbow Fountain, ca.1928.

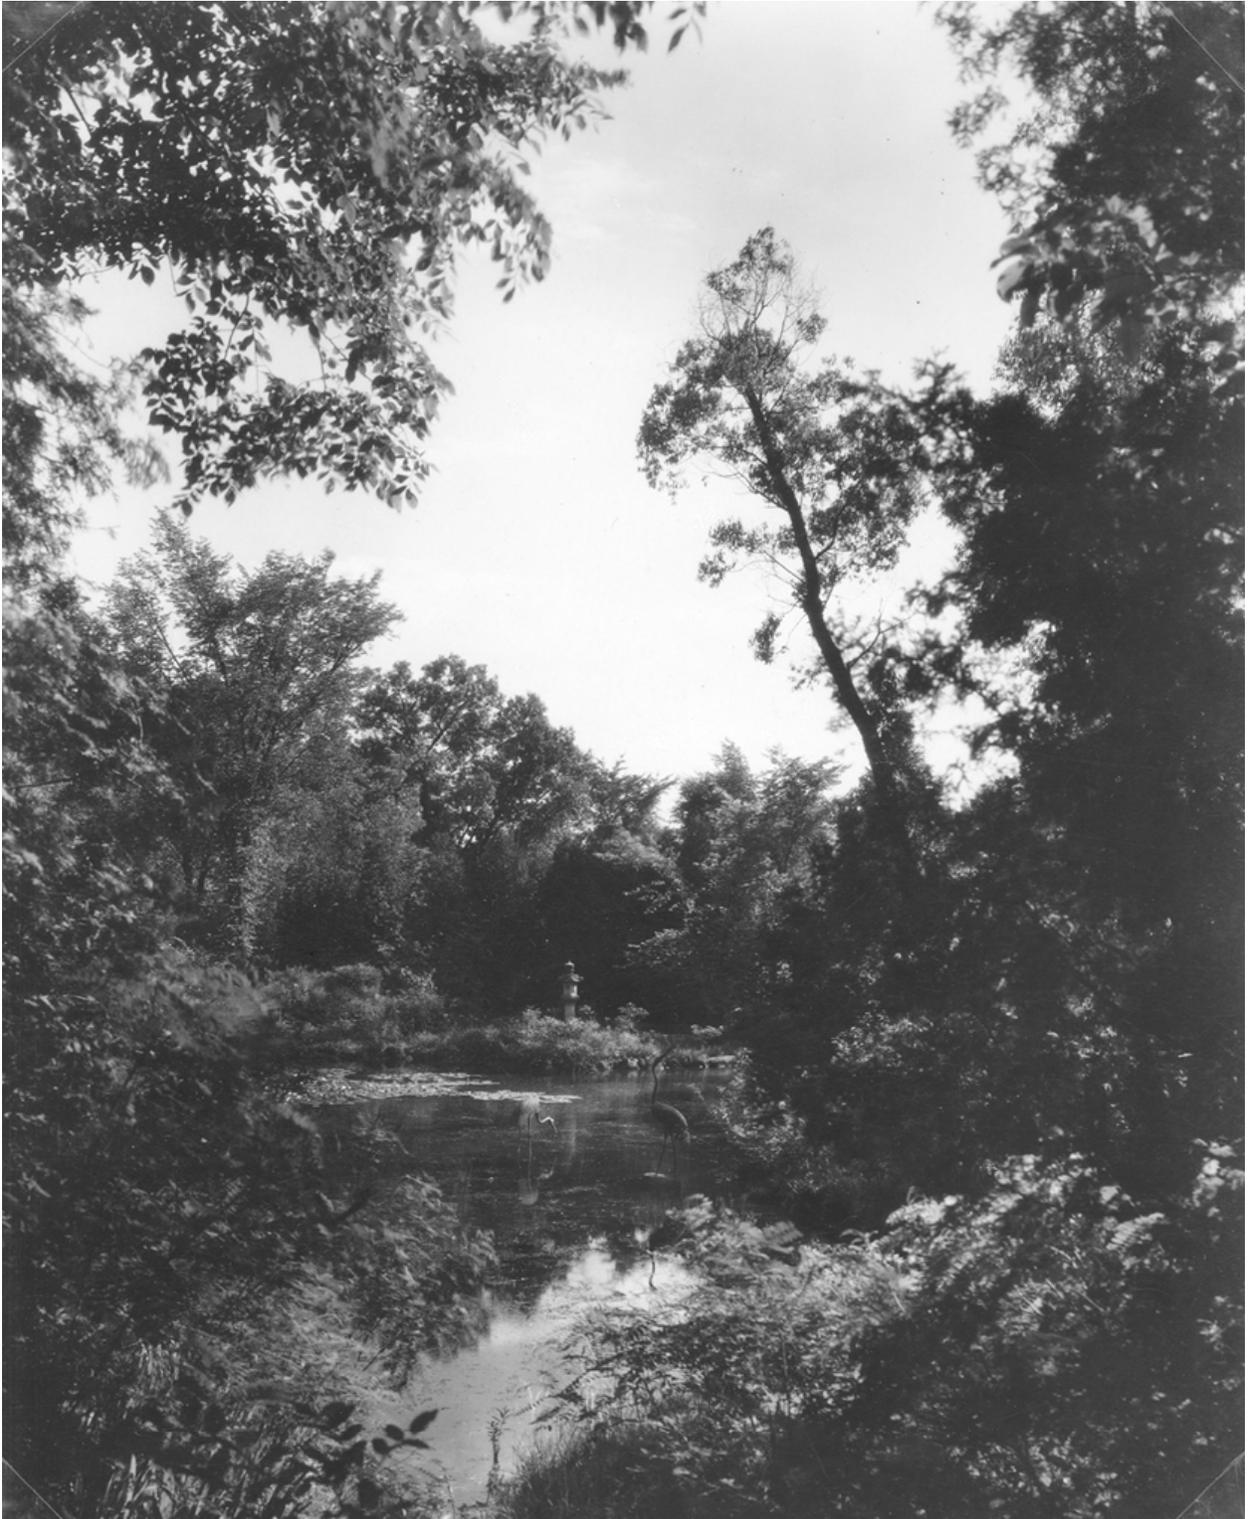
Figure 2.17 A view southwest from the top of the Flowing Well Cascade focuses on the Yokohama lantern, ca.1928.

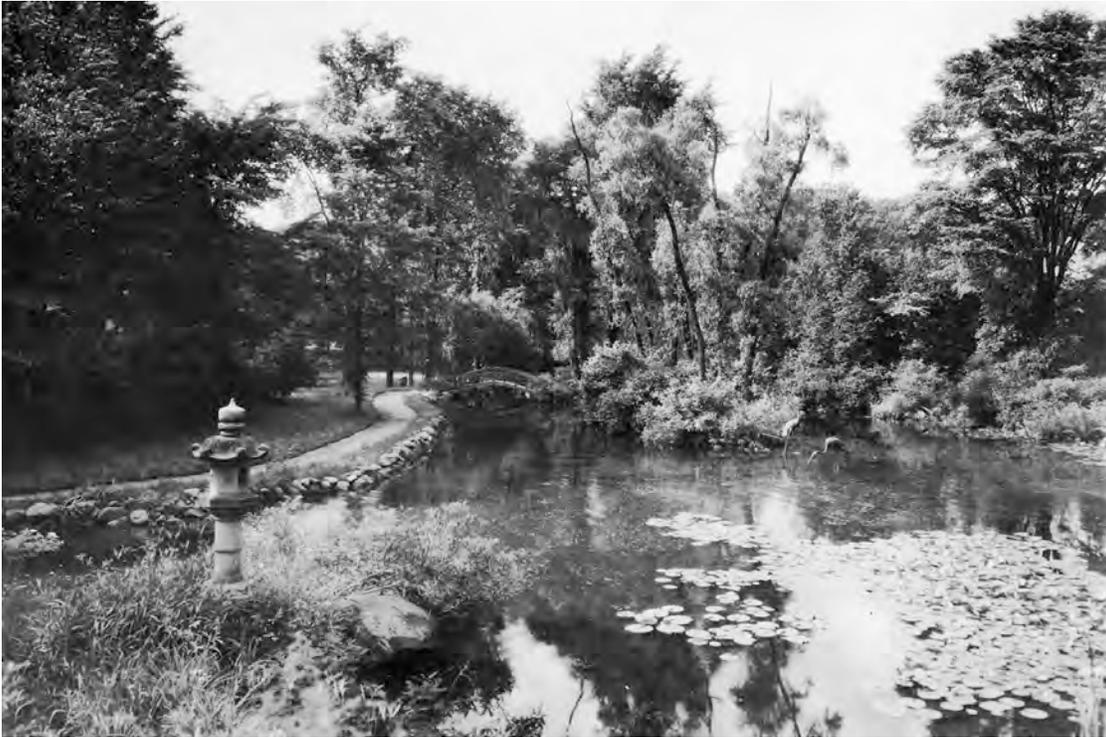
Figure 2.18 A view north from the Yokohama lantern shows visual connections to many points at the north side of the garden including the Japanese Bridge, Duck Island, and vegetation around the Flowing Well Cascade, ca.1928.
