Cranbrook Japanese Garden Historic Landscape Study

January 2018

Cranbrook Center for Collections and Research
Cranbrook Educational Community
Bloomfield Hills, Michigan

QUINN EVANS
ARCHITECTS

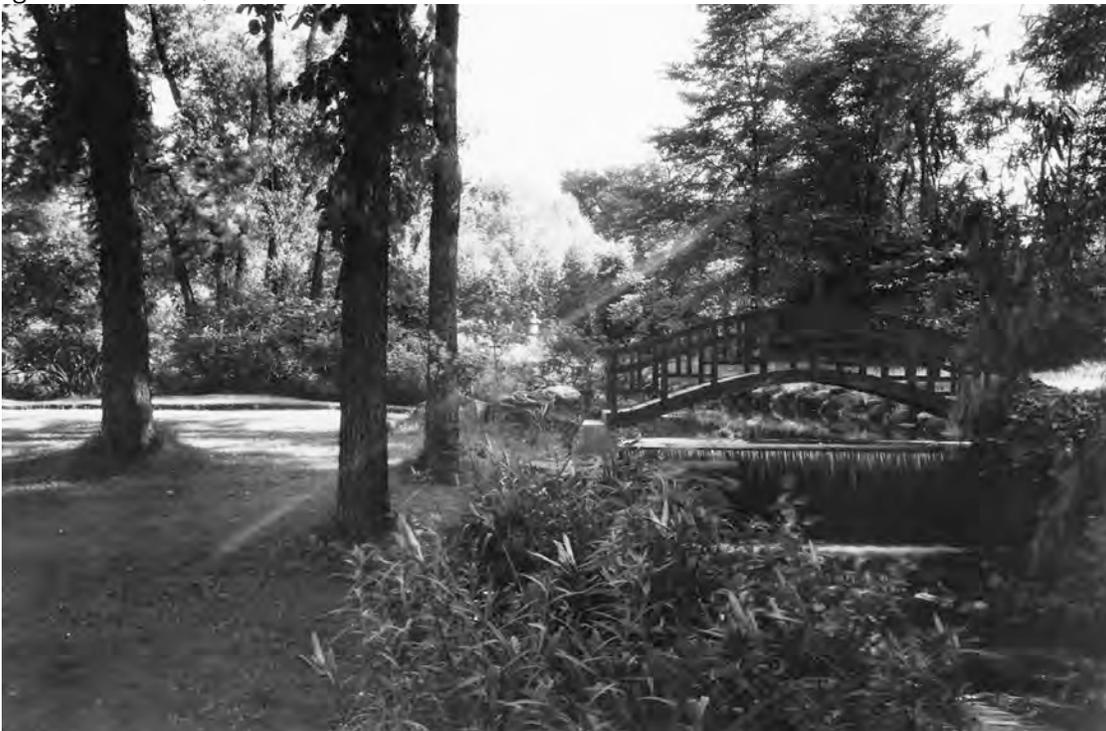
Figure 2.19 A view south from the Japanese Bridge provides a glimpse of the Yokohama lantern and other landscape features including daylilies, possibly bamboo, and a mown ground plane between the bridge and Duck Island, ca.1928.

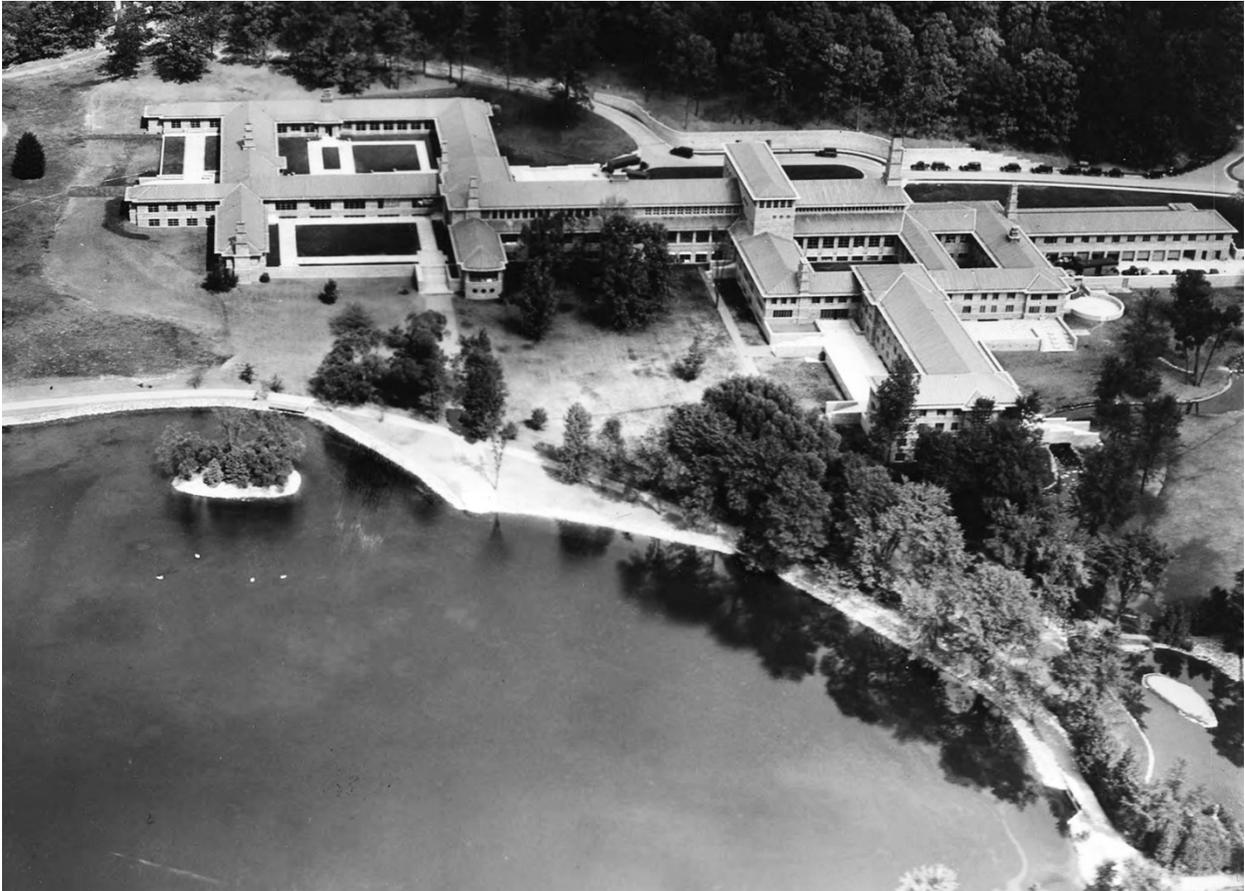
Figure 2.21 The nearly completed Kingswood School complex occupies the northeast shore of Kingswood Lake directly north of the Japanese Garden in 1931. The construction of the school results in changes to the waterways, character of the shoreline, features of the islands, and types of vegetation in the garden.

1929-1931 Kingswood School is designed in the Prairie Style of architecture Finnish architect Eliel Saarinen (Figure 2.21).³⁸ By completion in 1931, the grounds of the large school complex are connected to the Japanese Garden with paths and a bridge as well as with views through the selective clearing of vegetation between.³⁹ In the 1920s, George Gough Booth’s “1st Plan for ‘Kingswood’ as Day School Only” does not address the interface with the Japanese Garden but shows the building within a wooded setting directly on the lake.⁴⁰ This is significant because there does not appear to be a deliberate design for the changes documented within the Japanese Garden associated with the construction of the Kingswood School.

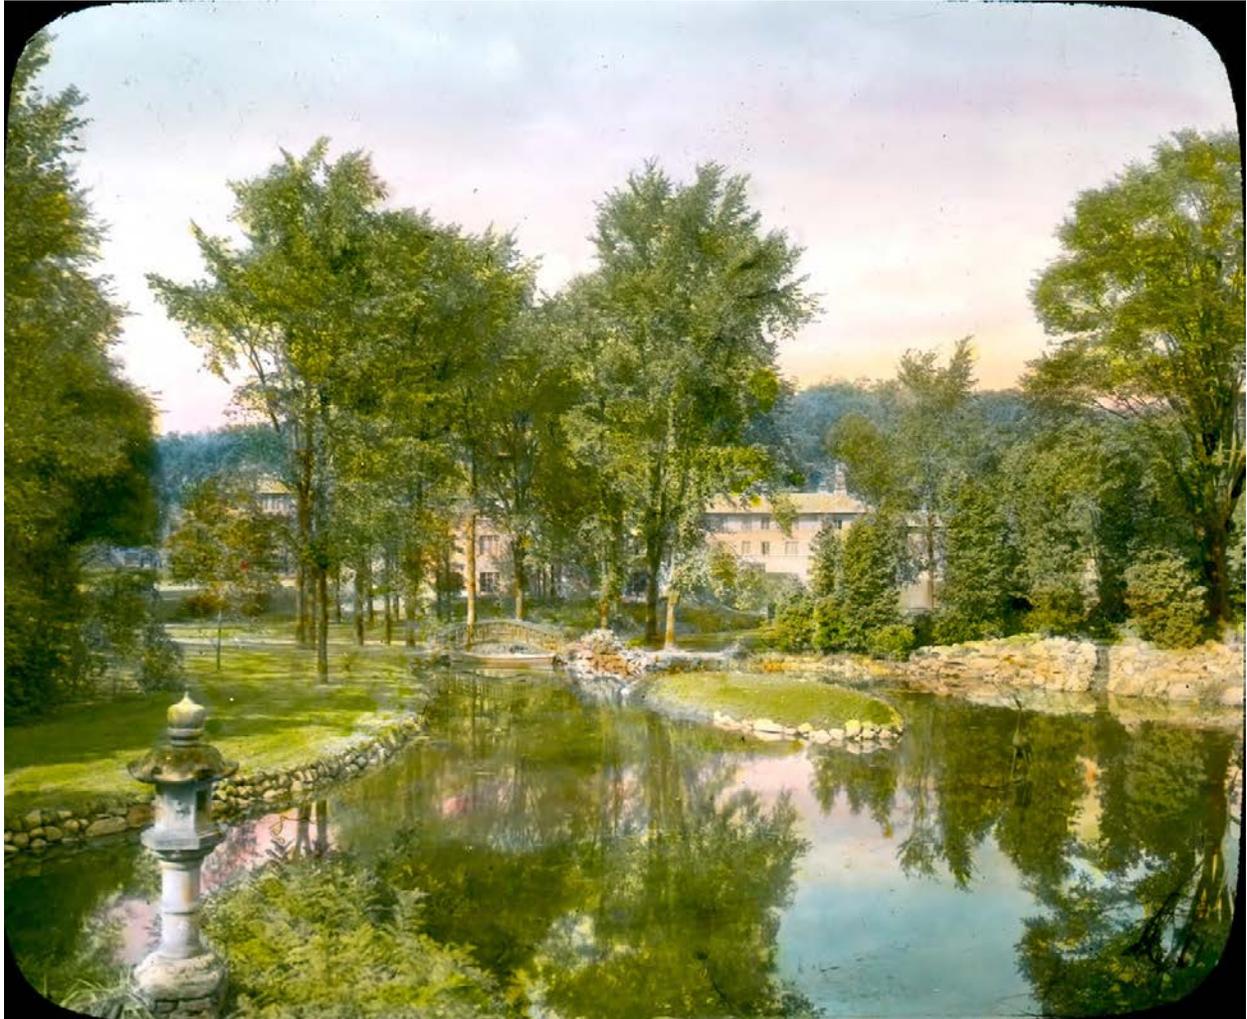
Figure 2.22 The landscape of the Japanese Garden is simplified after construction of Kingswood School in this 1932, hand-tinted glass slide of a George W. Hance photograph.

1932 Photographers George W. Hance and J. W. Hughes capture the character of the Japanese Garden and its relationship with the Kingswood School after construction. A hand-tinted glass slide of a Hance photograph presents the first color image of the garden (Figure 2.22). Later the photograph was used as a postcard with the title, “One of the delightful walks on the campus. The Japanese Garden.”⁴¹ At this time, the character of the landscape was simplified to create open ground plane throughout most parts of the garden that do not contain tree masses. Stone work around the pond, Duck Island, and the Flower Well Cascade, appears to have been stripped of vegetation and re-laid. Vegetation is different, although the edge stones echo the character of the early Japanese Garden. Additionally, the path built along the west edge of the pond in 1916 was removed and replaced with grass.

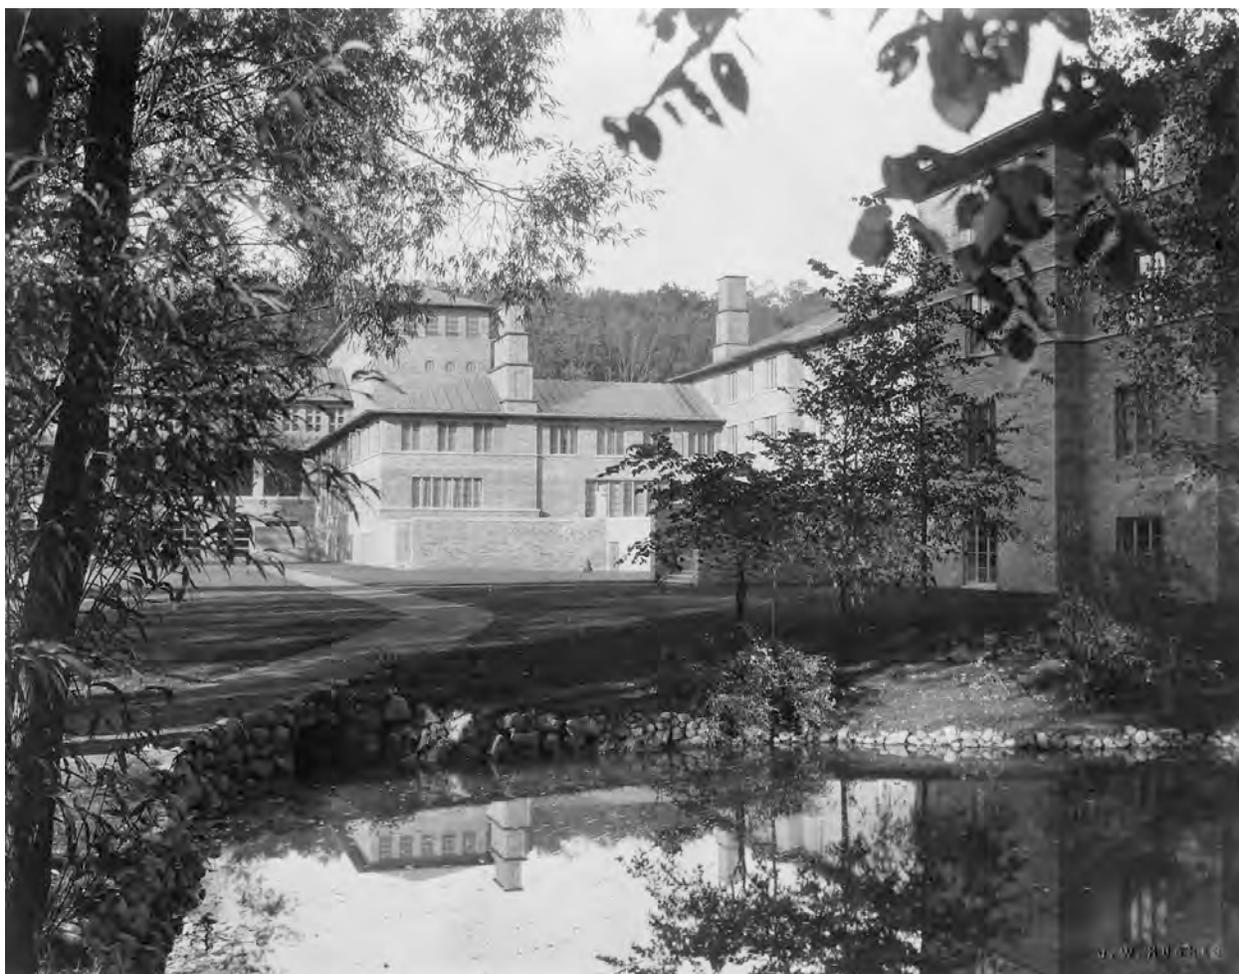
Figure 2.23 Edged with cobbles resembling the Japanese Garden aesthetic, new stone steps and a concrete bridge over Deep Pool connect the Lakeview Walk to other paths at Kingswood School in this 1932 photograph by J. W. Hughes.

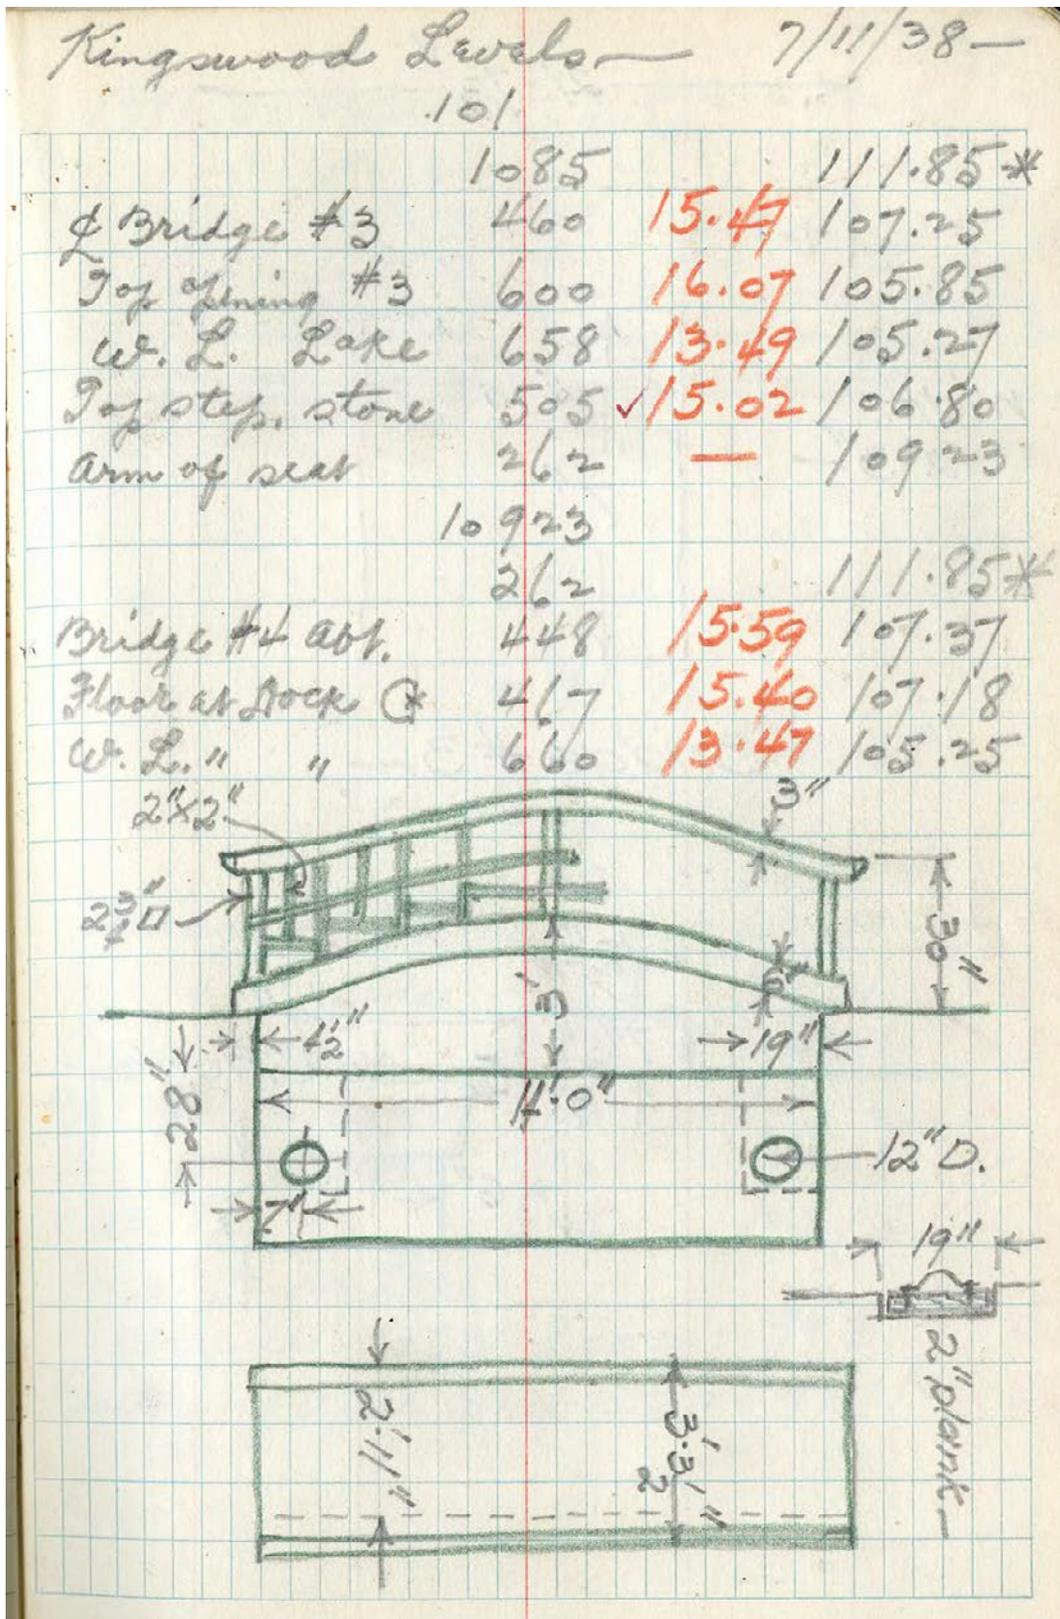
Figure 2.24 A dimensioned drawing of the Japanese Bridge by John Buckberrough shows dimensions of the structure in 1938.

1938 July 11. John Buckberrough, a civil engineer with the Cranbrook Architectural Office, makes a detailed, dimensioned drawing of Japanese Bridge presumably for repairs (Figure 2.24).⁴⁵

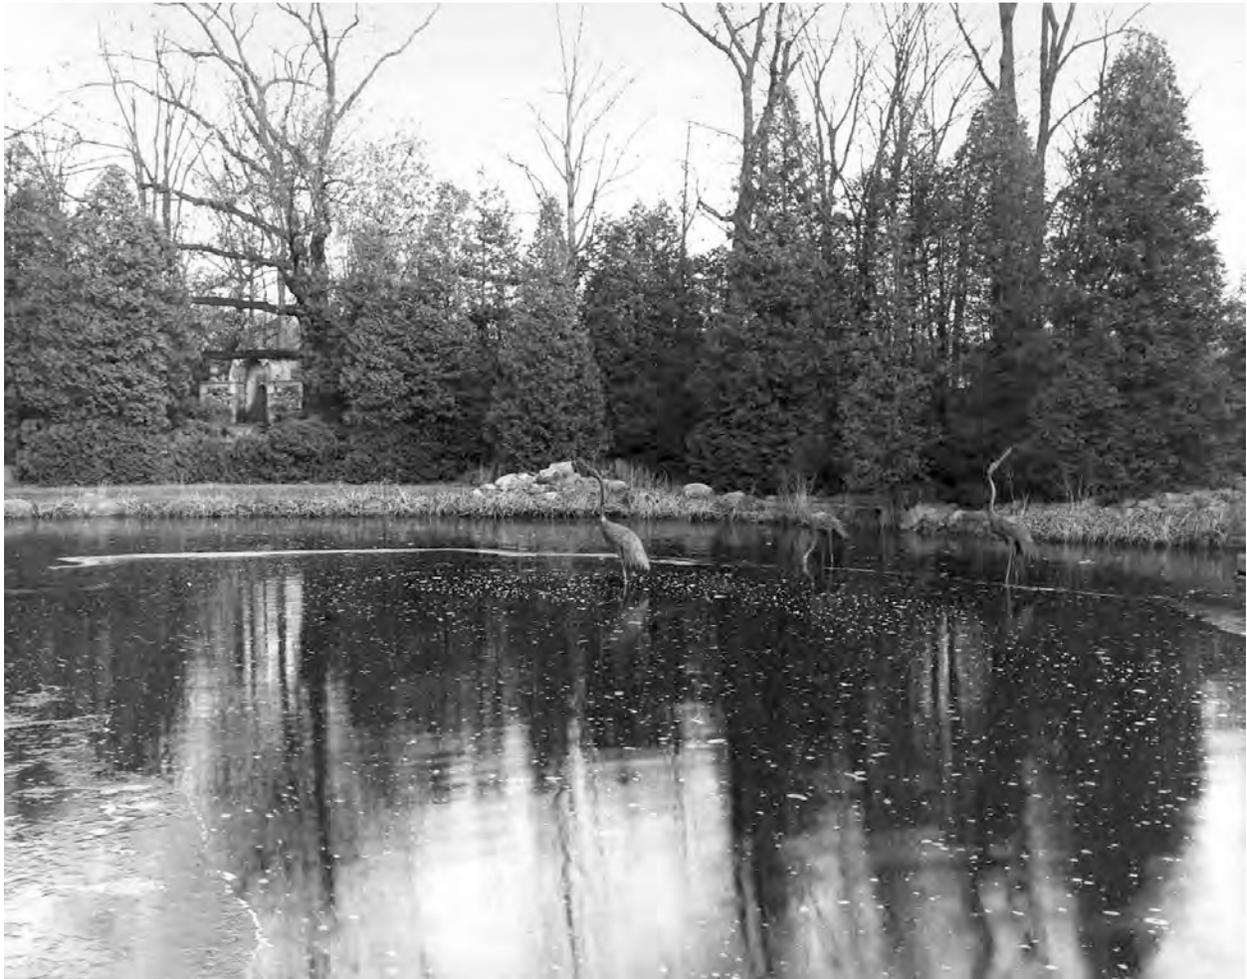
Figure 2.25 A view to the northeast from the vicinity of the Yokohama lantern shows crane sculptures and a maintained view through evergreen trees to the Rainbow Fountain and a large oak tree, ca. 1945.

1945 Photographs show the gradual maturation of the garden plants with dense masses of mature evergreens and the presence of daylilies and other plants intermingled with boulders along the pond edge. The Rainbow Fountain continues to be visible in a slot view to the northeast through evergreens from the Yokohama lantern (Figure 2.25). Three crane sculptures remain at the north end of Round Island.

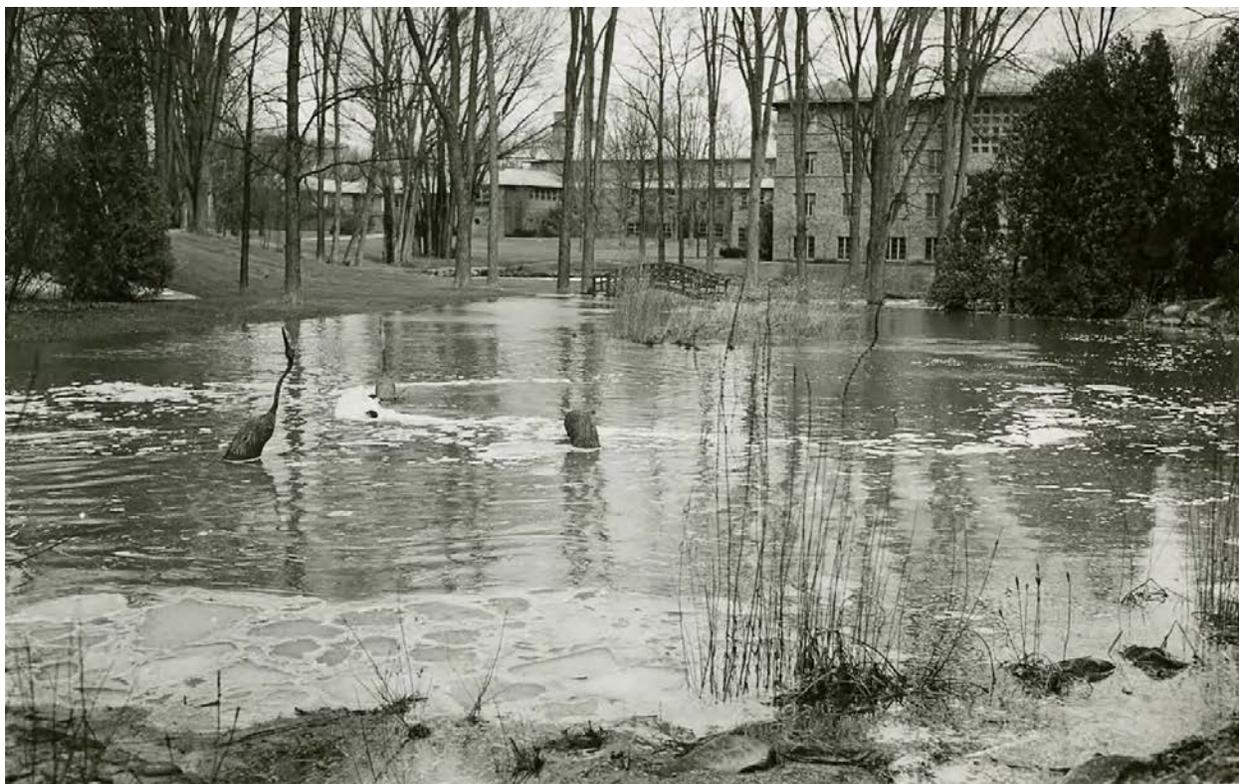
Figure 2.26 A view of the Japanese Garden from the south after the 1957 flood shows inundated sculptures and grassy banks.

1957 Spring floods breach the dam from Kingswood Lake into the Japanese Garden, washing soil and rock through the area and eroding the islands (Figures 2.26 and 2.27).⁴⁸ Later that year, the washed-out bridge is repaired. A new deck strengthened the original design by adding angle bar and bolts at each of the railing’s posts. Photographs in the *Woodwinds* yearbook after 1957 show how the railings are installed with the curved beam facing the interior of the bridge like a handrail rather than a decorative feature of its exterior.

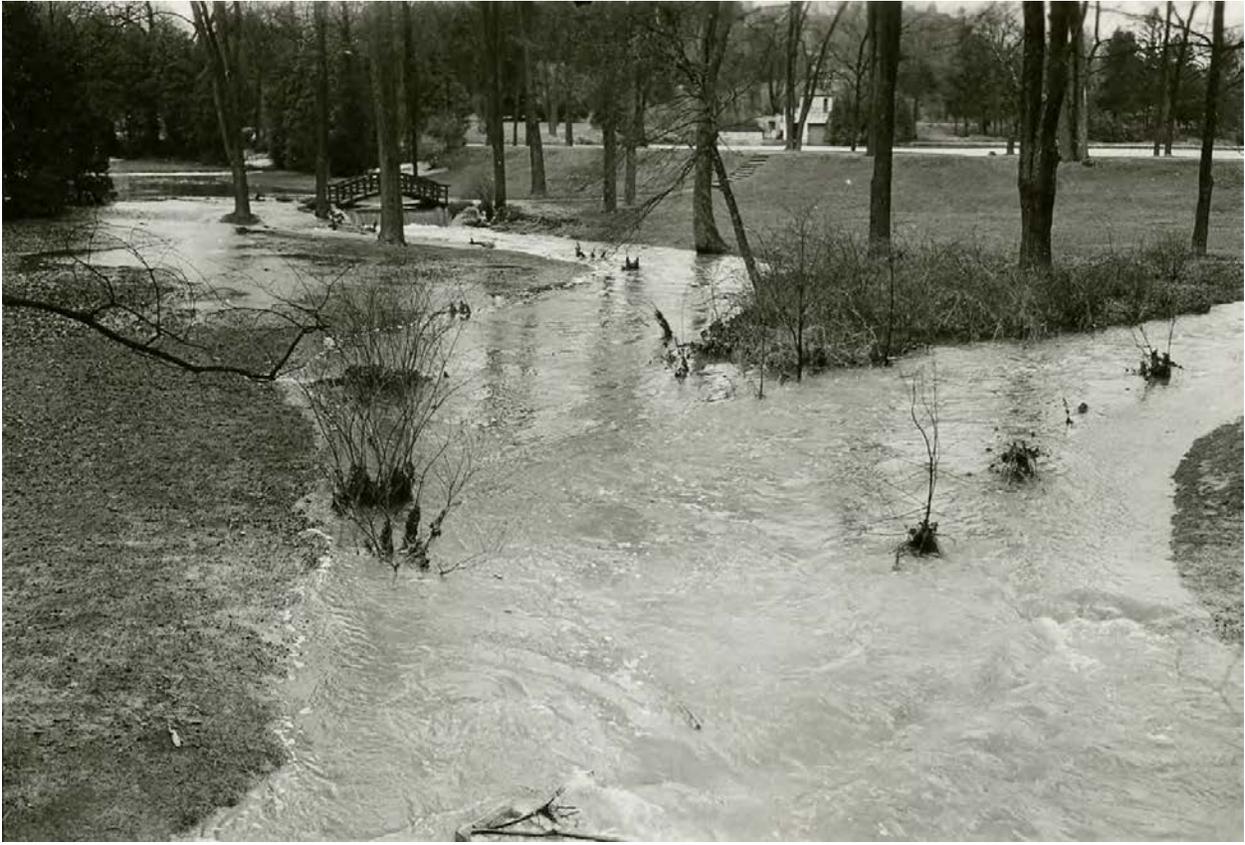
Figure 2.27 A view south toward the Japanese Bridge from the flooded confluence of Sunny Brook and Lower Crane Brook shows a landscape characterized by turf, evergreen tree masses, and a scattering of large canopy trees in 1957.

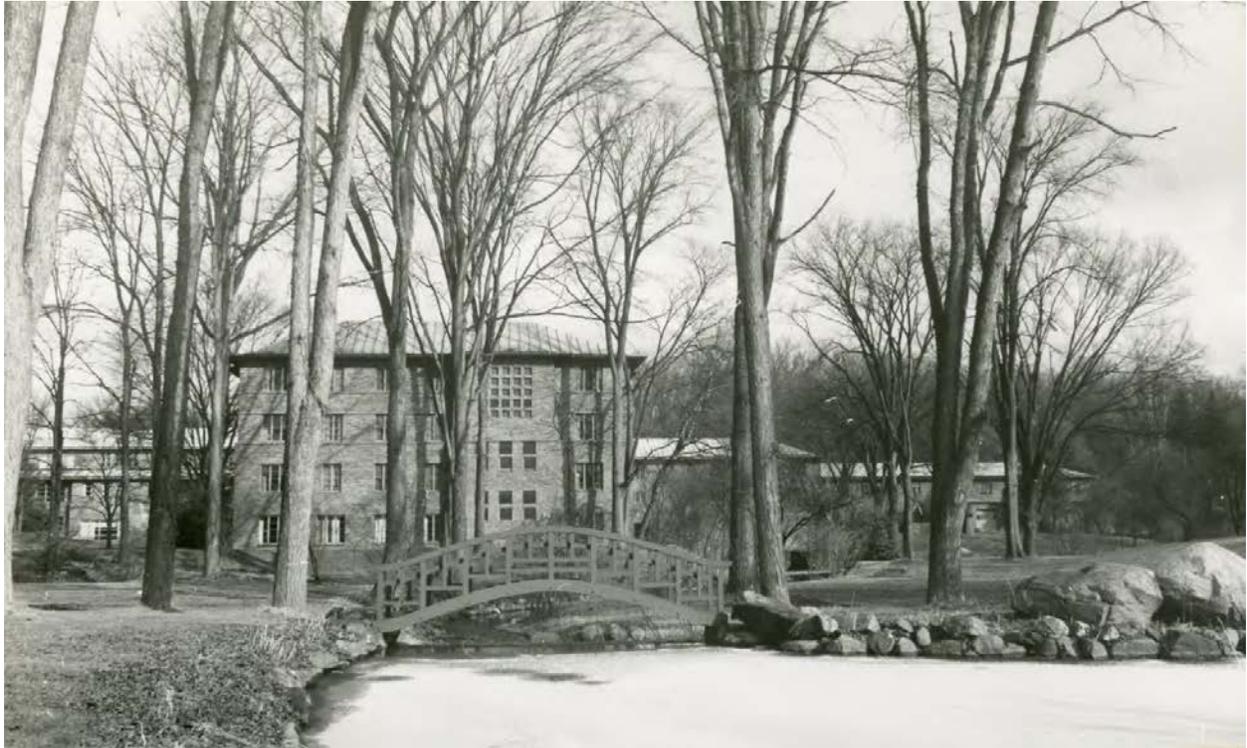
Figure 2.28 A photograph of the painted Japanese Bridge setting shows an open and park-like landscape between Kingswood School and the garden.

1966 The north end of the garden remains open with sweeping views to Kingswood School in the vicinity of the Japanese Bridge. Large boulders are located on the north bank of the Lily Pond and to the east of the bridge abutment (Figure 2.28).⁵⁰

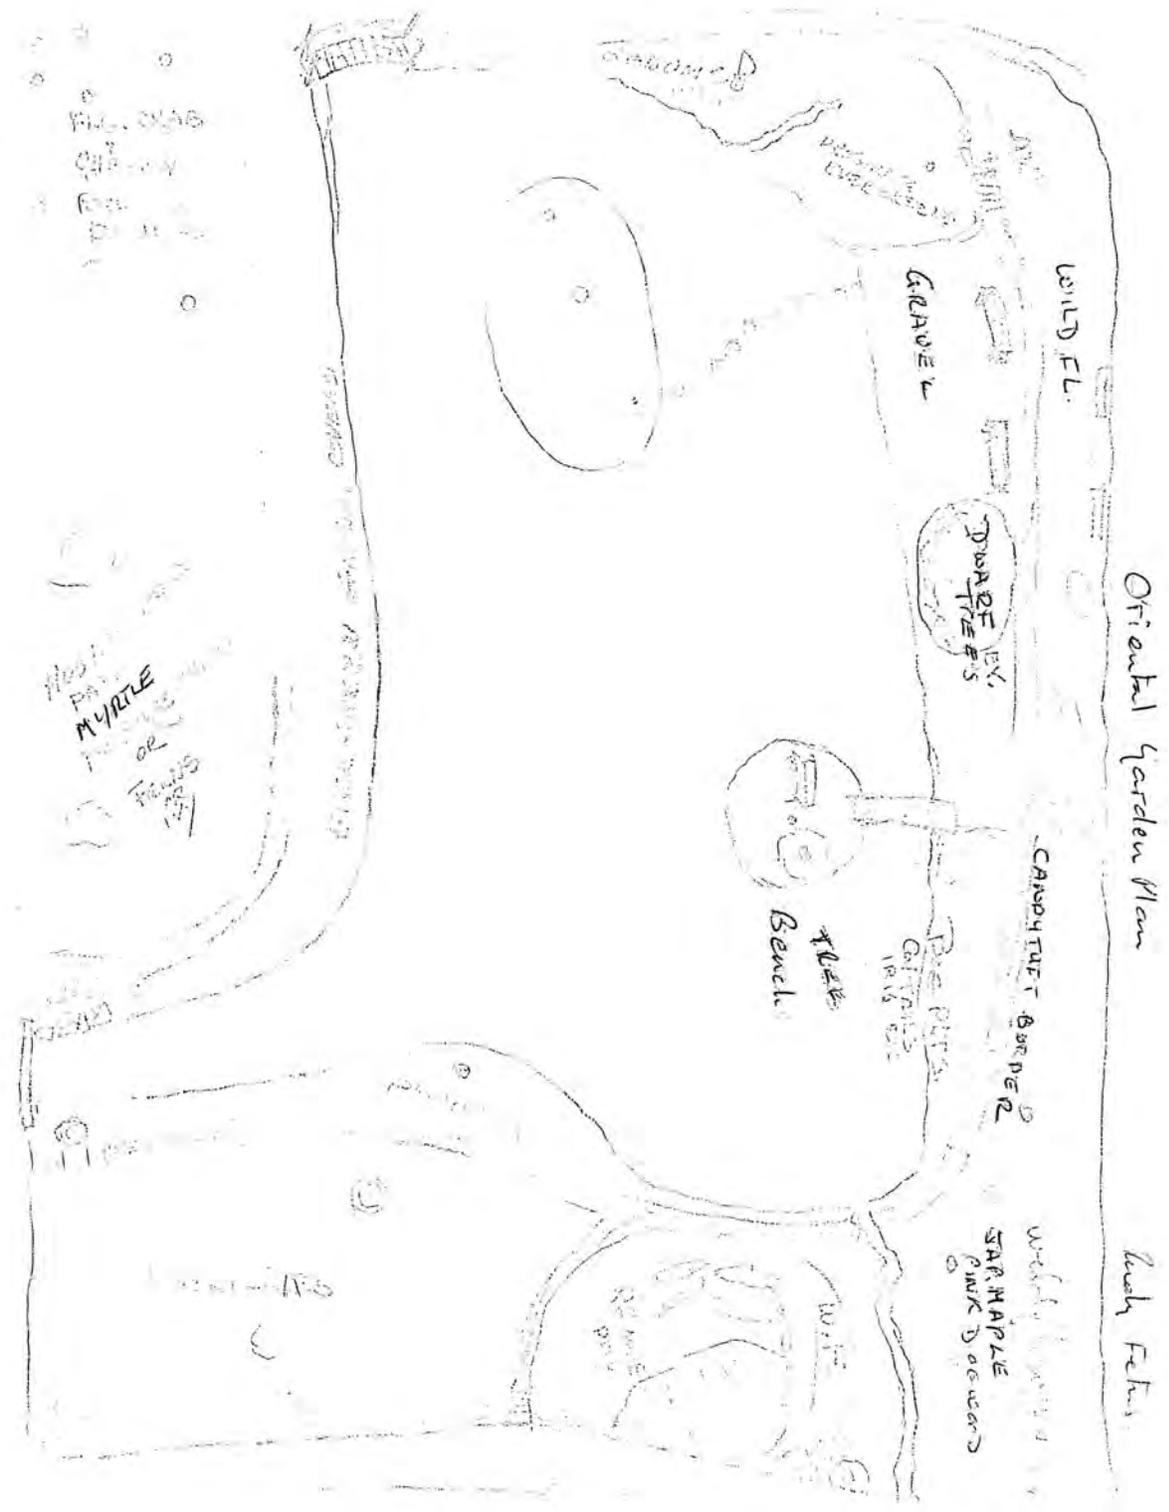
Figure 2.29 A hand drawn plan for renewal of the Japanese Garden by Rudy Fedus, 1975.

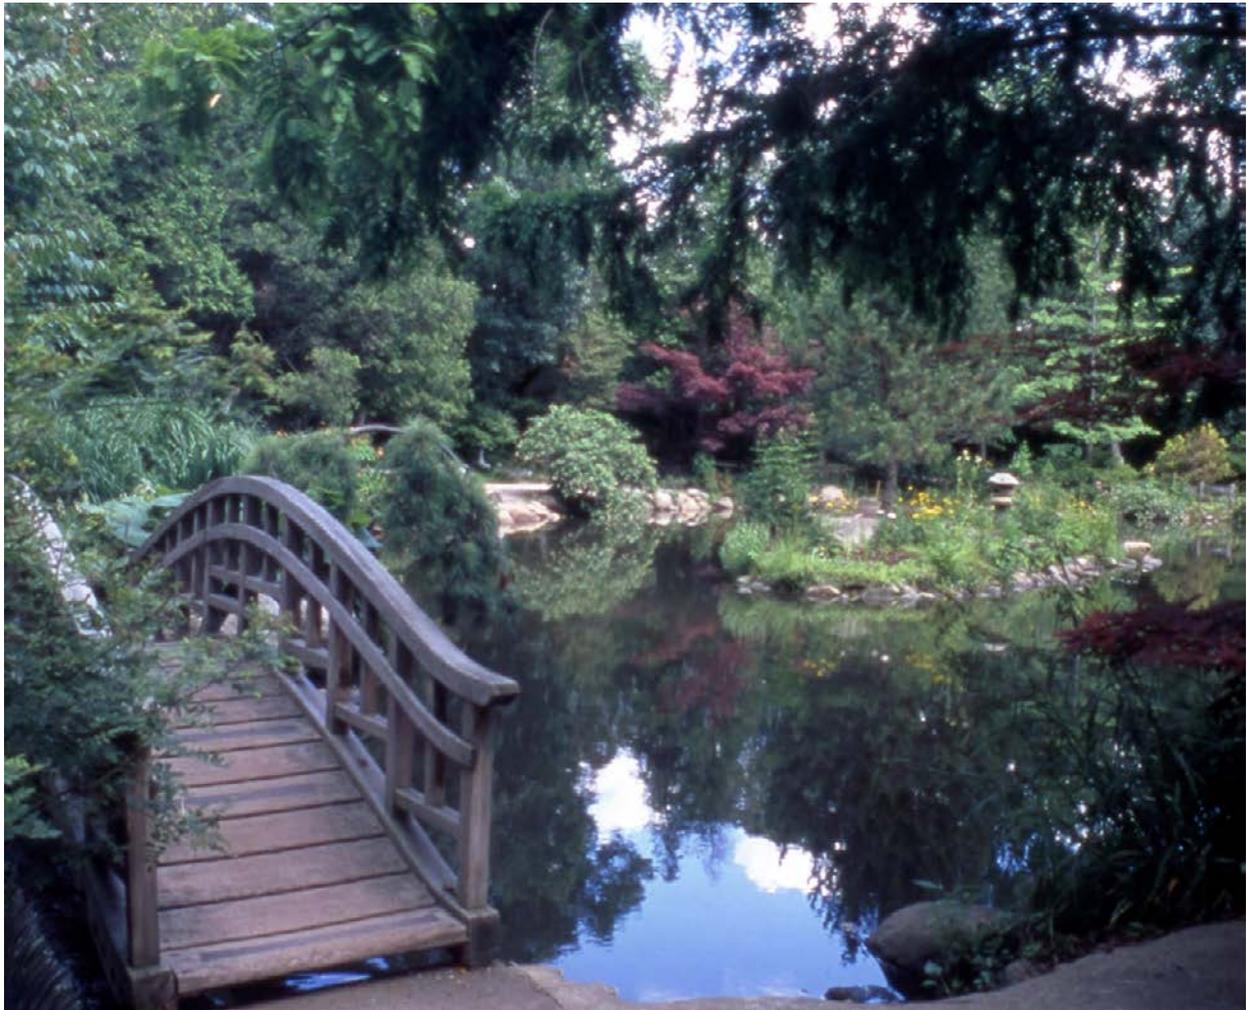
Figure 2.30 Lush plantings from garden renewal provide seasonal color and display a wide variety of plant forms around 1980.

palmatum) provide color throughout the garden (Figure 2.30). In addition to a wide variety of plants, refreshed garden features include gravel surfaces to paths, stone-lined banks, and a new small stone lantern on Duck Island. The base of the Yokohama lantern is absent of the stones that used to define its foundation by this time (Figure 2.31). A single jet fountain aerates the Lily Pond near the promontory of the lantern. The rebuilt Lily Pond Cascade flows from the Willow Pool near the base of a Siberian elm and contains young juniper, hosta, iris, mint, periwinkle, and other ground covers (Figure 2.32).

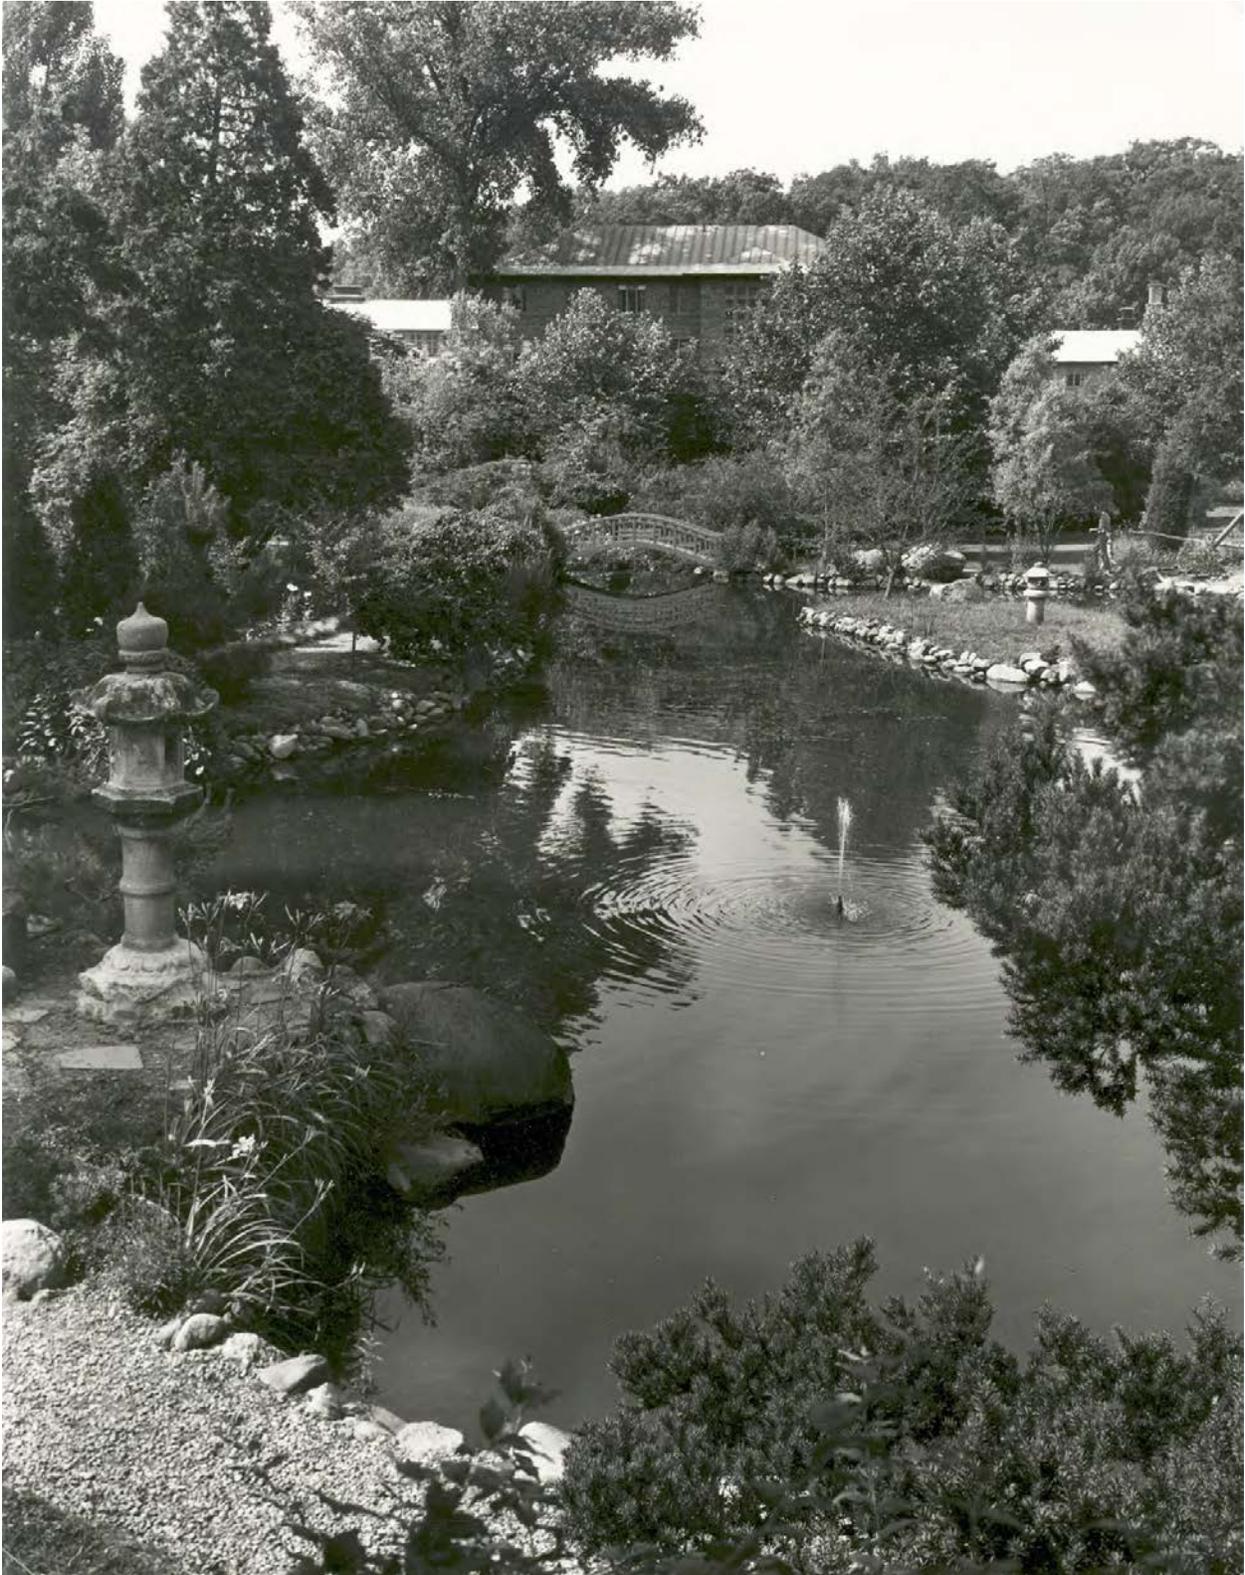
Figure 2.31 A view from the Yokohama lantern north toward Duck Island and the Japanese Bridge shows rich texture and an engaging setting created by varying forms of vegetation and hardscape features in 1980.

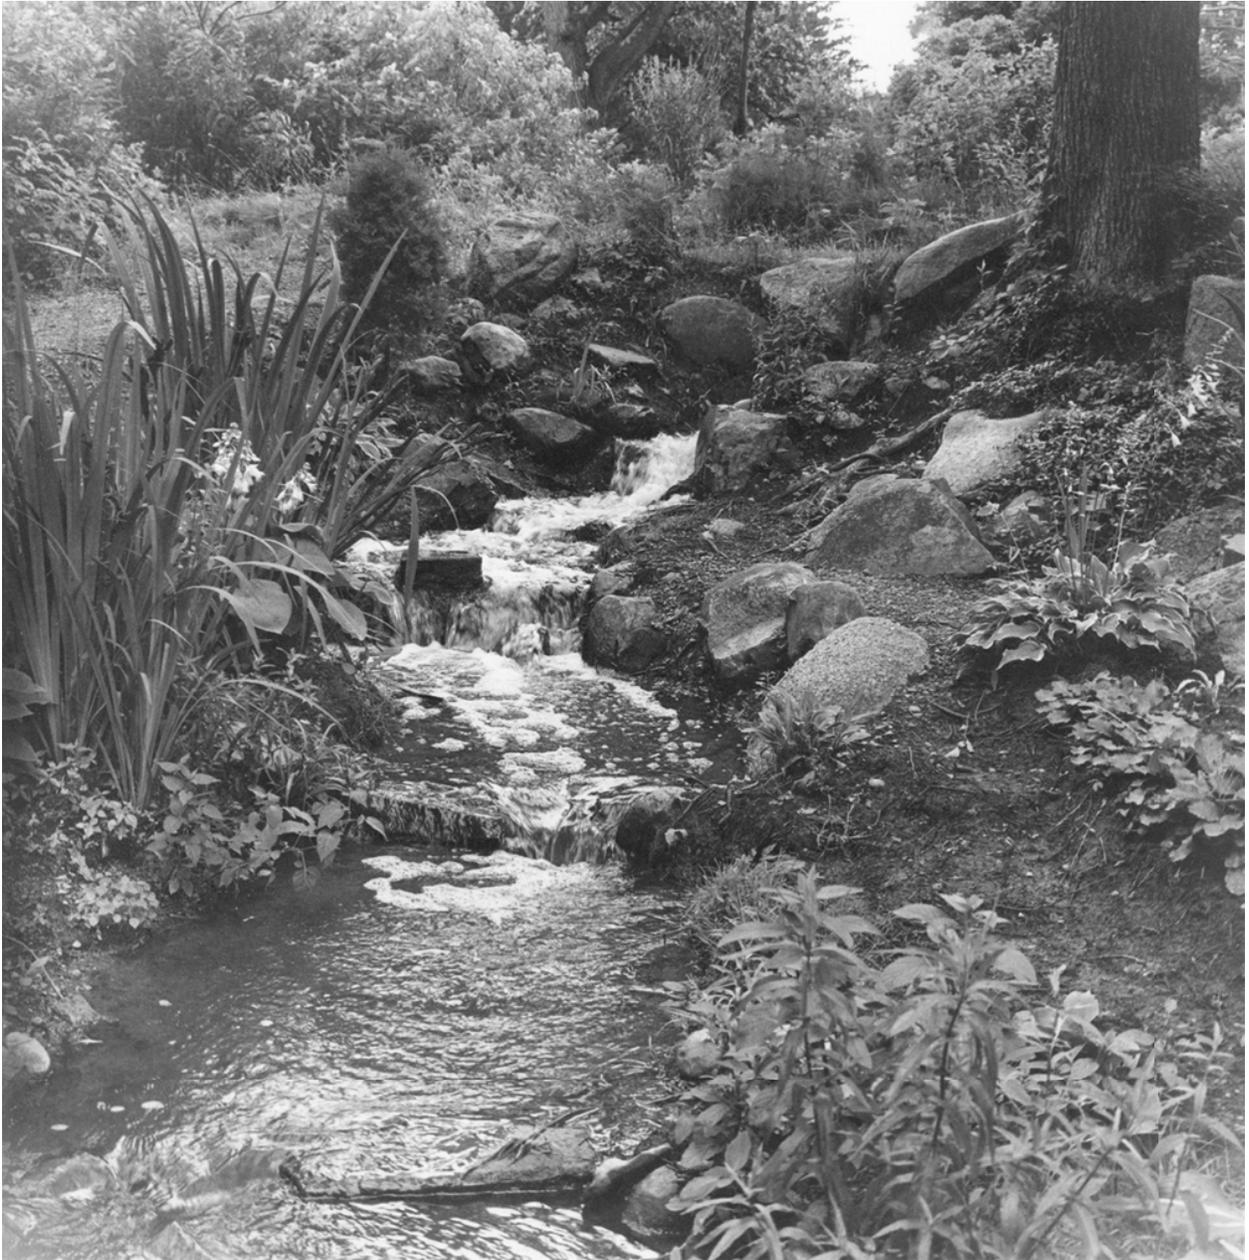
Figure 2.32 The rebuilt Lily Pond Cascade with hosta collection, ca. 1980, by Alan Lowry.

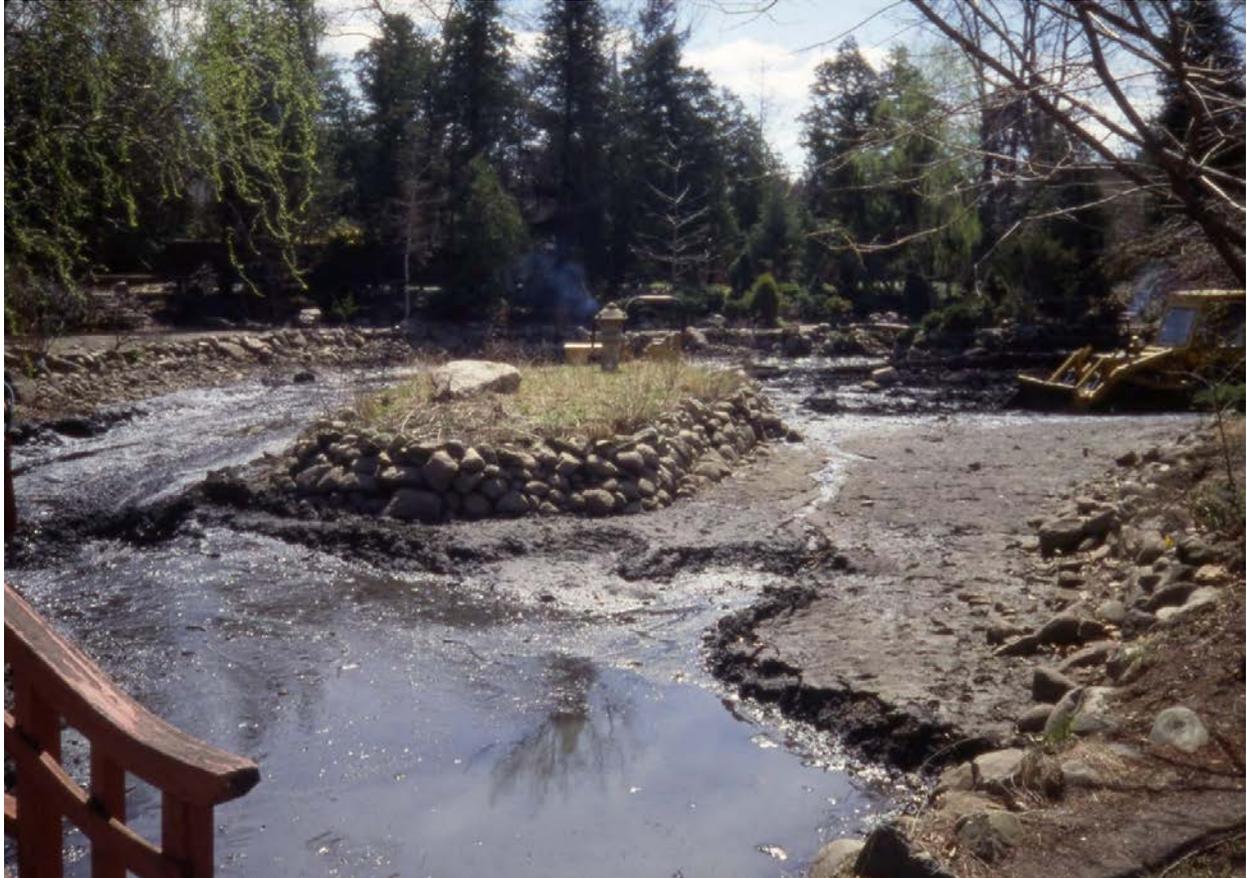
Figure 2.33 Dredging the Lily Pond to improve drainage reveals stones around the banks, 1988.

1988 In an effort to improve water flow, the Lily Pond is dredged (Figure 2.33).⁷¹

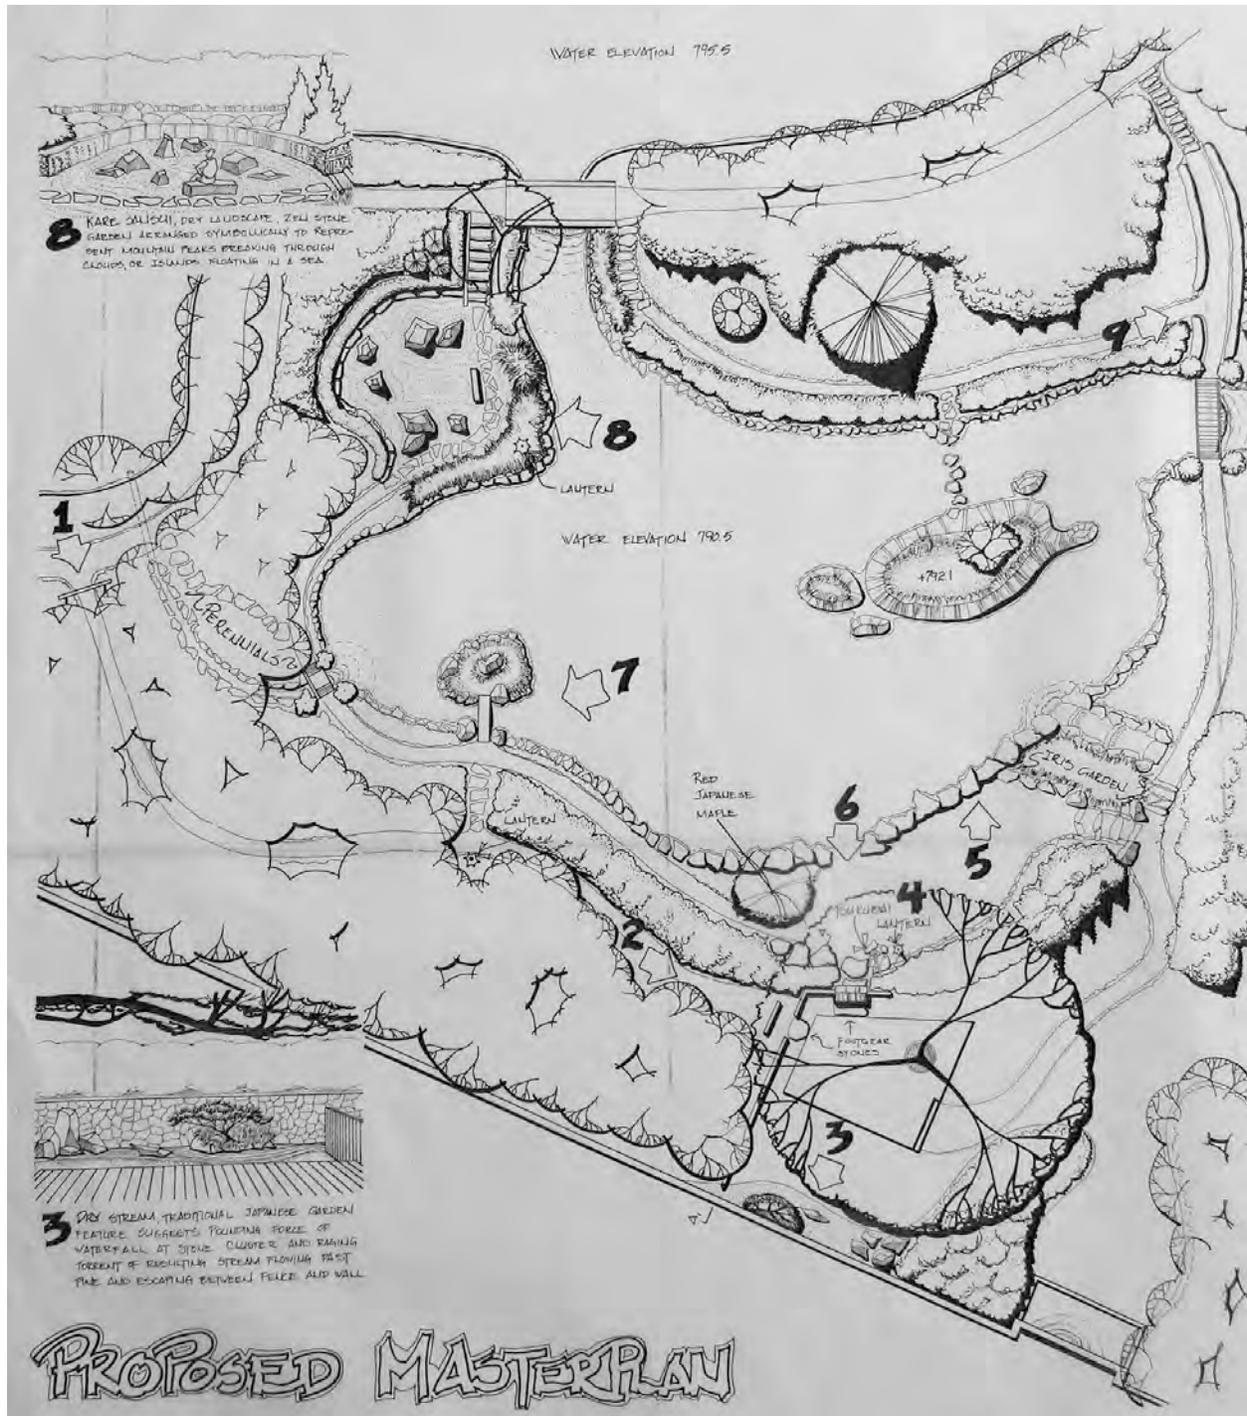
Figure 2.35 Partially implemented Japanese Garden: Proposed Master Plan by Becca Palder and Steve Polewski, 1989, AD.04.166.

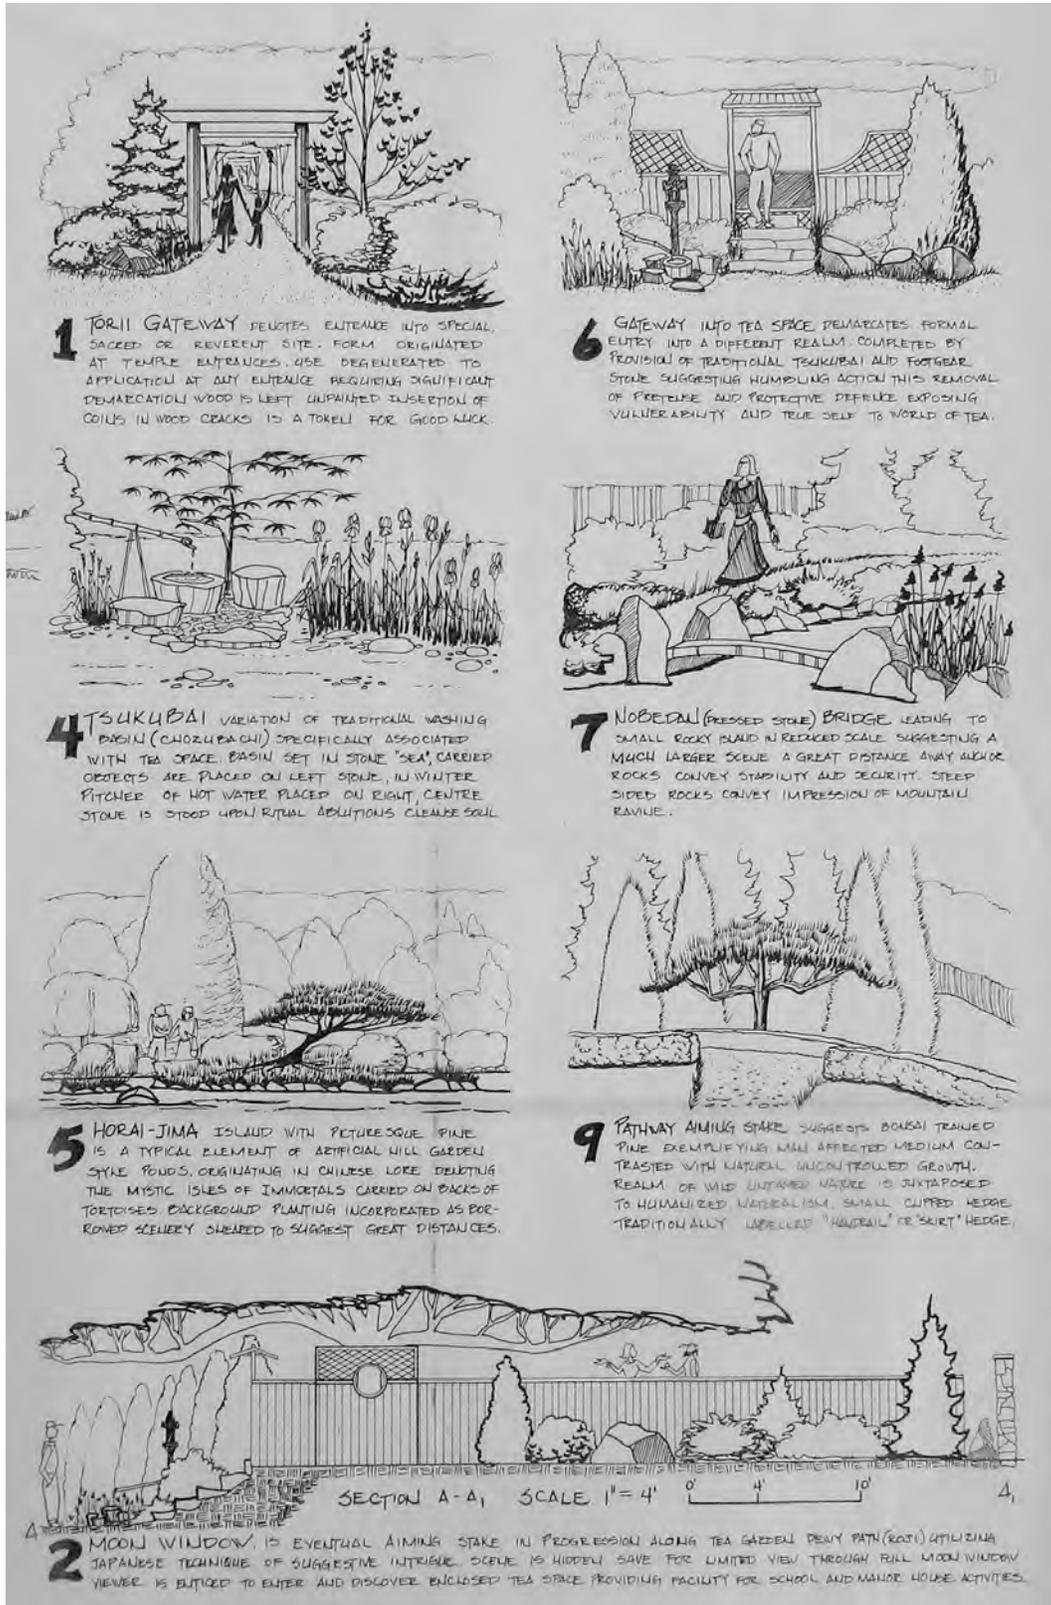
Figure 2.36 Vignettes of the partially implemented Japanese Garden: Proposed Master Plan by Becca Palder and Steve Polewski, 1989.
