Cranbrook Japanese Garden Historic Landscape Study

January 2018

Cranbrook Center for Collections and Research
Cranbrook Educational Community
Bloomfield Hills, Michigan

QUINN EVANS
ARCHITECTS

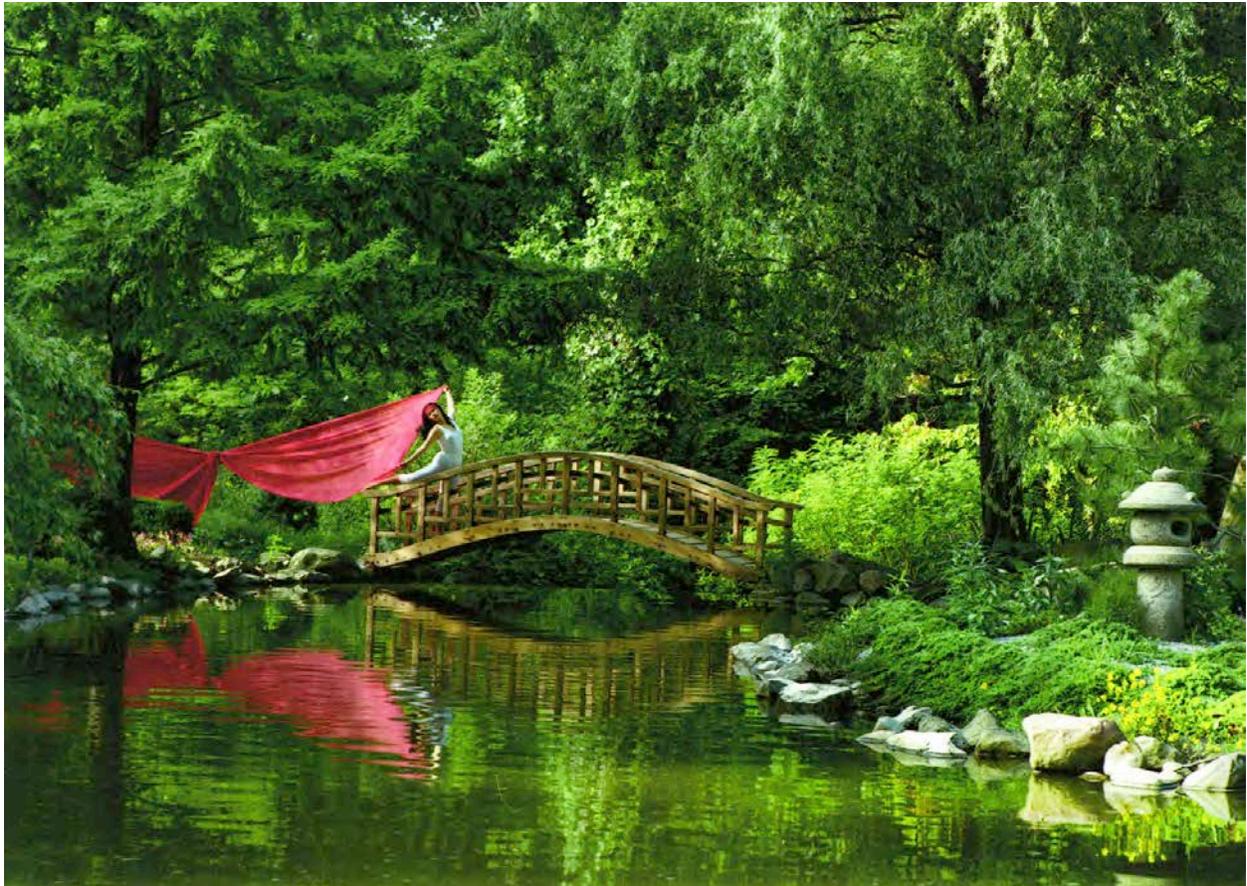
Figure 2.37 Textural complexity of vegetation, water, and structure at the Japanese Bridge create an artistic composition for this photograph by Fred Olds, ca. 1990.

1990 Lush vegetation around the Japanese Bridge continues to obscure views to Kingswood School outside of winter months. A photograph by Fred Olds shows that the bridge remains unpainted at least through 1990 (Figure 2.37).⁷⁸ Around this time approximately eight inches at the end of the bridge's railing are knocked off.⁷⁹

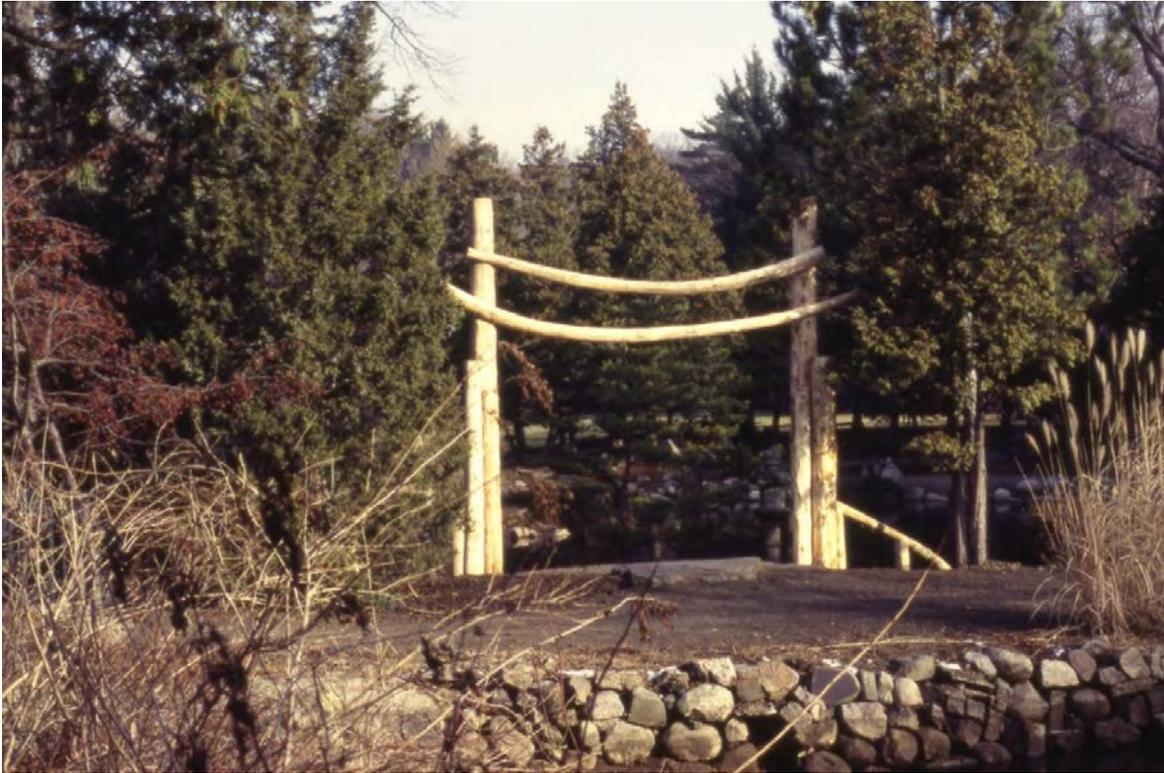
Figures 2.38 The Torii gate frames the new southwest entrance to the Japanese Garden in 1995.

1995 May 31. The plan is implemented and the “Official Opening of Phase I of Our Oriental Garden Renovation” occurs (Figures 2.38 and 2.39).⁸⁴

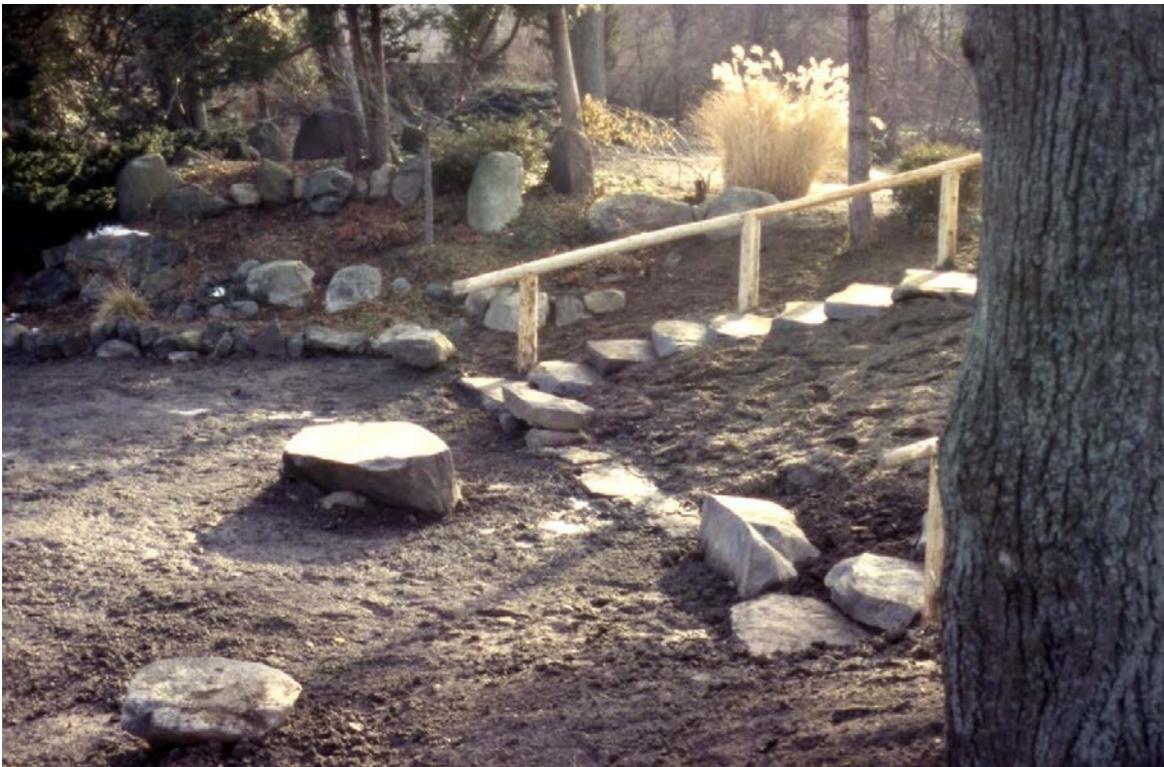
Figures 2.39 Stone steps, boulders, and plantings create a new setting at the south side of the Lily Pond 1995.

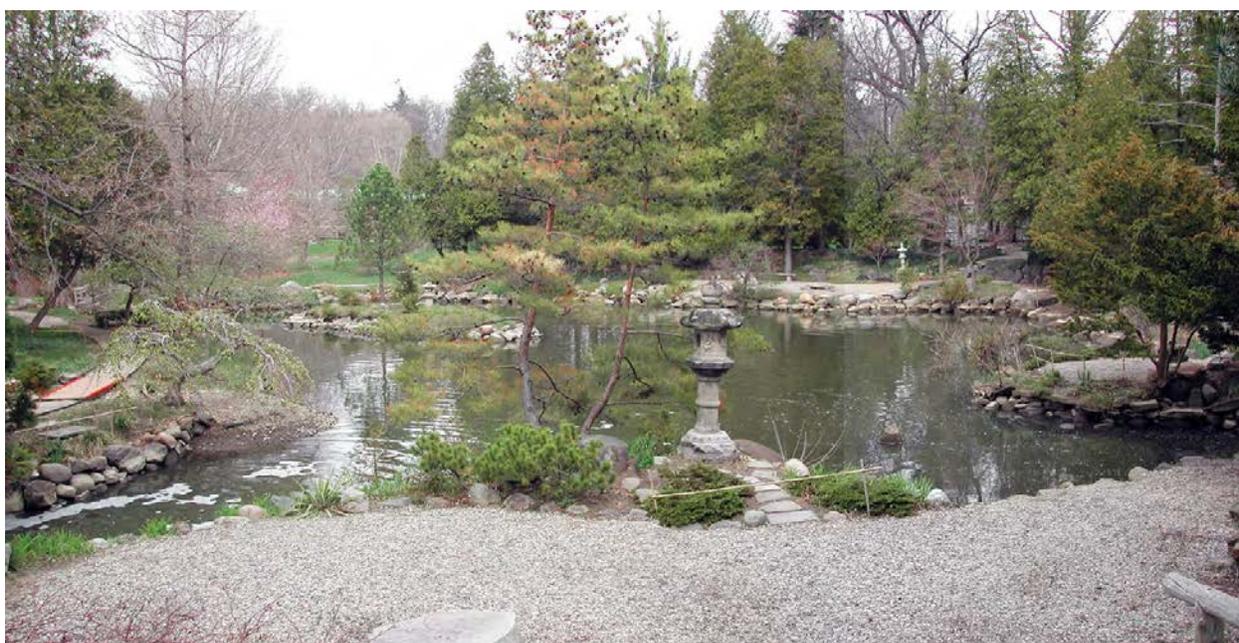
Figure 2.40 Panoramic photograph looking north across the Lily Pond shows a high degree of maintenance in the Japanese Garden around 2000.

ca. 2000 Photographs document the tended character of the Japanese Garden following the execution of garden designs from the 1990s (Figure 2.40). Fresh gravel highlights several areas around the Lily Pond including on Round Island. Small bamboo rails keep visitors away from sensitive areas. On the walk west of the Lily Pond, a red-painted wooden walkway spans the dry streambed. Leaves and bark of prostrate and upright evergreen trees and shrubs and the new leaves of daylilies provide color in the early spring.

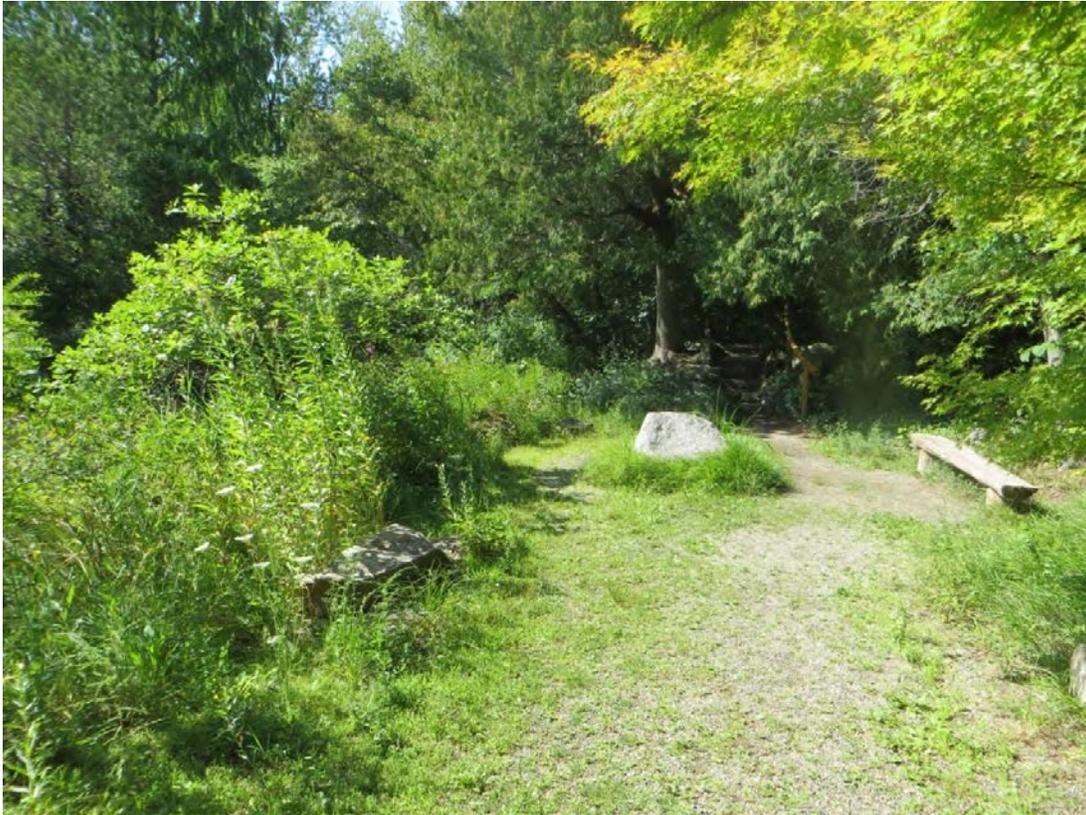
Figure 3.1 View of northeast landing from south. QEA, August 2017.

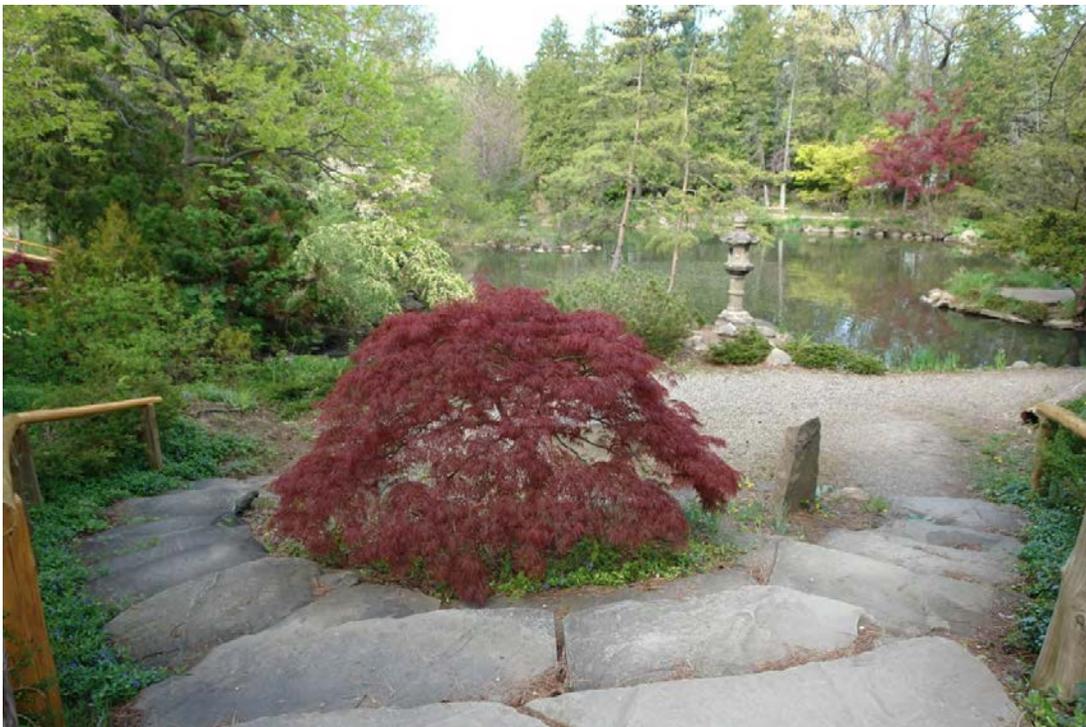
Figure 3.2 View of the south landing from east with the northeast landing in the background. QEA, May 2017.

Dating of existing trees in the absence of additional documentation is difficult given the variability of growing conditions within the garden. Most historic photographs of the Japanese Garden prior to 1929 do not clearly reveal species level information; nevertheless, the degree of documented change suggests that the majority of evergreen plantings postdate 1972 and relate to subsequent garden renewal efforts. There are numerous large and charismatic trees in the garden that have grown rapidly since the 1980s including a 26" dbh fern-leaved beech (*Fagus sylvatica* 'Asplenifolia'), a 27" dbh dawn redwood (*Metasequoia glyptostroboides*), and a 22" dbh bald-cypress (*Taxodium distichum*) (Figures 3.23 and 3.24). Stumps also indicate the presence of large, fast growing trees at the garden edges. A tree ring assessment on the massive stump of a Siberian elm (*Ulmus pumila*) near the Lily Pond Cascade indicates that it was planted or seeded into the location in the mid-1930s (Figure 3.25). Numerous specimen plantings abound including a female ginkgo (*Ginkgo biloba*) on the east bank of the Lily Pond and a dwarf Japanese maple (*Acer palmatum* 'Ever Red') near the south landing (Figure 3.2).

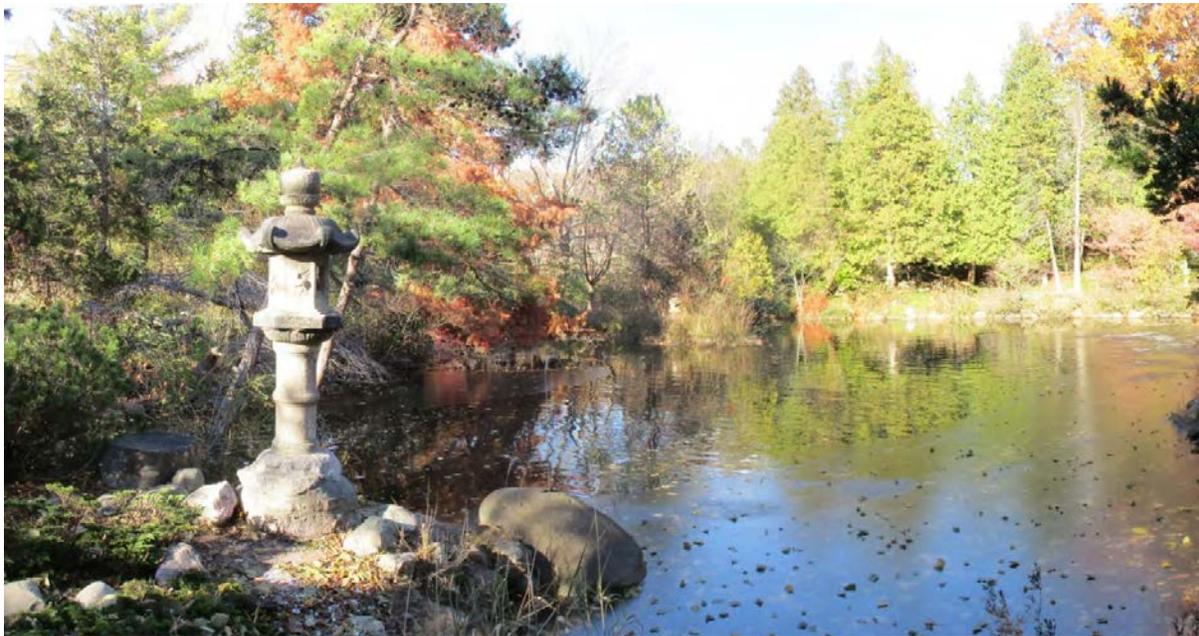
Figure 3.4 A view north from the Yokohama lantern retains connections to features on the north side of the garden including Duck Island and vegetation around the Flowing Well Cascade. Dense trees and shrubs along the west side of the Lily Pond obscure the stone shoreline and views to the Japanese Bridge. QEA, November 2017.

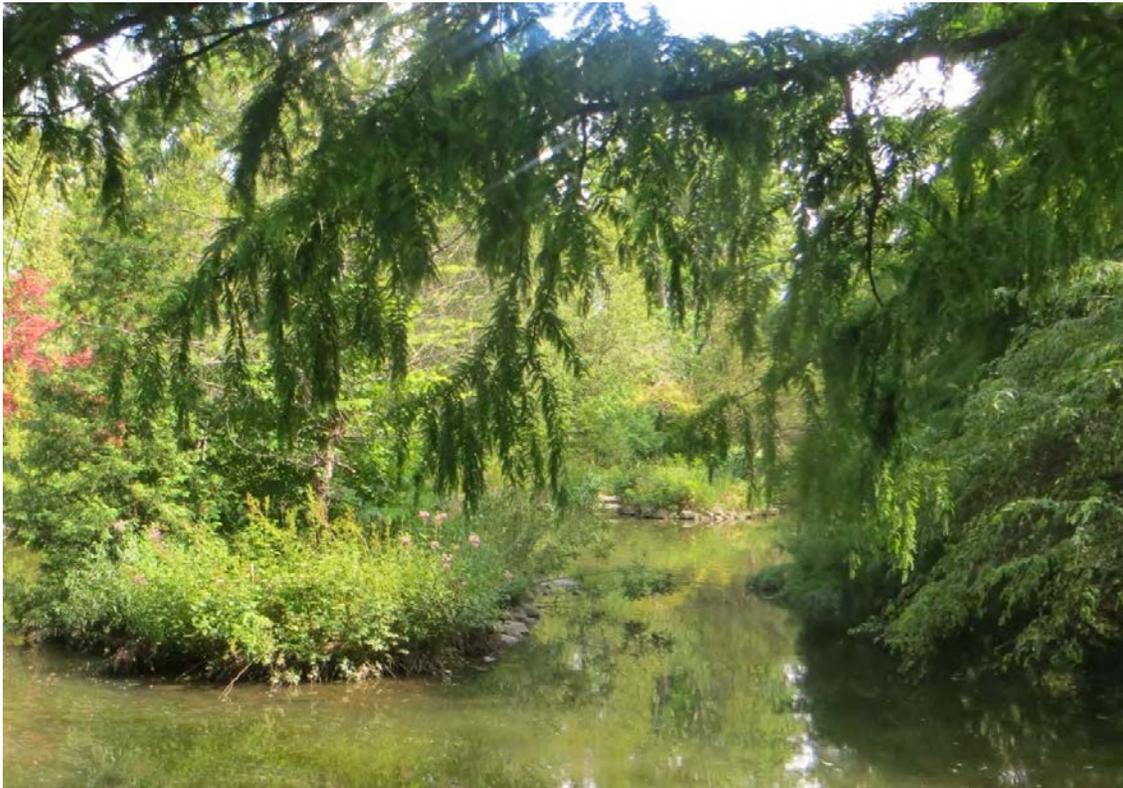
Figure 3.11 View south from the Japanese Bridge reveals the reduction of the viewed due to overhanging and dense edge vegetation. Stone edging conveys historic character on Duck Island and along the south shoreline. QEA, August 2017.

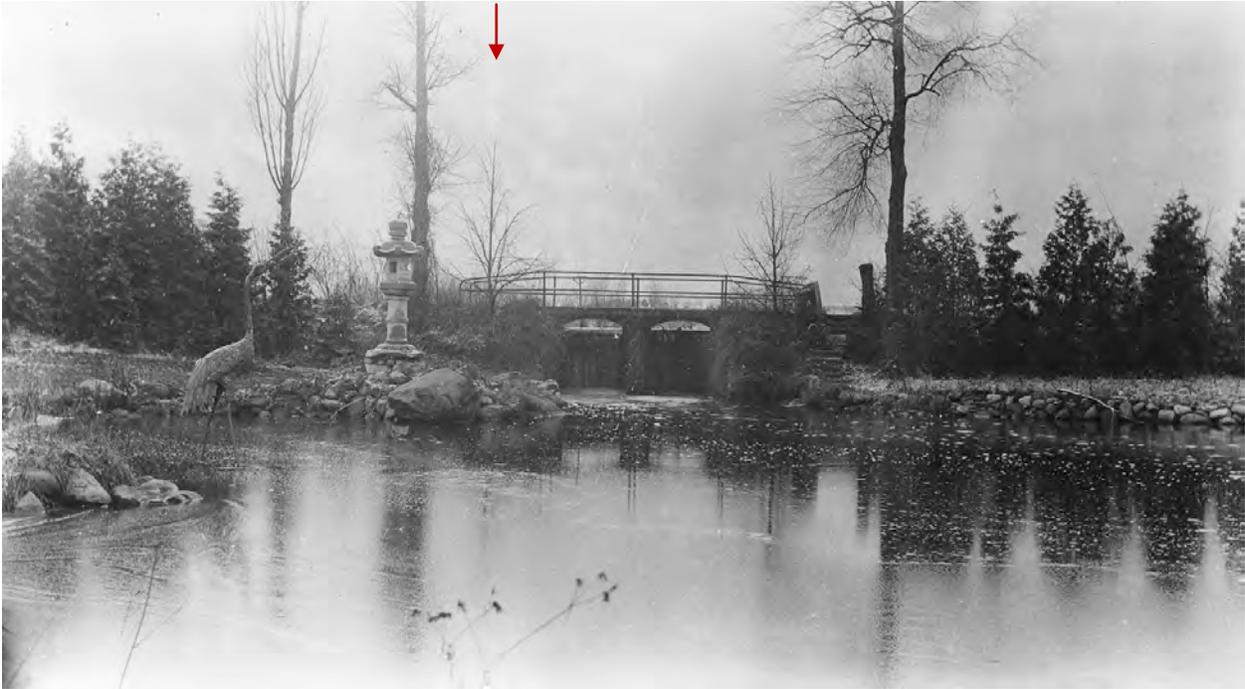
Figure 3.12 View west toward the East Water Gate, ca. 1916.

The principle of asymmetry is common in the Japanese Garden today but not pervasive. Naturalistic forms of the pond, islands, and historic pathways are highly varied. Views west toward the East Water Gate across the Lily Pond exemplify a transformation of symmetry over time (Figures 3.12 and 3.13). Loss and growth of vegetation alters the clearly manipulated, historic symmetry of canopy trees, vines, and flanking evergreen trees of the early garden. Bridges and water gates are symmetrical although views toward them have increasingly accentuated visual irregularity due to vegetation. The Japanese-style timber gate, or torii gate, and mirrored stone steps at the south end of the pond create a symmetrical composition cupping a single tree (Figure 3.14). The paired steps are the only symmetrical use of stone in the garden.

(*Quercus alba*), and an American linden (*Tilia americana*) that was historically one of a pair flanking the East Water Gate (Figures 3.12, 3.13 and 3.22).

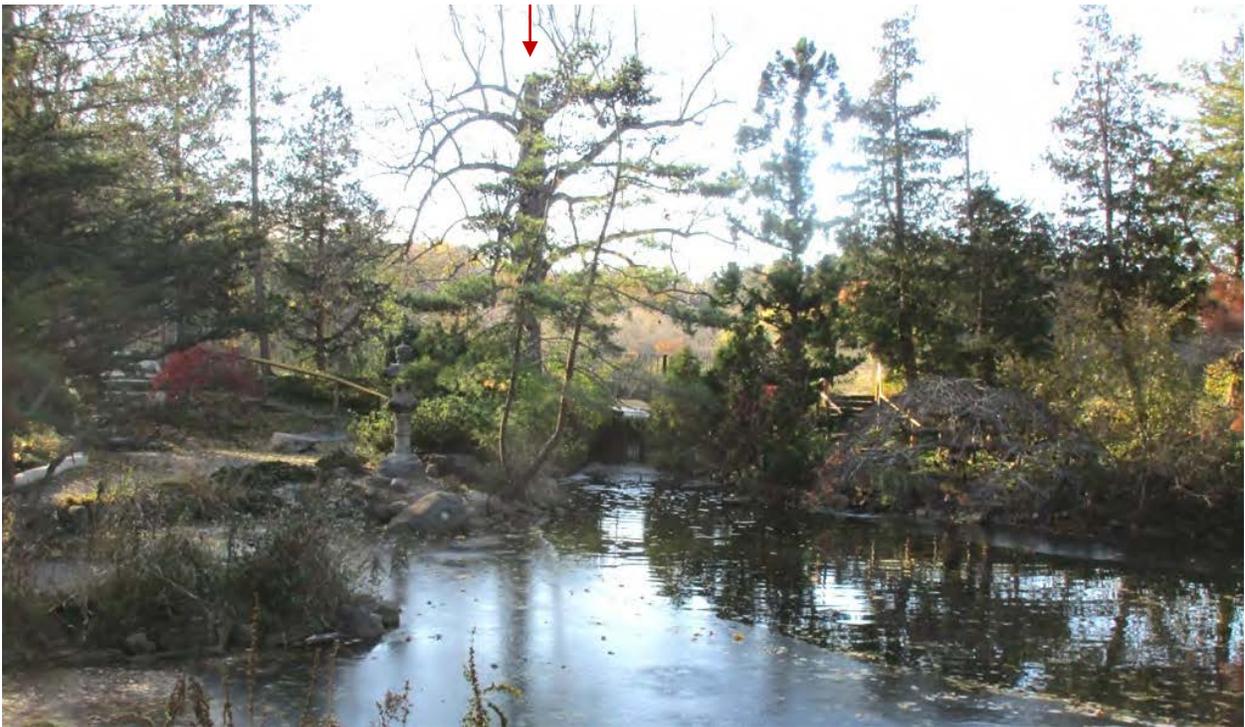
Figure 3.13 The view west from Round Island shows historical features such as the Yokohama Lantern, remaining historic trees, and stone steps south of the East Water Gate. A glimpse of the waterfall is present but the ordered and symmetrical composition of this part of the garden is not evident today. Red arrows indicate the remaining American linden in each view. QEA, November 2017.

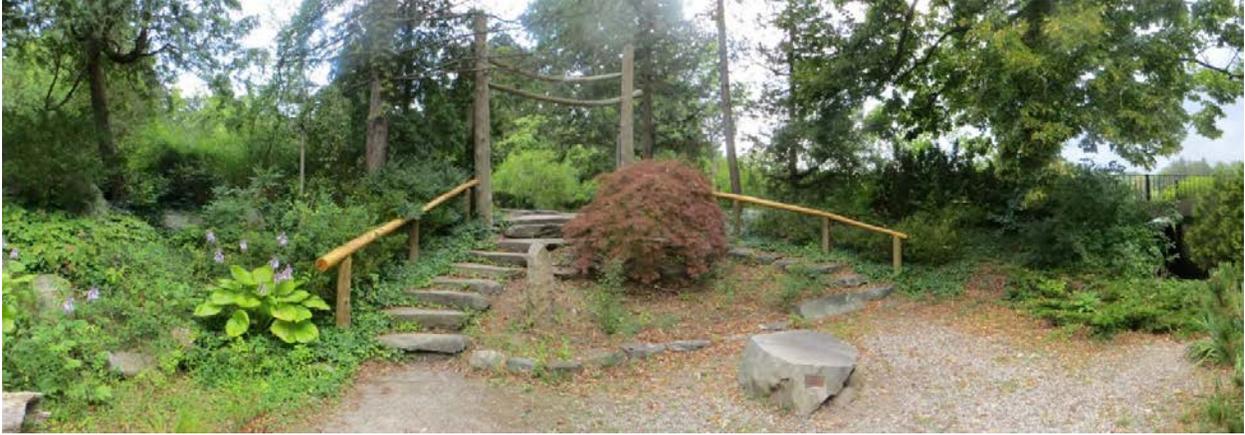
Figure 3.14 View southwest toward the torii gate QEA, August 2017.

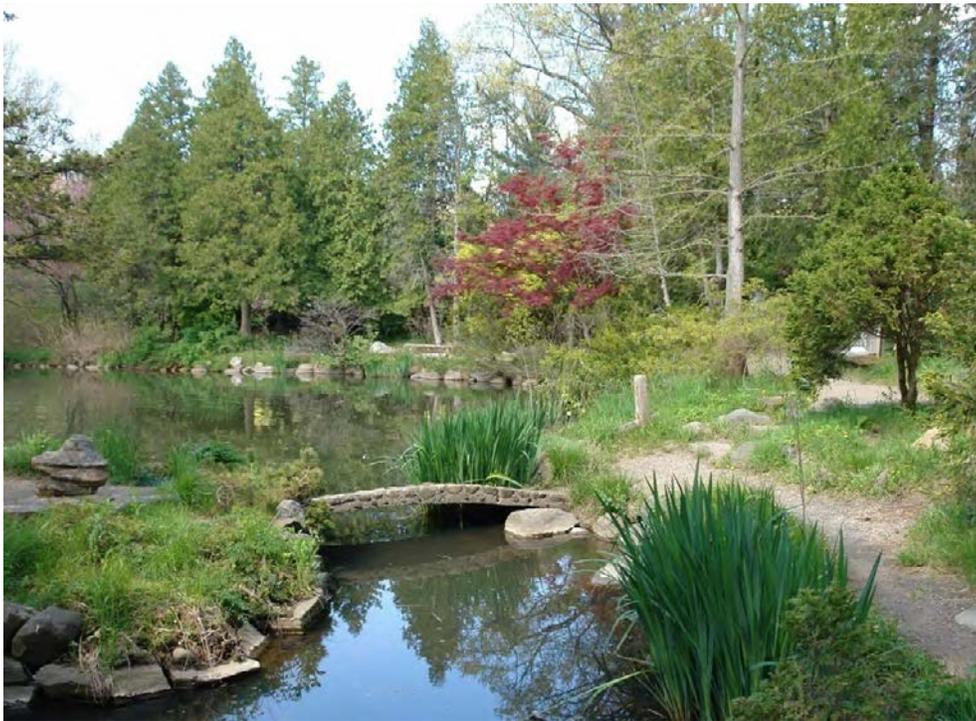
Figure 3.19 Boulders define the edge of the pond today; however, changes in aquatic vegetation in the Lily Pond and around the cascade alter historic landscape character. A fragmented section of what was formerly the lower east walk terminates at Round Island rather than extending to the Flowing Well Cascade. The cobblestone and concrete bridge may lie on the footings of an older bridge possibly visible in the ca. 1916 photograph. QEA, May 2017.

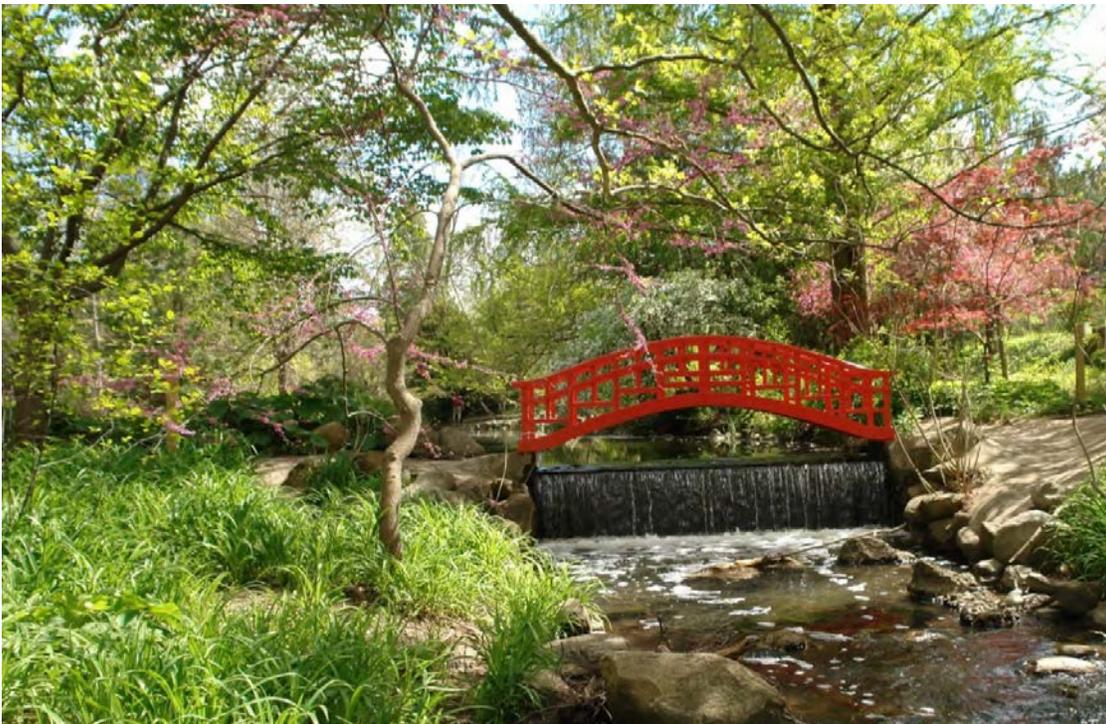
Figure 3.21 A view south from Lower Crane Brook toward the Japanese Garden shows abundant daylily beds and small trees near the Japanese Bridge instead of the mixed streamside sedges and grasses today. The visibility of the Yokohama Lantern and the banks of the Lily Pond, evident ca.1928, are largely obscured today. QEA, May 2017.

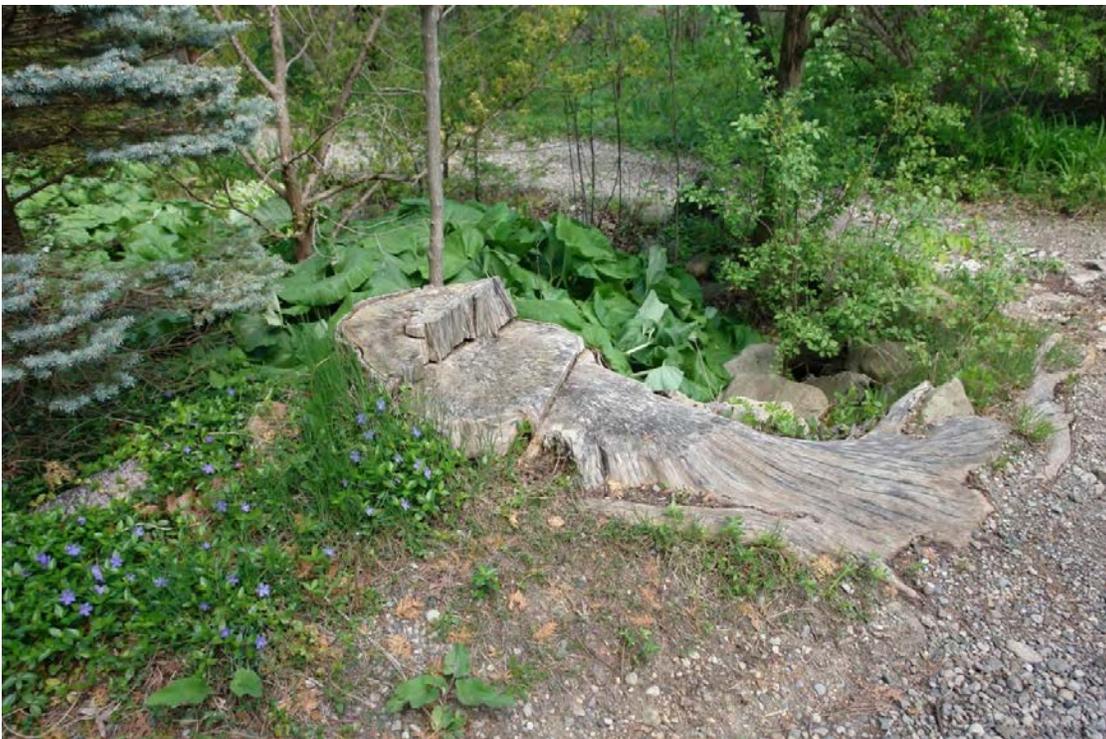
Figure 3.25 Tree rings on the stump of a Siberian elm at the Lily Pond Cascade indicate that it was planted or seeded into the location in the mid-1930s. QEA, May 2017.

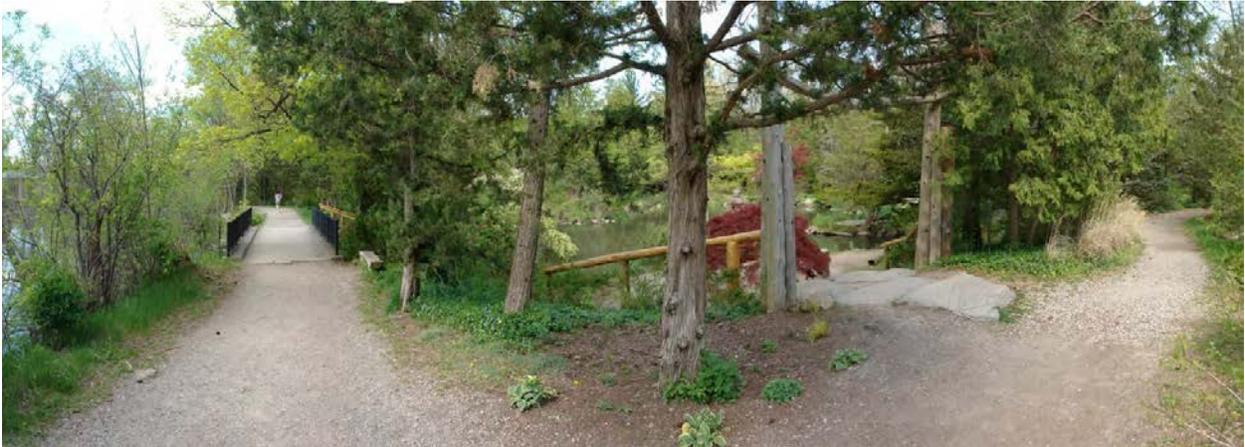
Figure 3.26 South entry to the Japanese Garden from the Lakeside Walk at the intersection of the Willow Pool Walk and the 1995 torii gate. QEA, May 2017.

Extant historic paths include those that are in the approximate location and with the same materials as the historic feature. Five paths and five transitional stone stairs remain from the 1920s (LP 2018). The Lakeside Walk, upper east walk, and Willow Pool Walk pertain to the upper circuit (Figures 3.26, 3.28 and 3.29). In addition, the south overlook is a small loop off the Willow Pool Walk that appears to be in the location of a path on the 1914 appraisal although it once continued to the south landing below (Figure 3.30). Of the lower circuit, only the lower west walk follows the historic pattern (Figures 3.3 and 3.7). Following removal in the 1930s, this path mimics the original route after reestablishment in the 1970s. This contrasts with the condition of the east side, where a segment of the historic lower path circuit was abandoned in recent years (Figures 3.18 and 3.19). Removal of the 60-foot segment between the Round Island bridge and the northeast landing may relate to issues with stability of the pond edge.

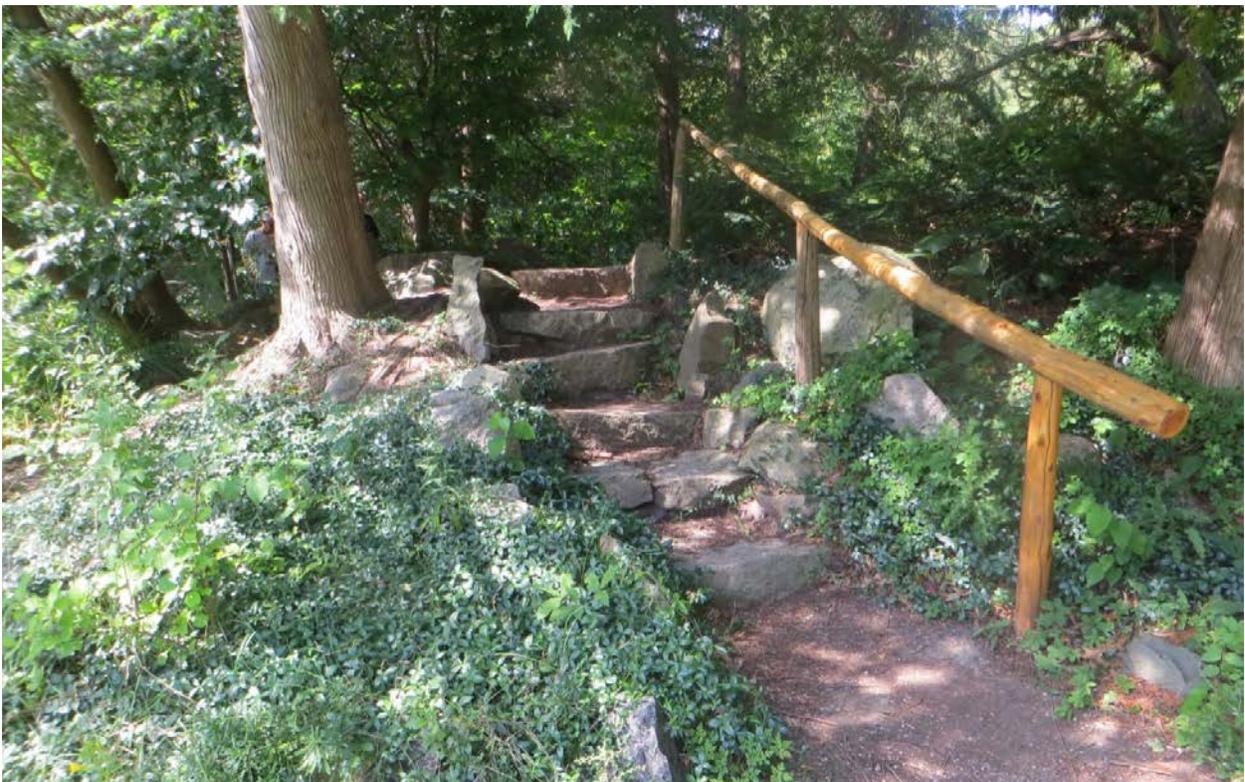
Figure 3.31 View north to the south set of stone steps and cedar rail by the Flowing Well Cascade. QEA, August 2017.

Several stone stairways and sloped paths transition the grades between upper and lower circuits. Of the connections, five sets of stone steps remain in roughly the same location with stone materials. These include the paired stone steps at the Flowing Well Cascade, two flights of steps between upper east walk and lower east walk at northeast landing and at Round Island, and two flights of steps between the Lakeside Walk and the lower west walk near the East Water Gate and near the Japanese Bridge (Figures 3.31, 3.32, 3.33, 3.34, 3.35, 3.23, and 3.36).

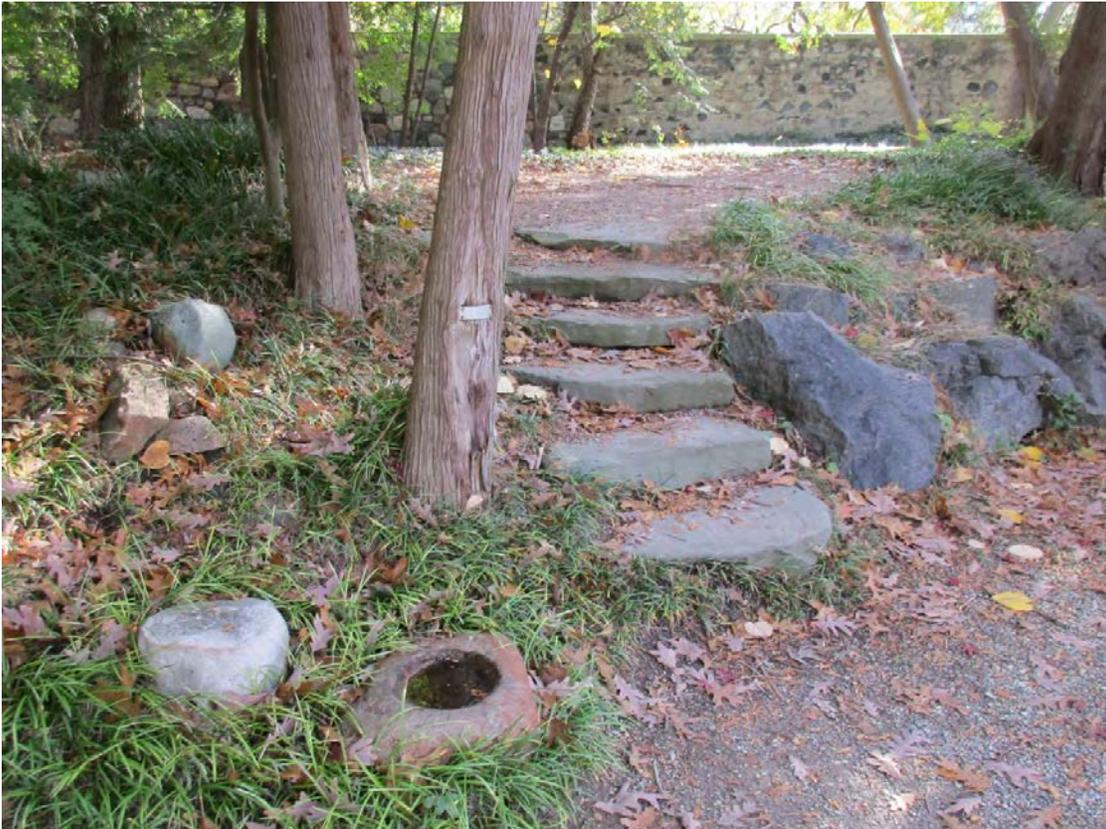
Figure 3.33 View east toward the stone steps between the upper west trail and the northeast landing. A stone water basin and plaque on a tree trunk appear in the foreground. The fieldstone perimeter wall appears in the background. QEA, October 2017.

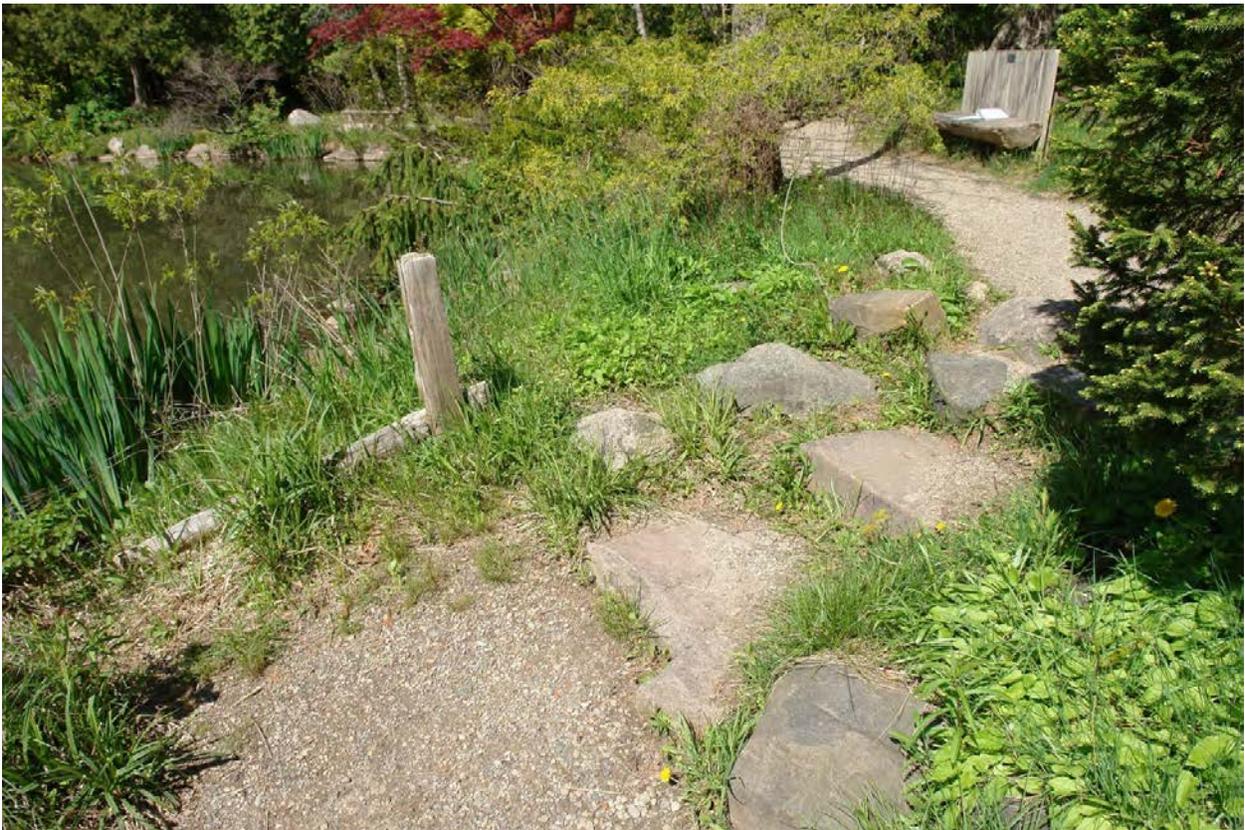
Figure 3.35 Stone steps from the upper east walk align with the bridge to Round Island. A remnant fence post and a wood bench appear along the edge of the pathways. QEA, May 2017.

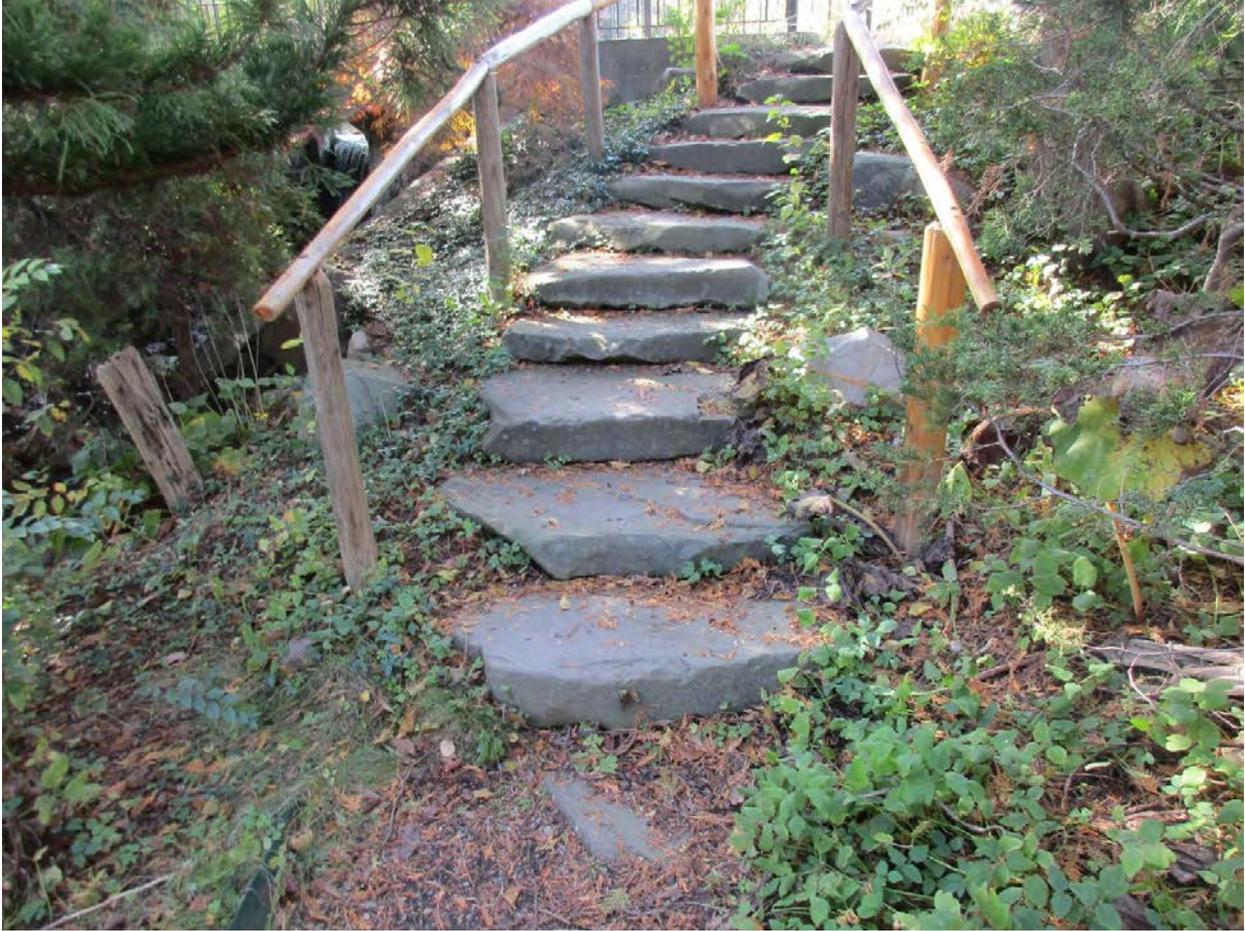
Figure 3.36 Stone steps between the Lakeside Walk and the lower west walk. An older fence post projects from the slope to the side of the new railings. QEA, October 2017.

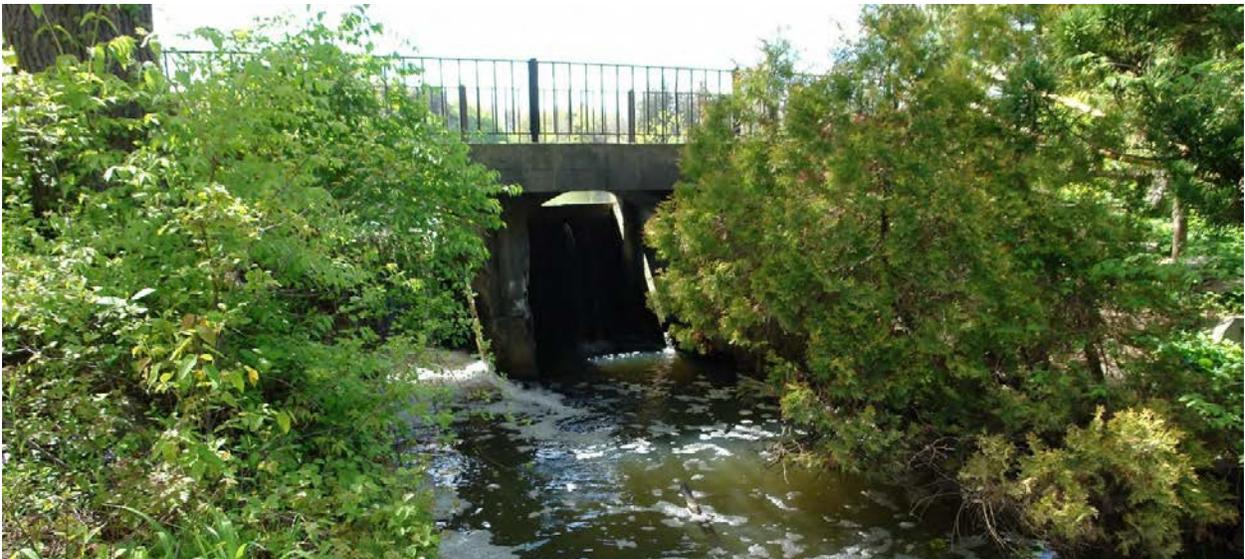
Figure 3.37 The bridge at the East Water Gate on the Lakeside Walk spans the inlet for the Lily Pond. QEA, May 2017.

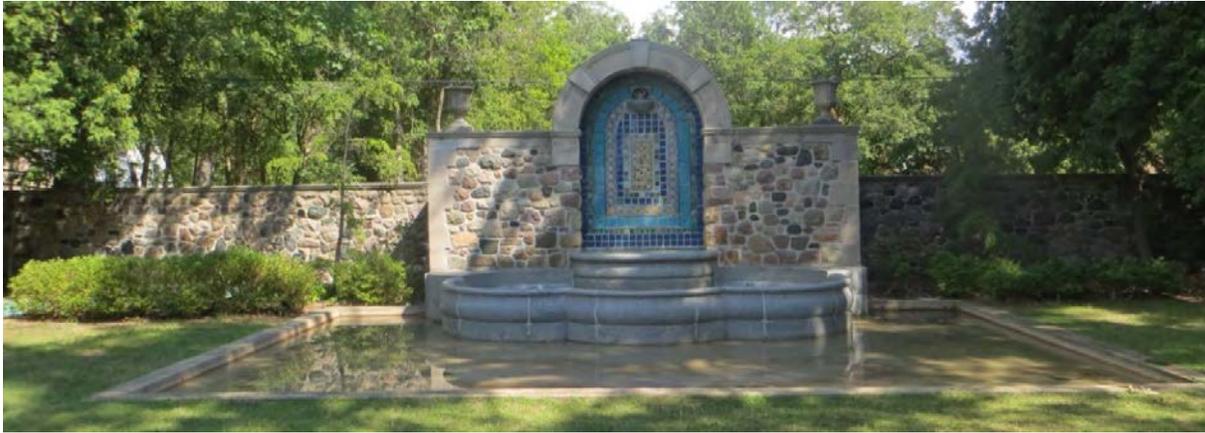
Figure 3.38 Integrated with the fieldstone perimeter wall, the Rainbow Fountain is visible northwest of the Japanese Garden. The source of water for the Flowing Well Cascade historically fed the fountain. QEA, August 2017.

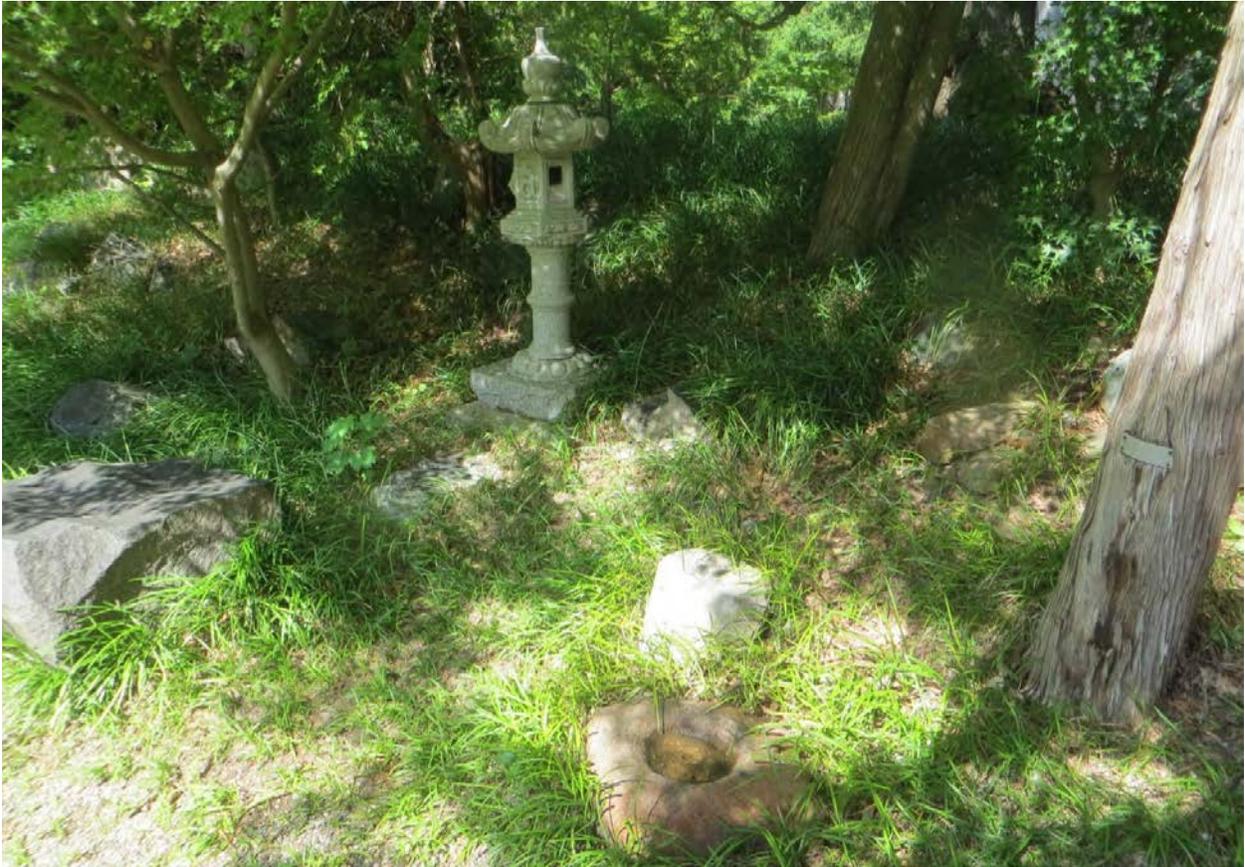
Figure 3.40 A pedestal-style lantern, similar in style but smaller than the Yokohama lantern, is located near a stone wash basin and instructional plaque on a tree at the northeast landing. QEA, August 2017.

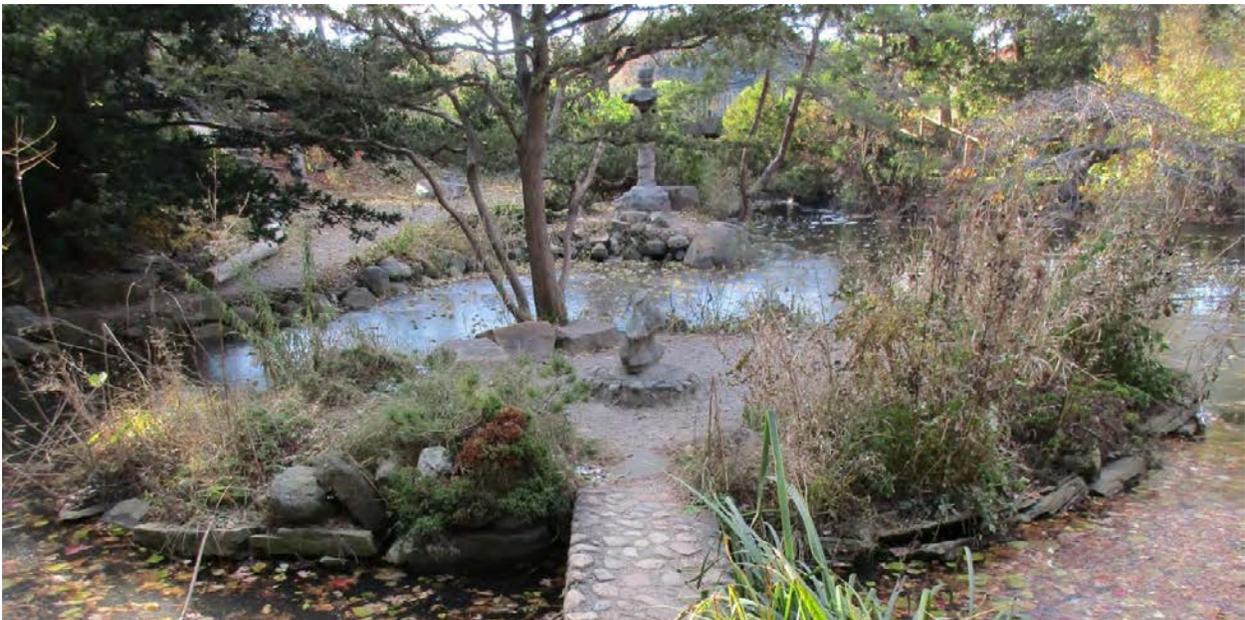
Figure 3.41 A sculptural stone is mounted to a concrete and cobblestone pedestal on Round Island. QEA, November 2017.

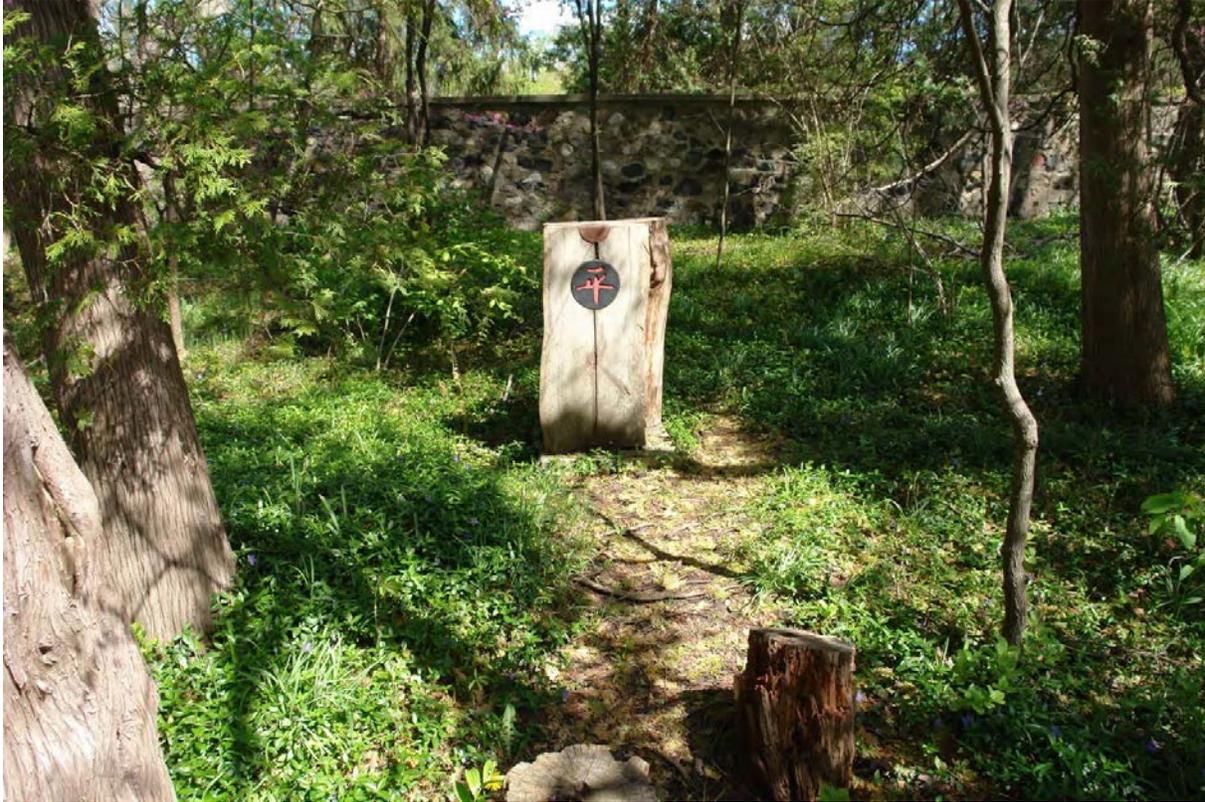
Figure 3.42 A sculpture incorporating a metal disc within a tree trunk is installed between the perimeter wall and the upper east walk. QEA, May 2017.

Excellence.” South of the fountain, a wood and metal sculpture stands within a wooded setting between the perimeter wall and the upper east walk (Figure 3.42). A remnant sculpture also lies against a bamboo screen on the north side of the path between the Japanese Bridge and the Lakeside Walk (Figure 3.16).
