Cranbrook Japanese Garden Historic Landscape Study

January 2018

Cranbrook Center for Collections and Research
Cranbrook Educational Community
Bloomfield Hills, Michigan

QUINN EVANS
ARCHITECTS

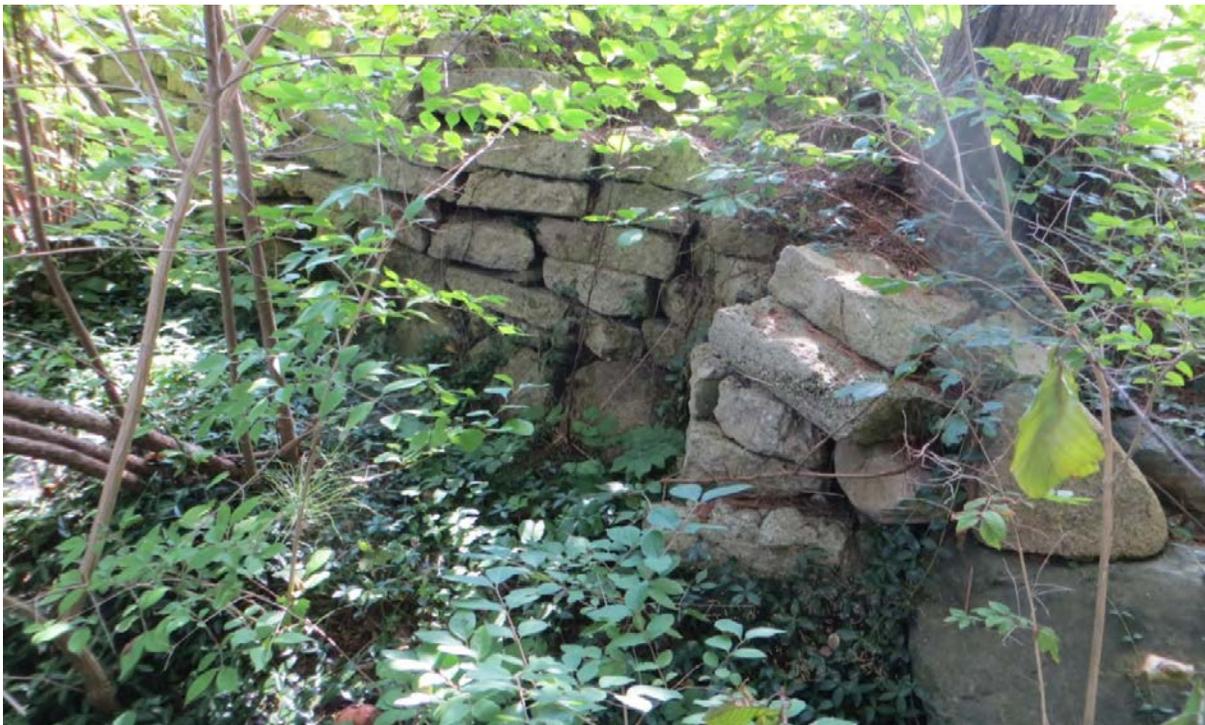
Figure 3.42 Stacked concrete blocks form a retaining wall below the Lakeside Walk north of the East Water Gate. QEA, August 2017.

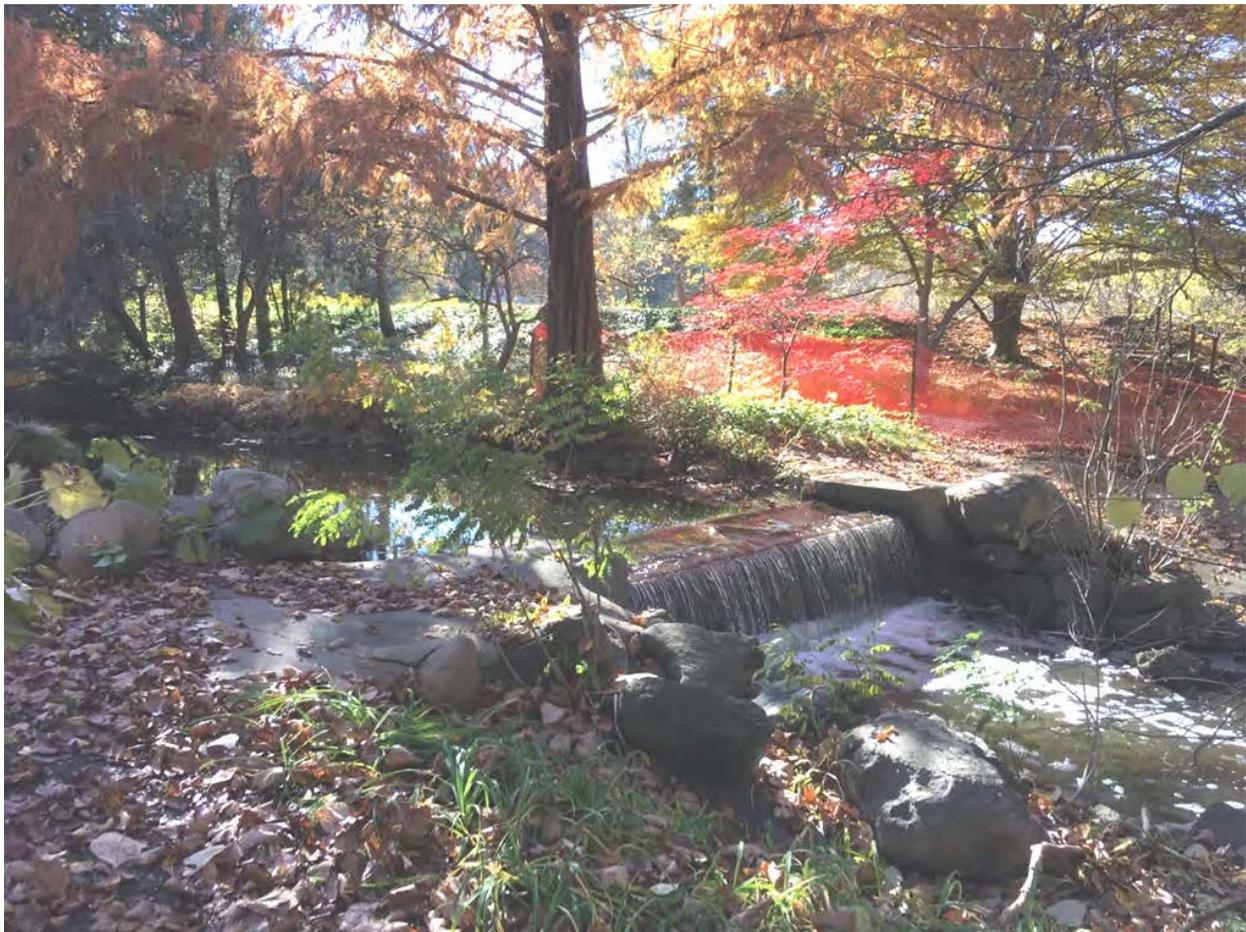
Figure 3.43 The Japanese Bridge dam controls the water level of the Lily Pond. This view toward the southwest indicates how sound from the waterfall would project to the north. This photograph shows the dam during reconstruction of the Japanese Bridge. QEA, November 2016.

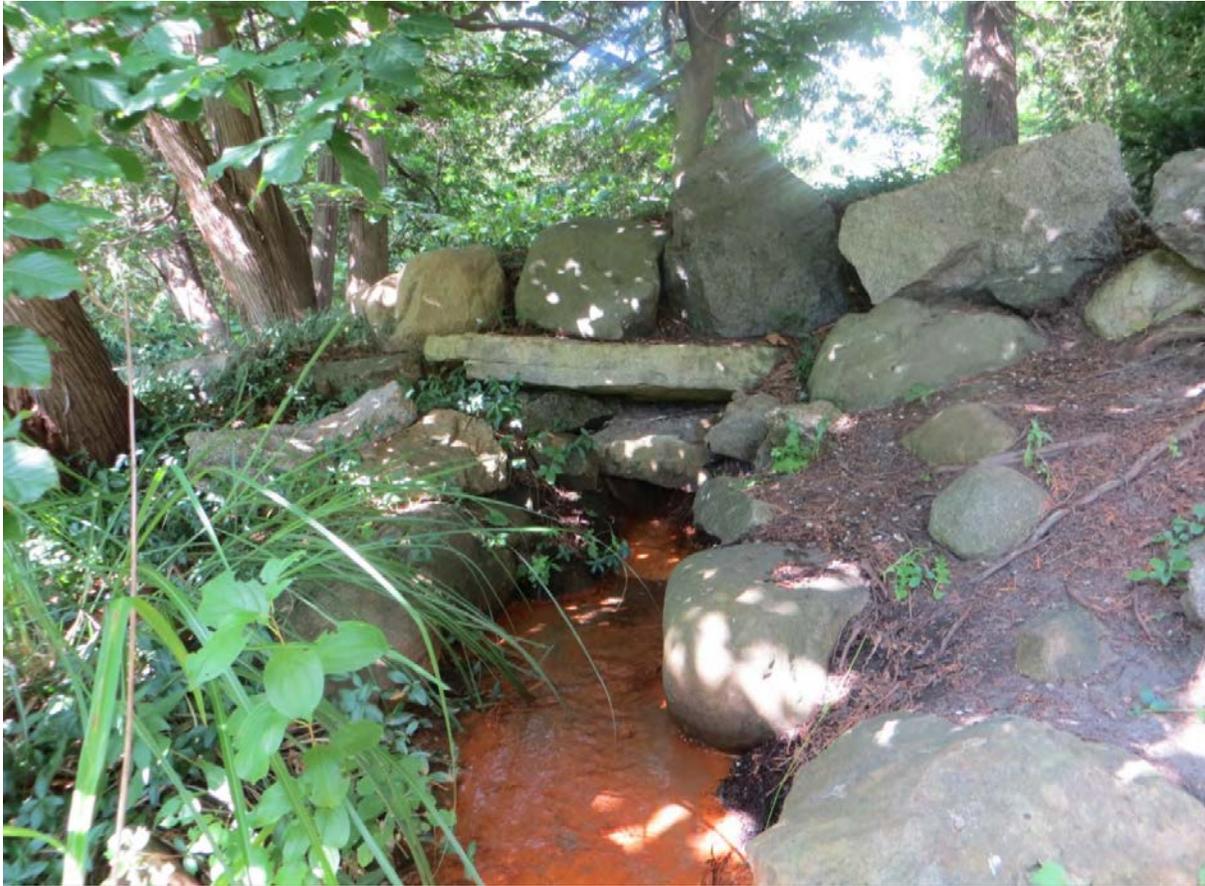
Figure 3.44 High iron content from the natural spring stains the channel of the Flowing Well Cascade. QEA, August 2017.

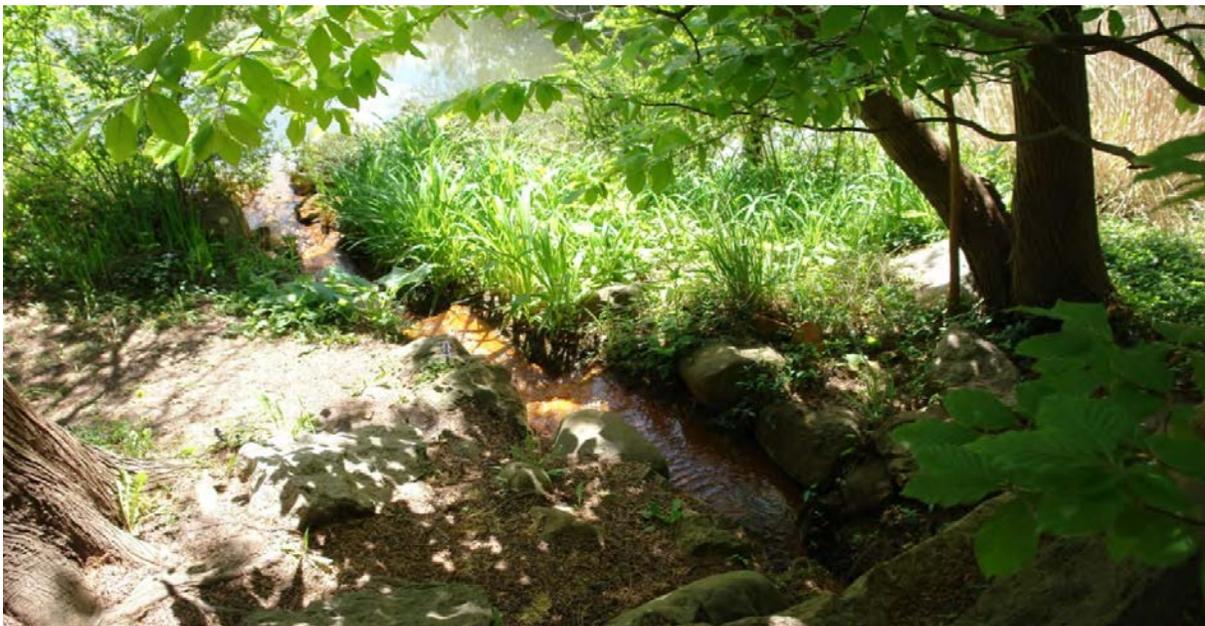
Figure 3.45 Vegetation covers the stones that define the Flowing Well Cascade. QEA, August 2017.

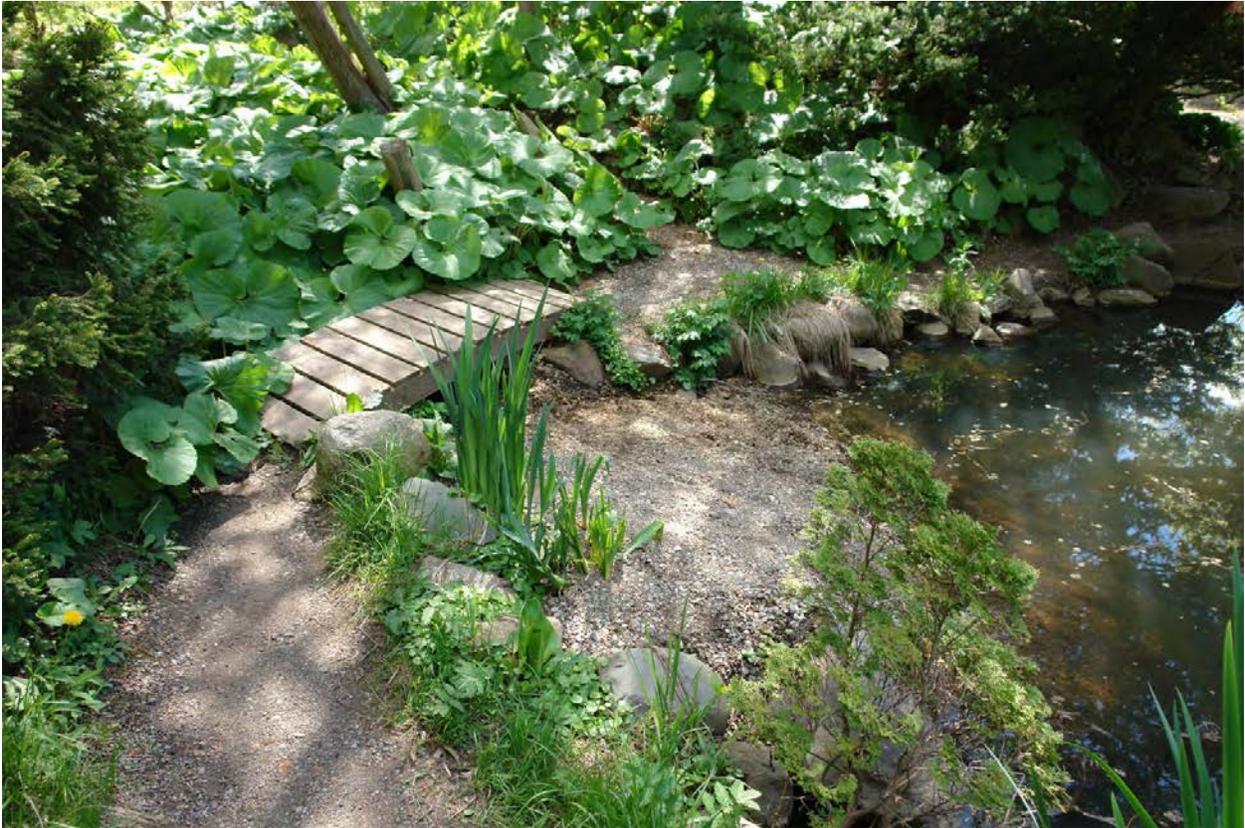
Figure 3.45 The large-leafed butterbur, a small wooden bridge cover the dry bed of the Lily Pond Cascade at its gravel delta. QEA, August 2017.

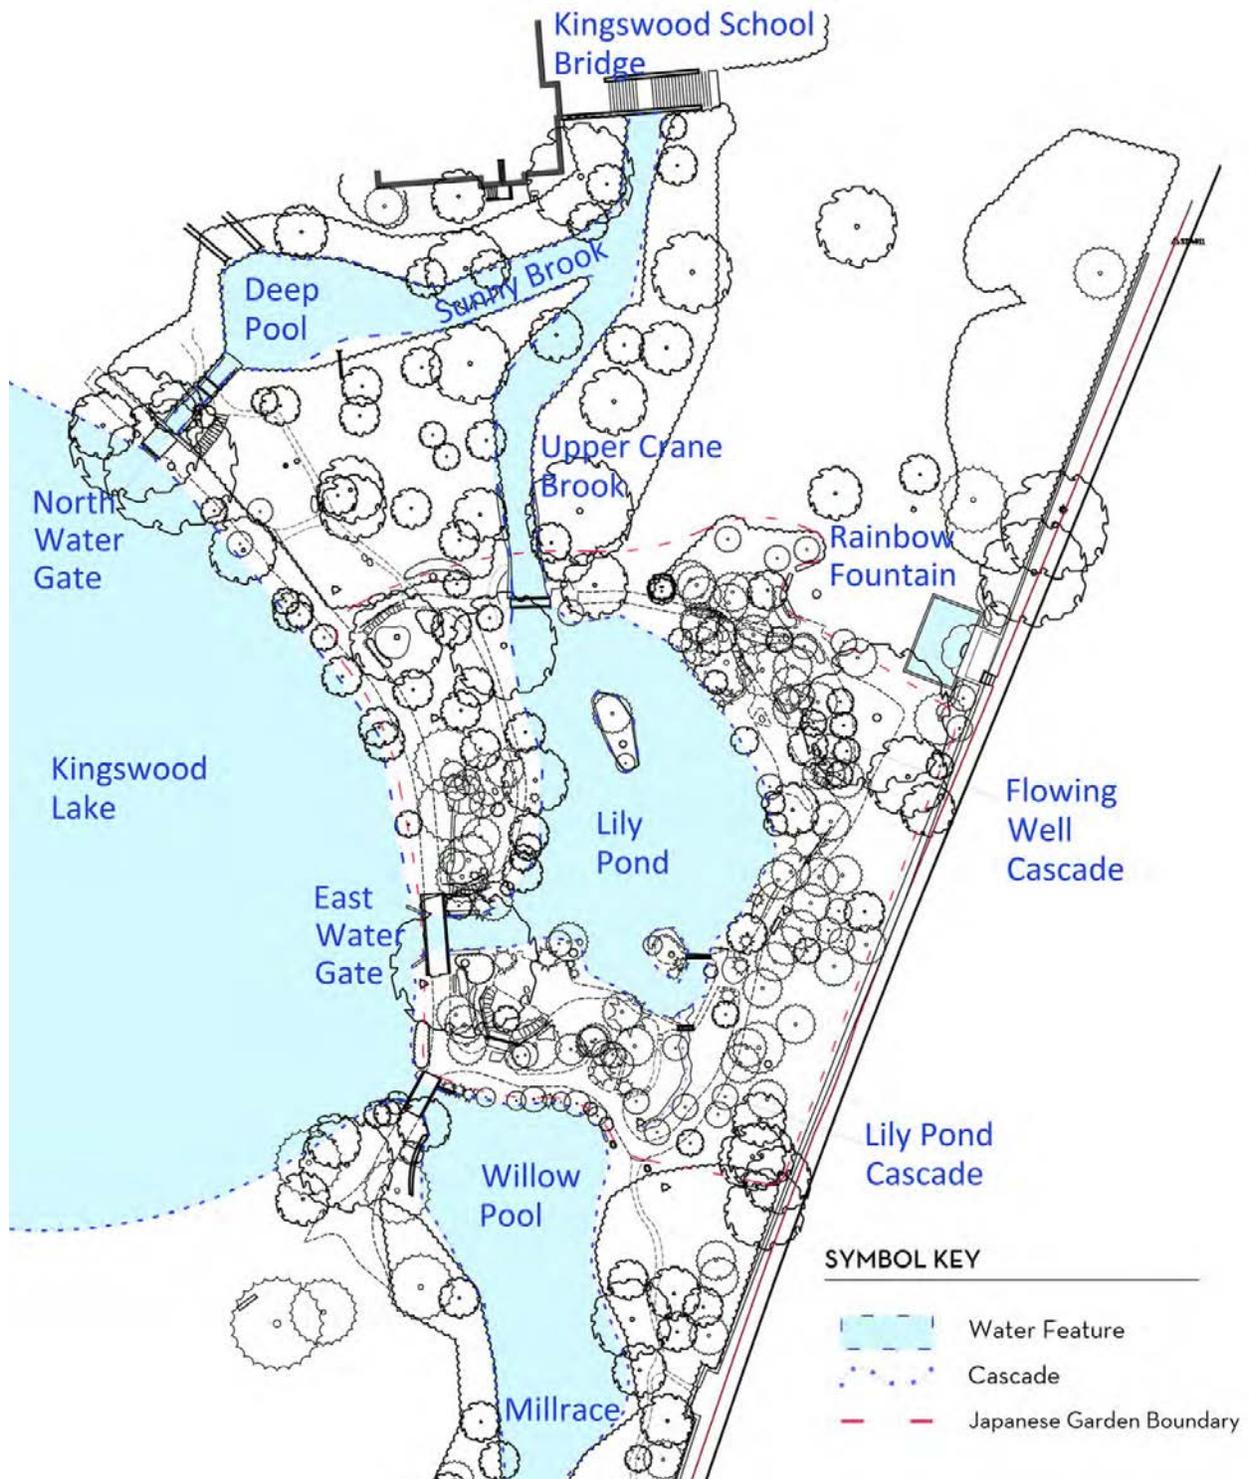
Figure B.1 Water related features in the vicinity of the Japanese Garden. QEA, 2018.

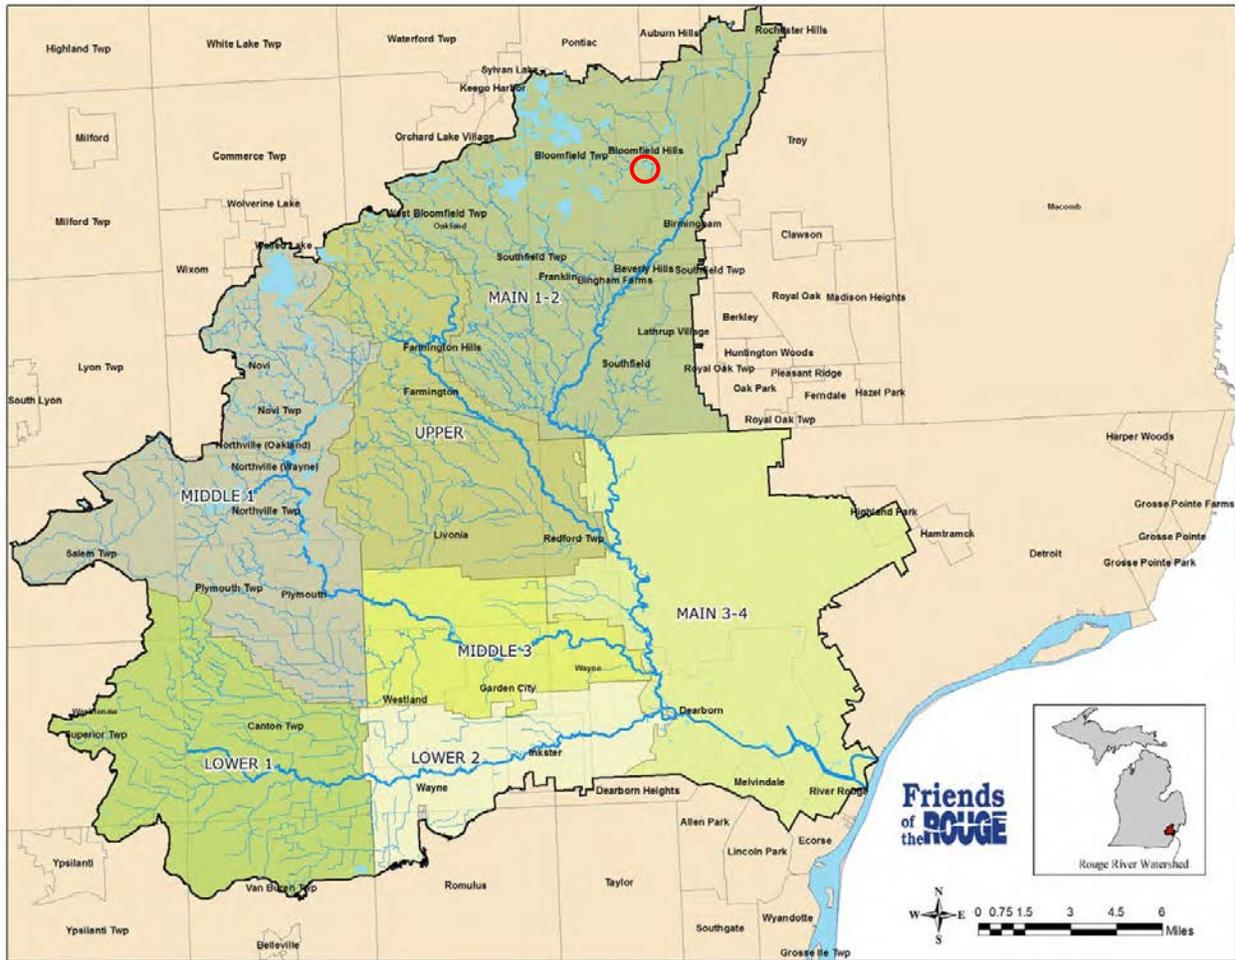
Figure B.2 Rouge River watershed map with Cranbrook circled in red. Friends of the Rouge River, 2017.

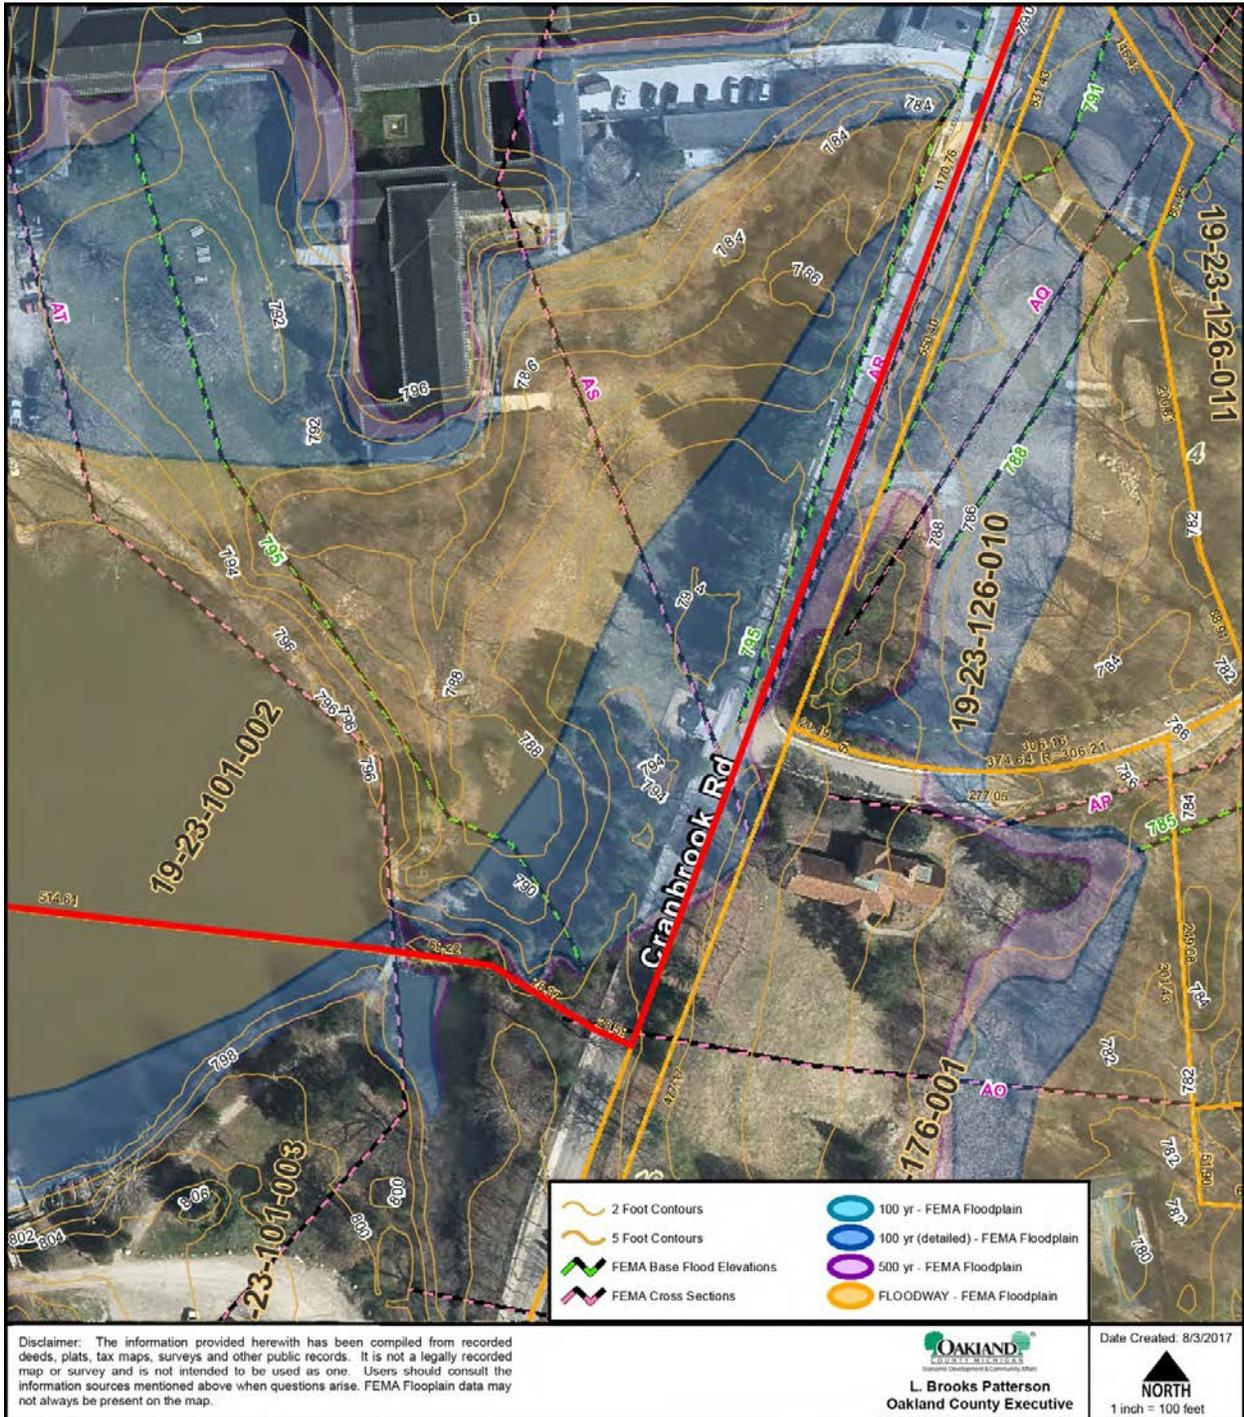
Figure B.4 FEMA floodplain data for the Japanese Garden area. City of Bloomfield Hills, 2017.
